### KIAMA MUNICIPAL COUNCIL COASTAL PROTECTION ACT 1979

# COASTAL ZONE MANAGEMENT PLAN FOR THE CROOKED RIVER ESTUARY

Final Version November 2015

Crooked River Coastal Zone Management Plan

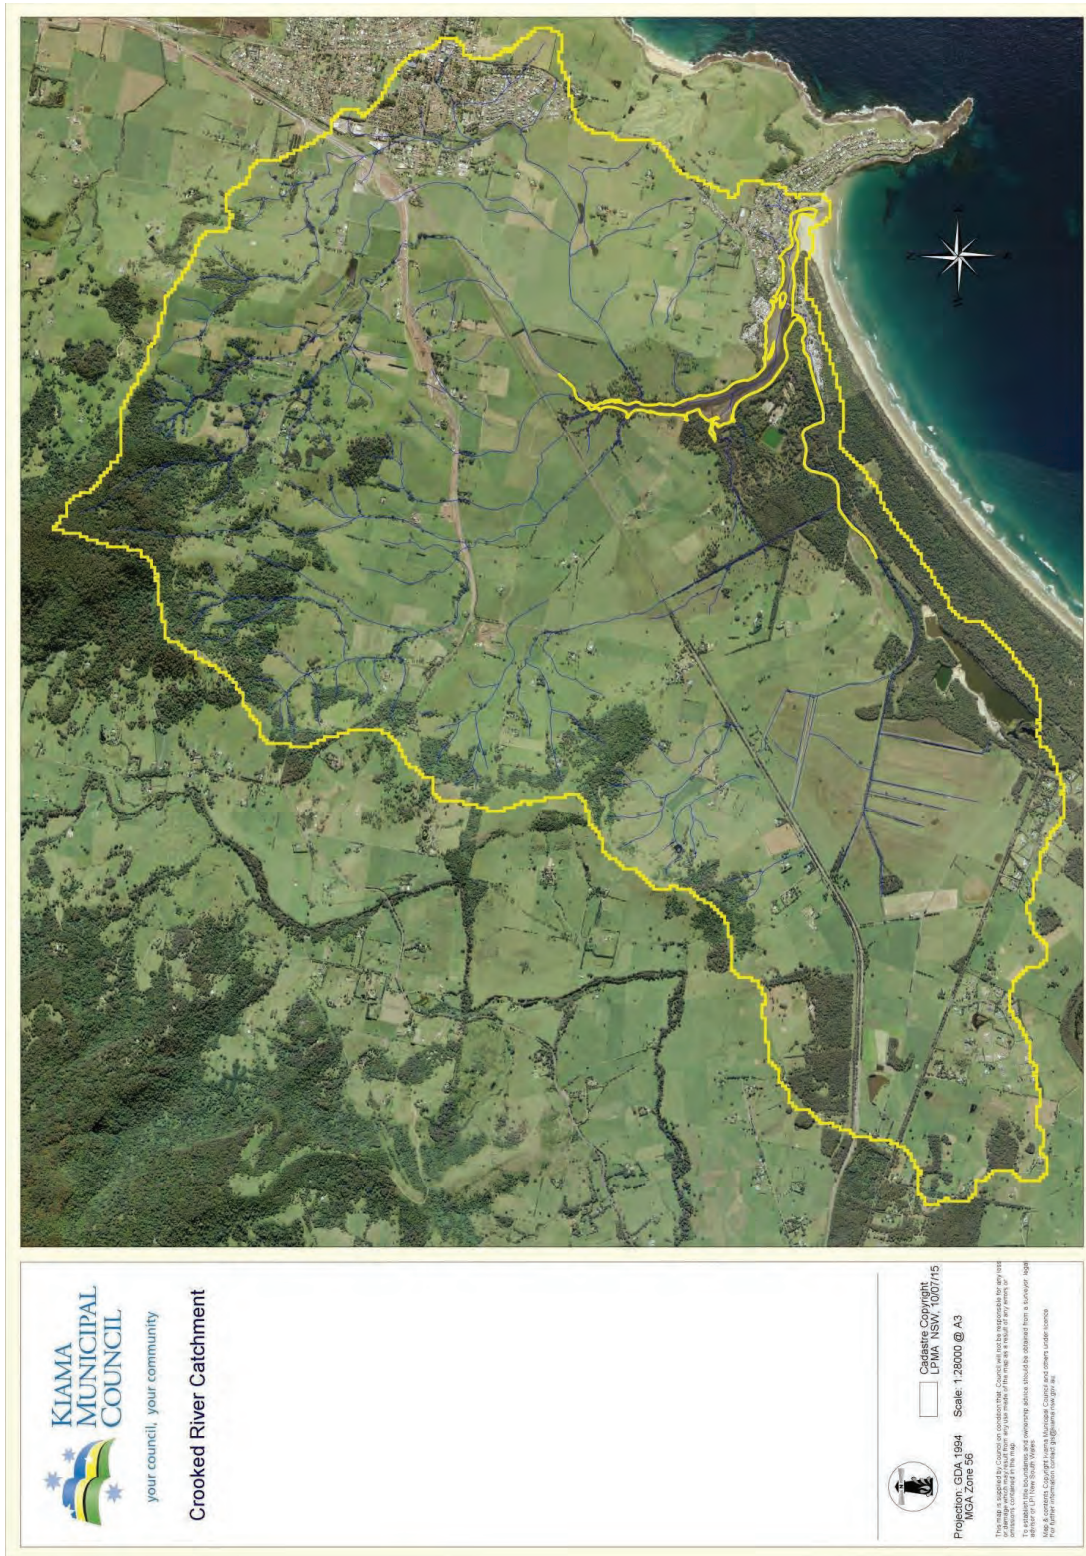
Figure 1: Crooked River catchment and natural drainage

Figure 1, depicts the Crooked River catchment area over which this plan applies. The study area comprises the tidal waterways and foreshore adjacent to the Crooked River estuary including the entrance and tributaries. Greater emphasis is placed on the estuarine reach, however consideration is given to other areas of the catchment where issues or processes are potentially affecting estuary health, as the condition of the estuary is heavily influenced by catchment wide factors.

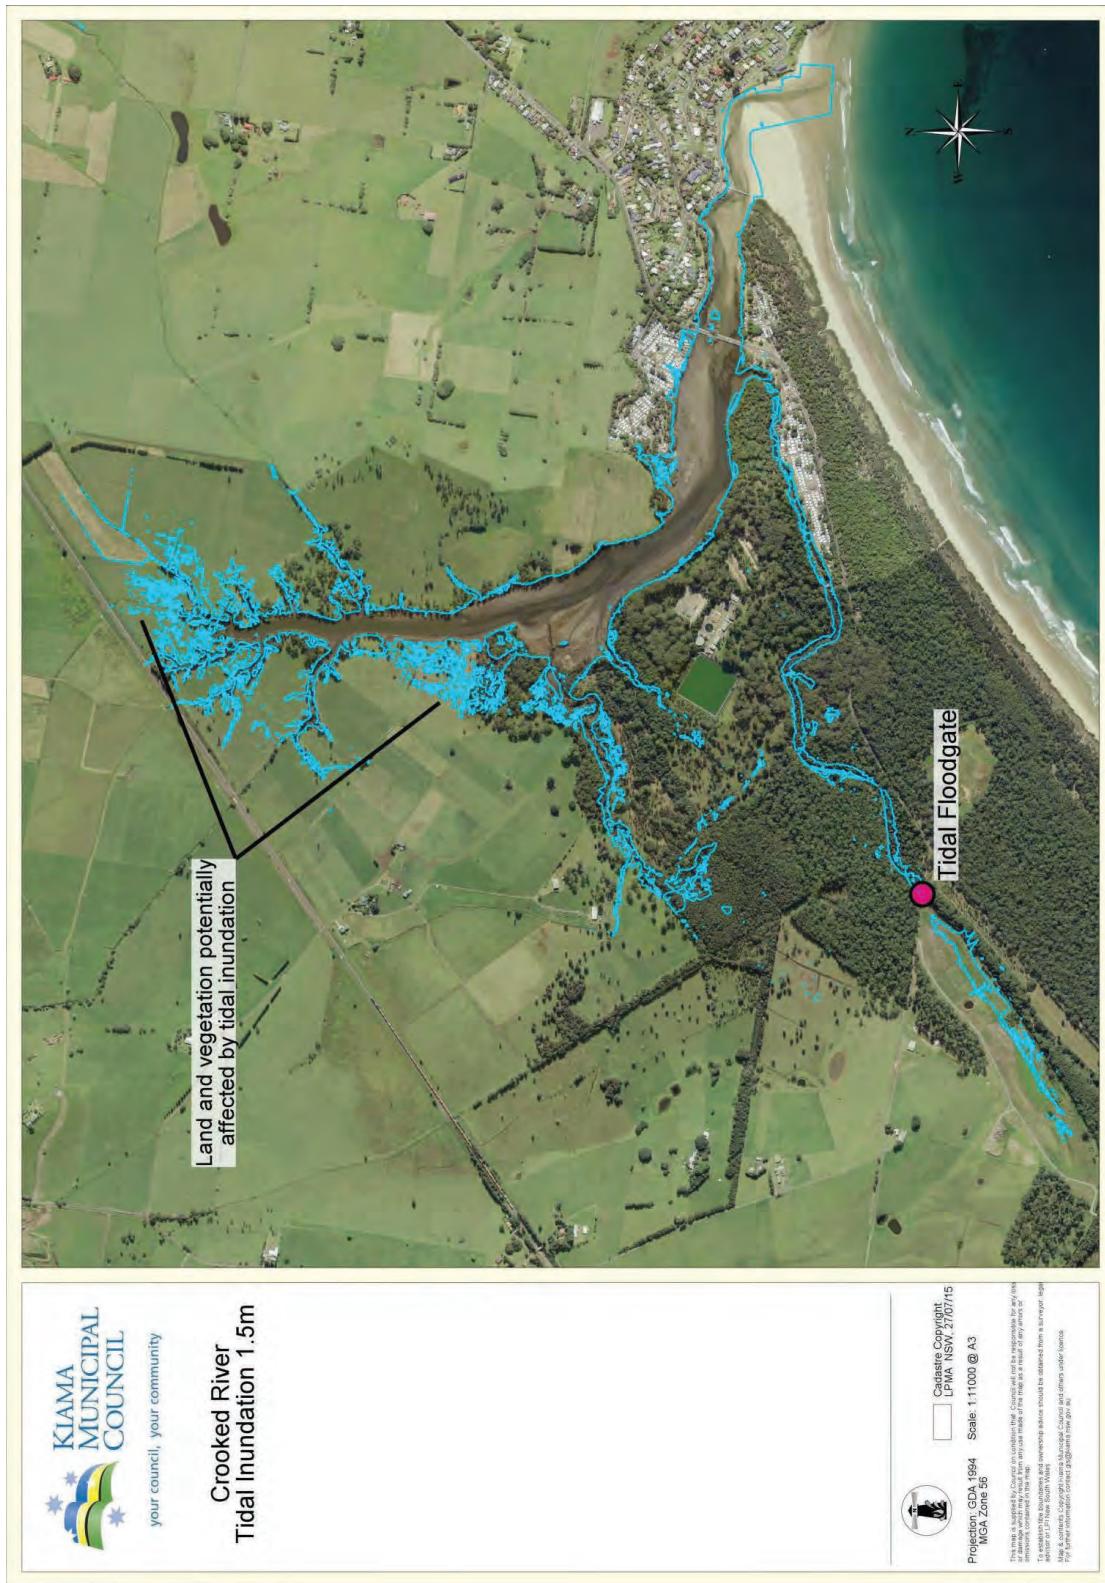
Figure 3 (a): Crooked River tidal inundation mapping 1.5m

In the absence of any Kiama specific sea level rise projections, Kiama Council has adopted the benchmarks as described in 2009 by the former NSW Government policy, until further research is available. Simple inundation modeling was undertaken to determine likely scenarios for 2050 and 2100 in relation to tidal conditions due to sea level rise. The tidal plots comparing Crooked River estuary tides and ocean tides are shown in Figure 5. These show that when the tide enters into the Crooked River estuary there is very little attenuation of the high tide, however the low tide appears to be greatly attenuated.

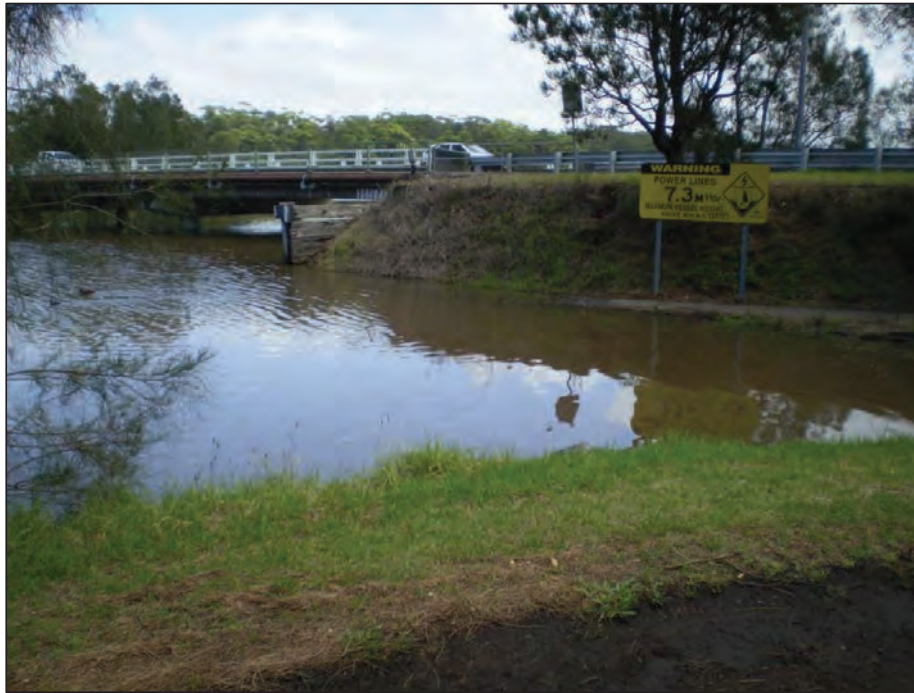
**Figure 4: Flooding of the pedestrian underpass at the Crooked River Road Bridge, Gerroa in January 2012**

Anecdotally, minimal inundation does occur along parts of the foreshore of the Holiday Park fronting the northern bank of the Crooked River and the pedestrian underpass for Crooked River Road is periodically under water (Figure 4). As well as inundation, flood waters have particular impact in the scouring of creek / river banks. A recent incident following a major rain event occurred in the Blue Angle Creek in February 2014 (right), where scouring of the channel exposed the bank sediments to the atmosphere and washed large amounts of organic matter into the creek. Subsequent oxygen demand of the decaying matter and natural sulfate reducing bacteria most likely were responsible for low dissolved oxygen conditions, a sulphurous odour and a small number of fish mortalities.

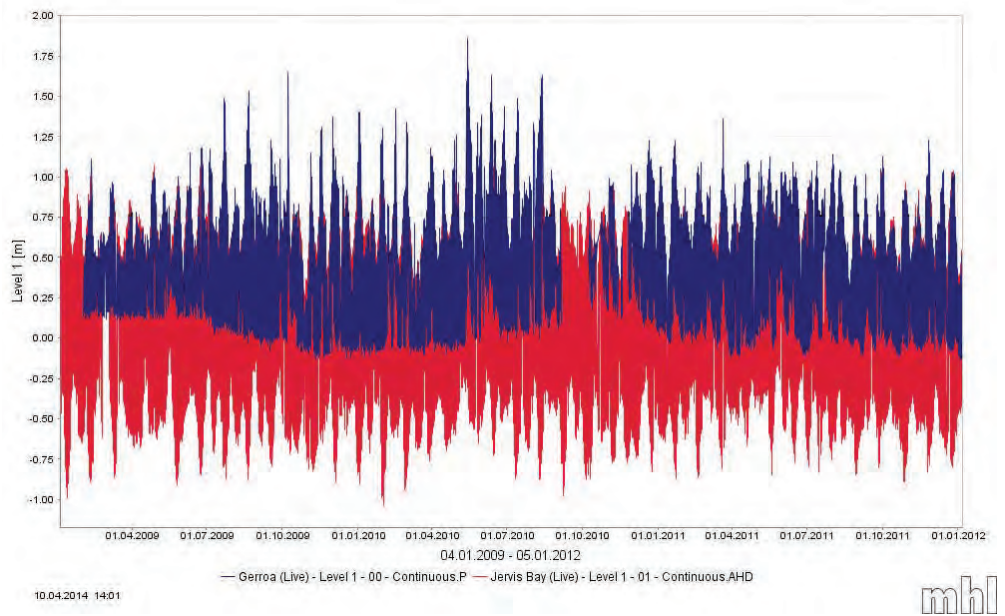
Figure 5: Crooked River water level gauge data overlaying HMAS Creswell ocean tidal gauge data

A tidal environment influences the Crooked River estuary when the entrance is open, and due to the river's in-filled nature, tides are enhanced. This facilitates the deposition of marine sediments in the lower reaches of the estuary, leading to sometimes extended periods of closure. Whilst the tidal range of the Crooked River is at times significantly less than the ocean, it appears from the water level gauge data that the high tide propagates into the estuary at near 100% of the ocean tide. This is demonstrated in Figure 5, which is the Crooked River water level gauge data, overlaying the HMAS Creswell (Jervis Bay) ocean tide gauge data. A flushing time of 4.2 days (OEH 2011), means that Crooked River is relatively well flushed when compared with other Intermittently Closed and Open Lakes and Lagoons (ICOLLs).

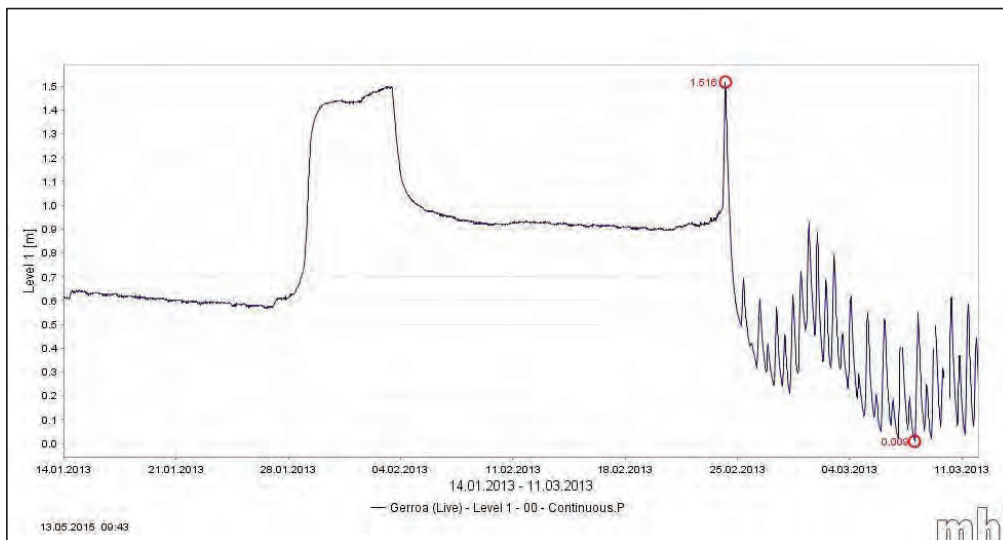
**Figure 6: Crooked River artificial opening event February 2013**

The issue of the entrance closing is still a concern in the wider community, and there have been incidents of illegal opening of the estuary entrance. One such instance on 4 February 2013 led to the sand around the boat ramp at the mouth of the Crooked River being washed away, demonstrating not only that unmanaged opening of the entrance can cause ecological damage, but can also affect different user groups who utilise the facilities at the Crooked River entrance. The water level gauge data also shows that this artificial opening only led to a partial draining of the estuary, and not a reinstatement of tidal flow, with the full opening of the system occurring on 24 February 2013 following heavy rainfall. This is depicted in Figure 6.

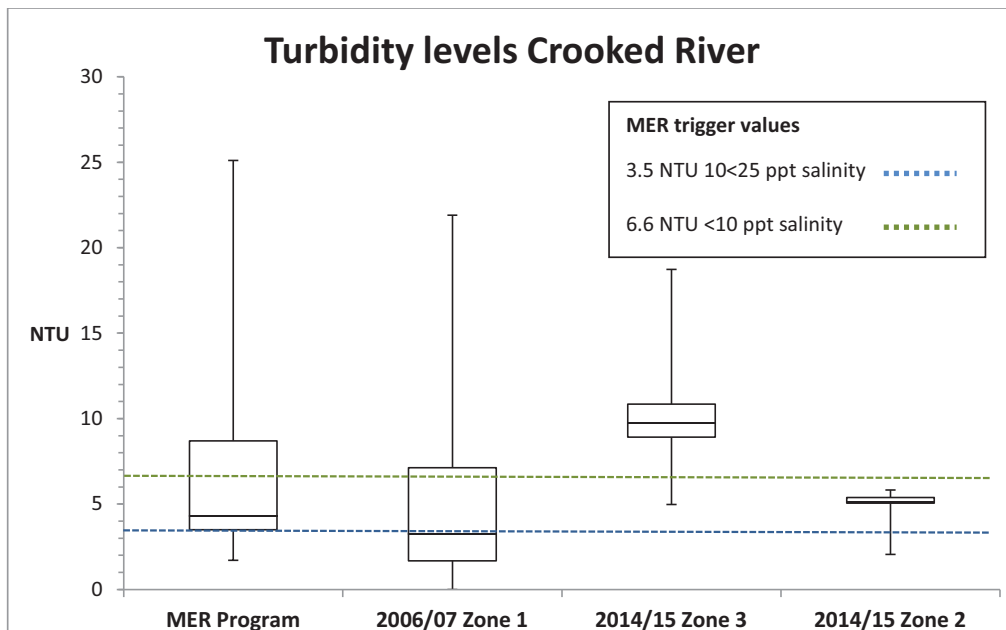
Figure 8(b): Turbidity levels in Crooked River

Figure 8(b) represents the sampling data from the NSW MER Technical Report Series for the state of the catchments report, the 2006/07 Kiama Council sampling data and the 2014/15 MER sampling. The data shows that at times the Crooked River has high levels of turbidity, particularly in the upper part of the estuary.

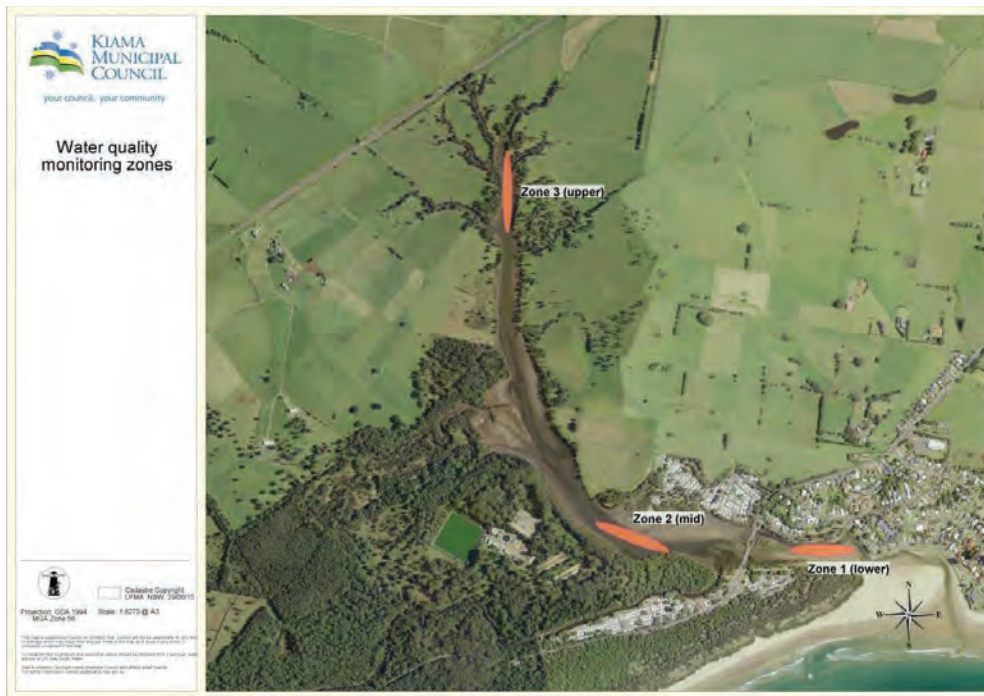
**Figure 9: Sampling Zones involved with the 2013-14 Estuary Health Monitoring**

*Chlorophyll a* results showed that of the 17 monthly samples collected and analysed, 5 samples exceeded the 2.9ug/L trigger value. All except one of those *chlorophyll a* samples was taken in Zone 3, at the upper limit of the estuary. The maximum *chlorophyll a* sample was 14ug/mL which is half the worst expected value of 30ug/L, as determined by the Office of Environment and Heritage MER strategy. The sampling zones for the 2013-14 sampling can be seen in Figure 8.

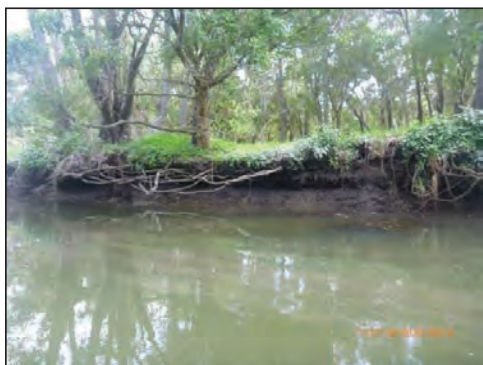
Figure 11(a) Upper estuary bank erosion

Formalising access and creating riparian buffer zones may deal with some of the issues. It is expected that a mix of hard (10d) and soft engineering solutions will be required to provide the best outcome for asset protection and ecological and habitat value.

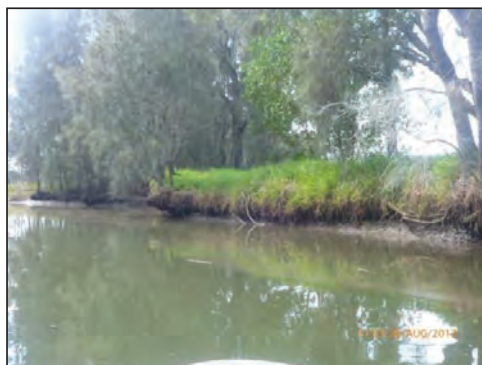
Figure 11(b) Mid estuary bank erosion

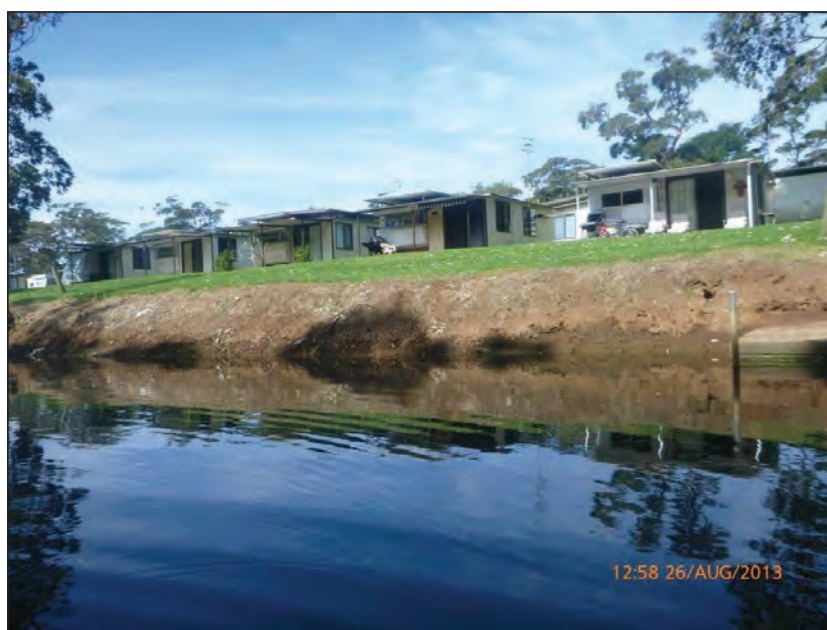
Figure 11(c): Areas of exposed bank in Blue Angle Creek

Options	Description	Figure	Pros	Cons
Manage erosion occurring on Council controlled and community land	Engage engineering expertise to assess and propose design plans for bank erosion occurring in Blue Angle Creek and Crooked River	Figure 11,12 Action 2.1	Reduces sedimentation of the Crooked River estuary  Benefits assets which are at risk from erosion  Can be used to formalize access to riparian area	High cost of rock wall stabilization and other engineering solutions  A substantial flooding event may still result in erosion of the bank  Maintenance of rock walls

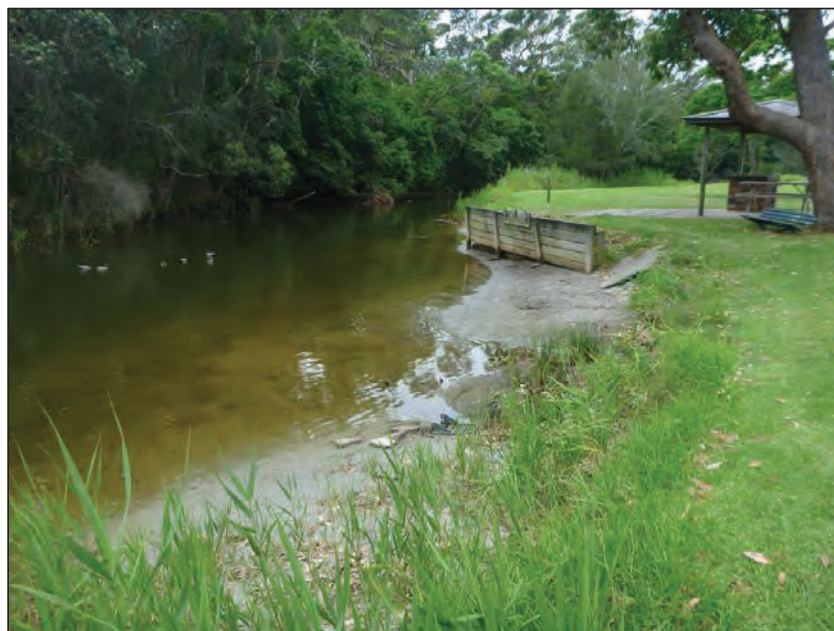
**Figure 11(d): Erosion occurring in Blue Angle Creek**

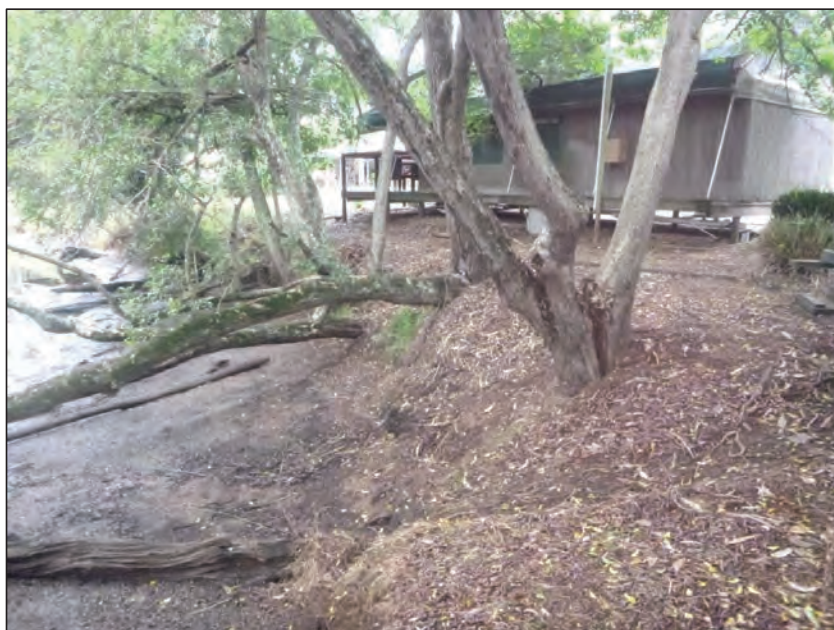
**Figure 11(e): Erosion occurring in Blue Angle Creek (photo D.Weicek 2015)**

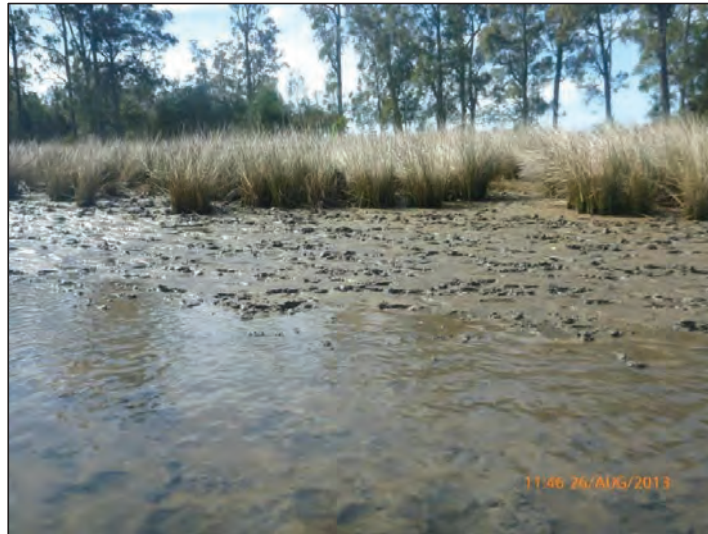
**Figure 15: Evidence of stock access to the main Crooked River channel**

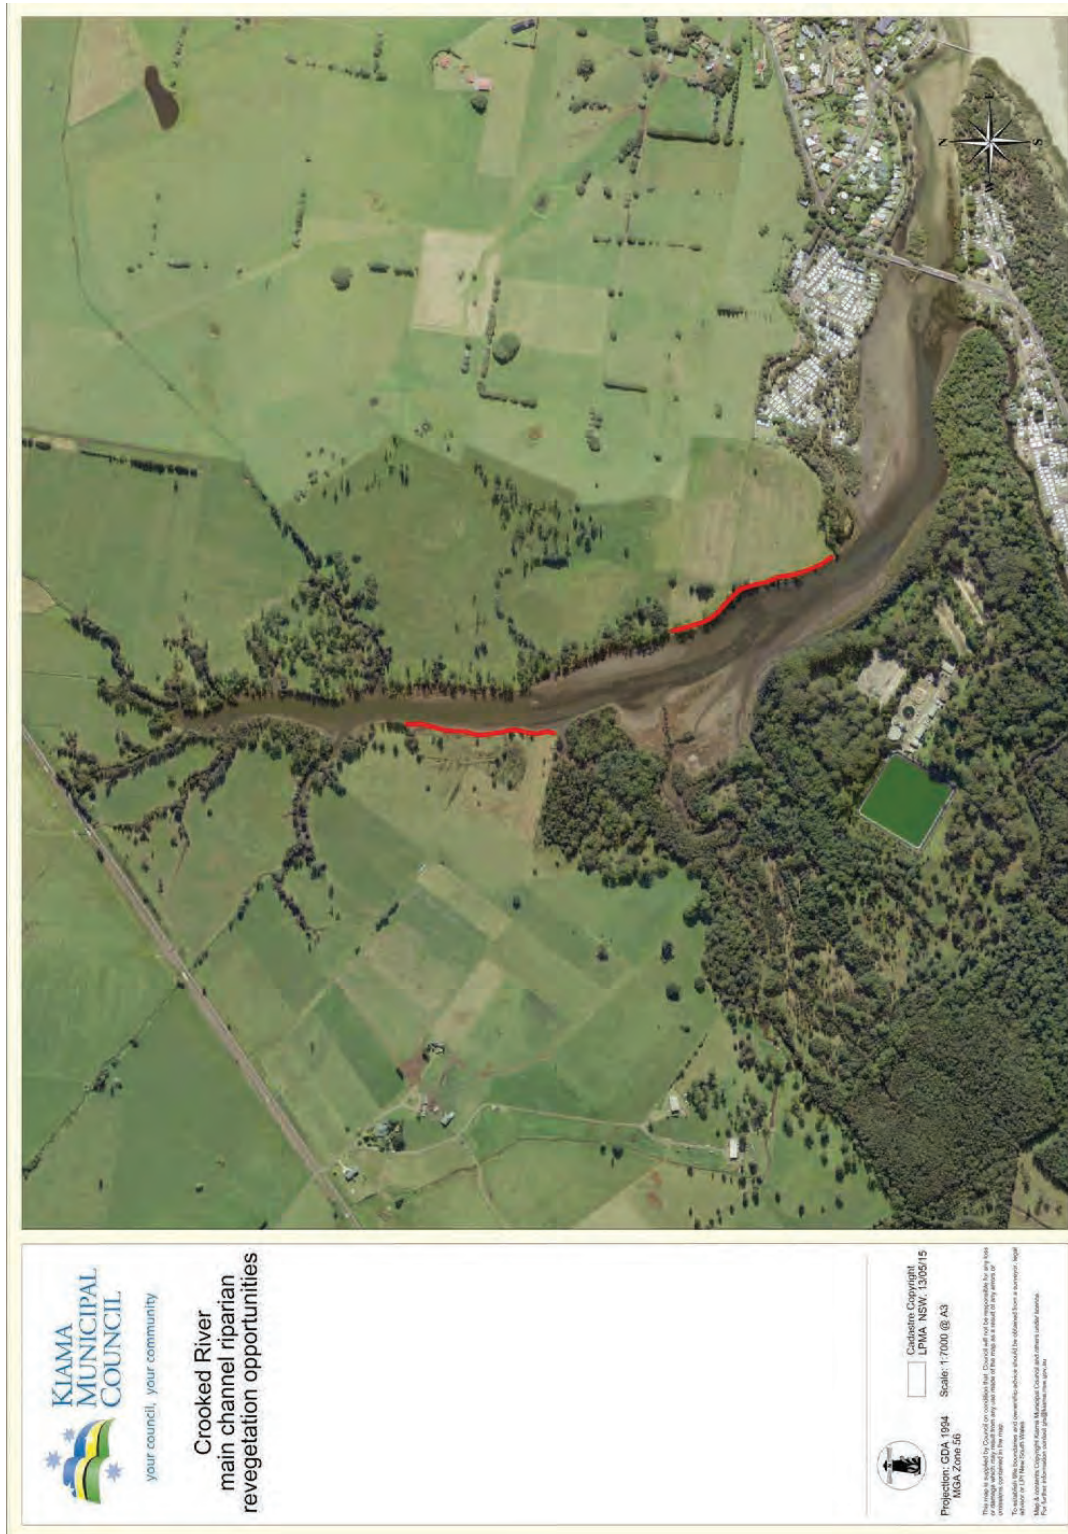
Figure 17: Crooked River main channel riparian revegetation opportunities

The Crooked River estuary has large tracts of riparian vegetation in its lower reaches in the Seven Mile Beach Reserve and Gerroa WRP property. The mid and upper estuary verges have riparian vegetation of varying width surrounding the majority of the estuary, however there are two notable areas where there is virtually no riparian vegetation. These areas are potential future fencing and revegetation projects for the Local Land Services and catchment landholders to undertake, subject to support and funding for these initiatives. These two areas are identified in Figure 17. As well as establishing connectivity in these areas, it is important for projects focused on weed control and

additional stock exclusion fencing and revegetation activities to be implemented throughout the catchment. These projects will add to the overall resilience of the freshwater tributaries and Crooked River estuary by increasing riparian buffer widths which will contribute to reducing the identified high nutrient levels and faecal contamination which periodically occurs in the main estuary body.

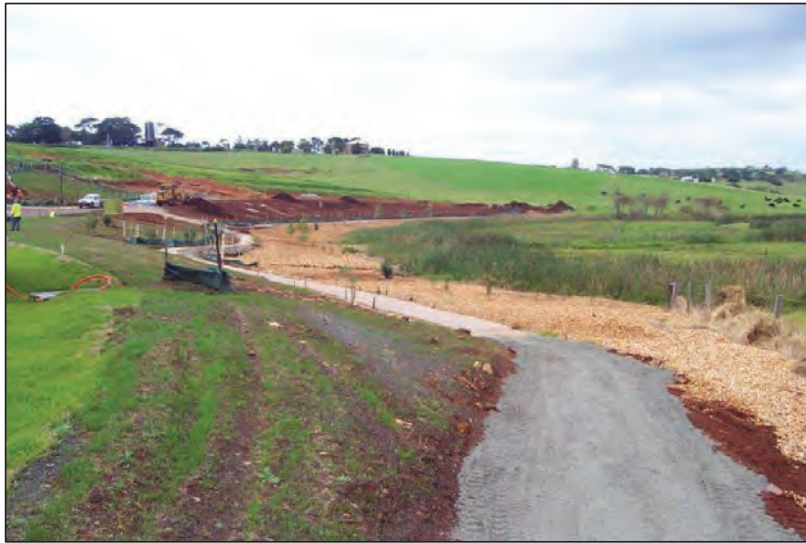
**Figure 21: Riparian rehabilitation Elambra Estate**

To deal with the change of land use and potential for environmental impacts associated with residential development of Elambra Estate, Kiama Council created Chapter 22 of Council's Development Control Plan 2012 dedicated to Elambra Estate – 'Chapter 22 – Site Specific Controls Elambra Estate'. Development controls include the requirement for onsite stormwater retention and re-use, all lots to be connected to sewer and dedication of riparian land abutting Union Creek is to be rehabilitated and dedicated to Council as public reserve. A Union Creek Plan of Management was also prepared, which detailed the requirements for the management of the riparian lands included in the Elambra Estate development including riparian plantings (Figure 21). The Union Creek Plan of Management can be viewed at Kiama Council's website [www.kiama.nsw.gov.au](http://www.kiama.nsw.gov.au), under the plans and policies section.

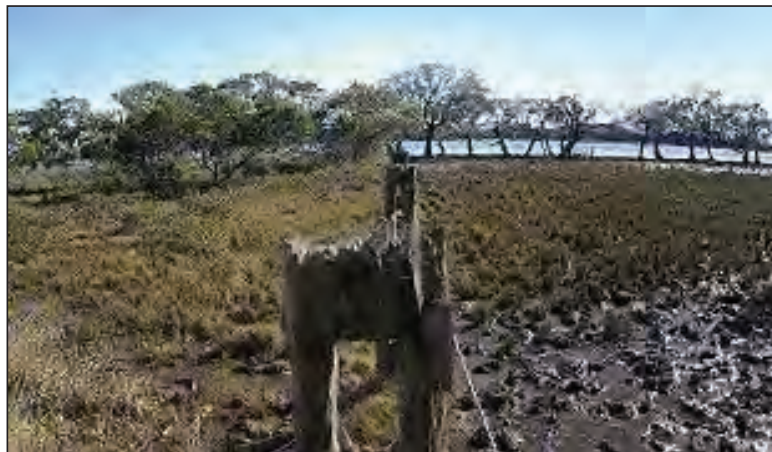
**Photograph sourced from NSW DPI website showing the impact of stock exclusion fencing on riparian zones (Photo L.Bogie)**

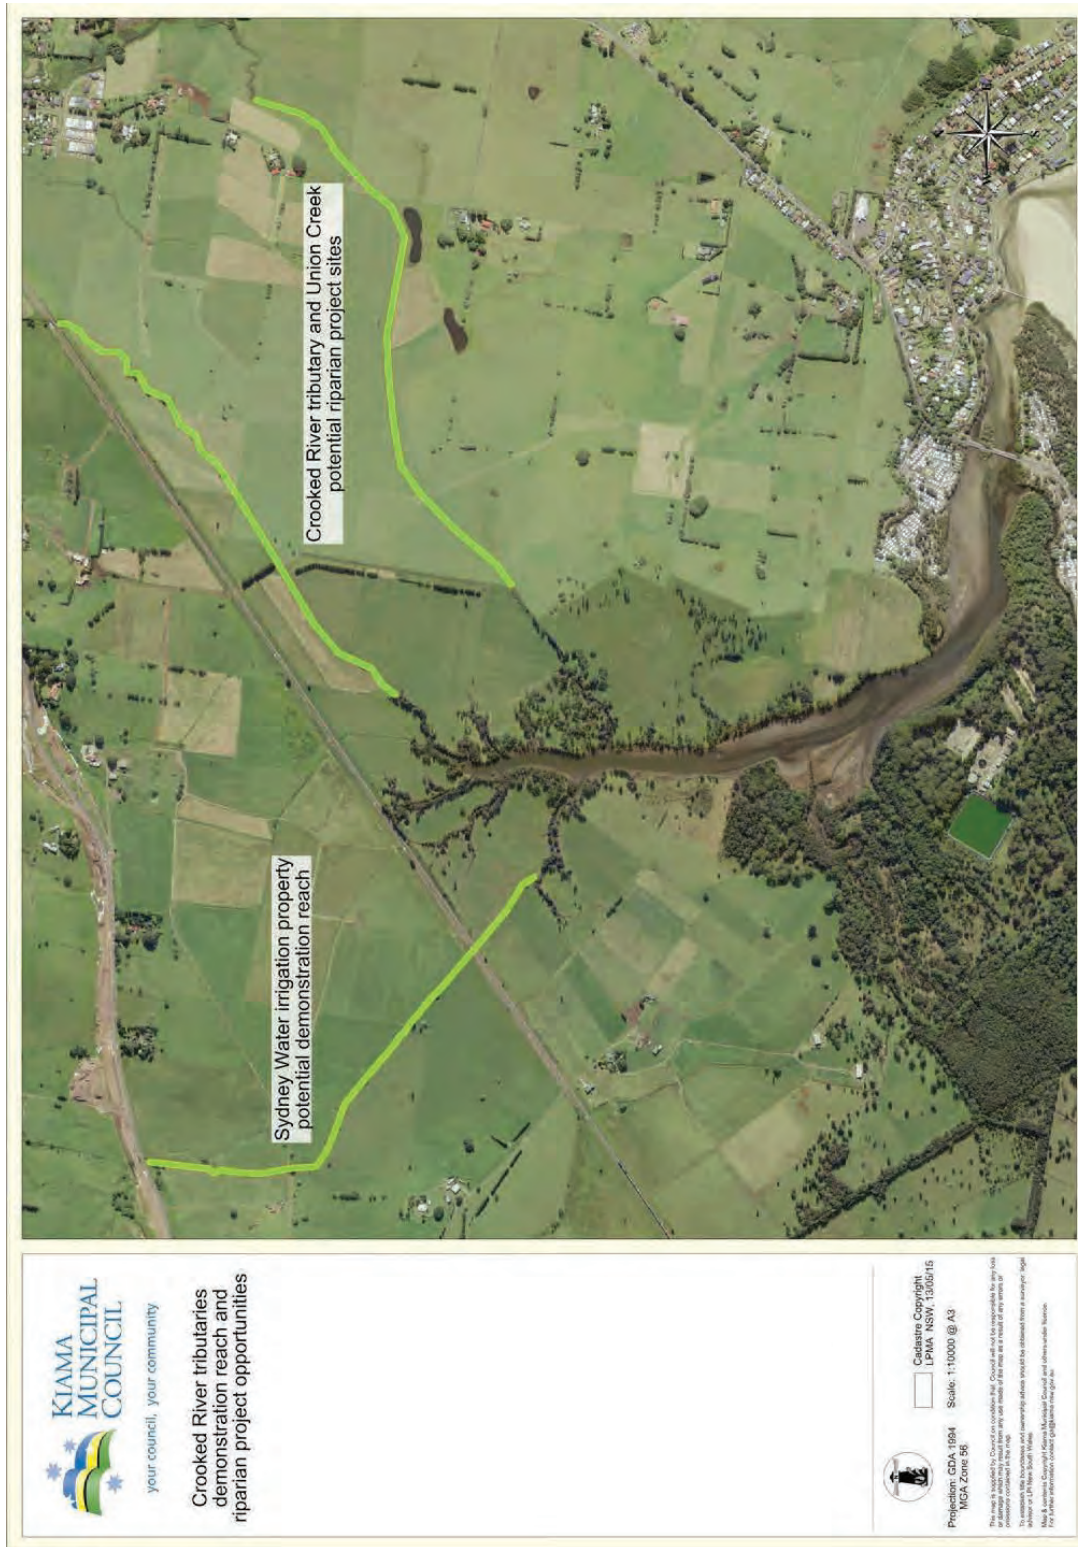
Figure 23: Potential riparian management demonstration reach, Sydney Water irrigation property and other tributaries, Crooked River

The demonstration reach concept would undertake projects to improve estuary health outcomes such as stock exclusion, off stream watering and riparian revegetation project which would be utilized to promote these activities within the catchment. A potential site has been suggested in Figure 23, as well as identifying other tributaries which could be considered for demonstration reach projects. The demonstration reach concept provides an opportunity to kick start or build momentum for investment in natural resource management strategies within a catchment, through completion of small scale projects which can be utilized in field days and build community connection through communication of ideas and methodologies. These projects are generally funded through grant funding opportunities and supported through state government agencies such as South East Local Land Services and the Department of Primary Industry.

Options	Description	Figure	Pros	Cons
Develop best practice demonstration sites for riparian land management within the Crooked River catchment	Riparian revegetation, stock exclusion and off stream watering projects	Figure 23 Action 1.1, 1.7, 3.3	Creates buffer between stock and direct water access  Potential to attract interest from other landholders in the catchment  Provides filtration for runoff  Relatively low cost for implementation	Requires buffer area on productive land  Funding support required  Landholder acceptance required  Ongoing maintenance requirements
Publishing estuary health data	Create and publish estuary health report cards to communicate with the community	Action 1.3	Easy to understand communication tool  Provides broad trend analysis on water quality in the estuary	Annual water sampling required to complete the report cards  Costs to sample on annual basis  Not targeted to identify sources of nutrients and turbidity

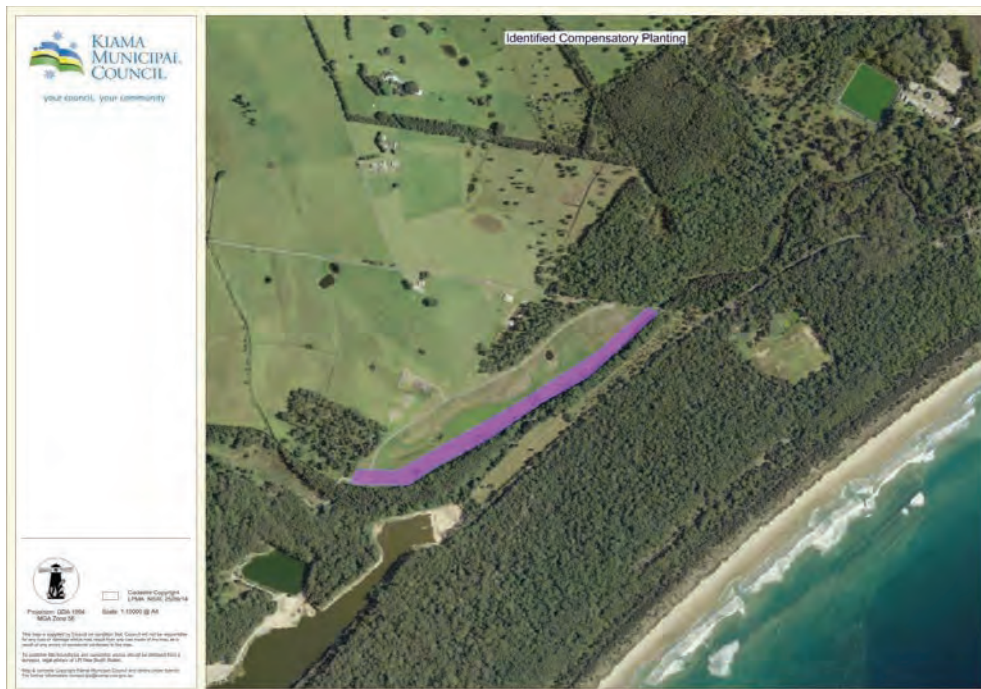
Figure 24: Future compensatory planting for Blue Angle Creek which will reduce the potential for flood scour

In February 2014 a flood scour event in the Blue Angle Creek catchment led to oxygen depleted conditions and a small fish kill in the Blue Angle Creek below the flood gate. A field assessment by Council staff, Cleary Brothers representatives and Office of Environment and Heritage officers found the event to be naturally occurring, but exacerbated by the enhanced draining capacity of the cleared land above the floodgate. It was identified that the planting out of the compensatory corridor along Blue Angle Creek may assist to reduce the impact of flood scour in future. This planting is identified in Figure 24, and is identified to be completed as part of the consent conditions for the extension of the Gerroa sand mining operation. The compensatory plantings already underway on the Cleary Brothers site as part of the development consent conditions detailed in the Gerroa Sand Resource Quarry Environmental Management Plan (2009), can be seen outlined in Figure 25. This revegetation demonstrates how projects can be implemented to provide connection of fragmented vegetation patches across a landscape. These figures identify approximate locations of the revegetation activities and should not be used to determine if compensatory plantings have been carried out in compliance with the QEMP 2009 and consent conditions.

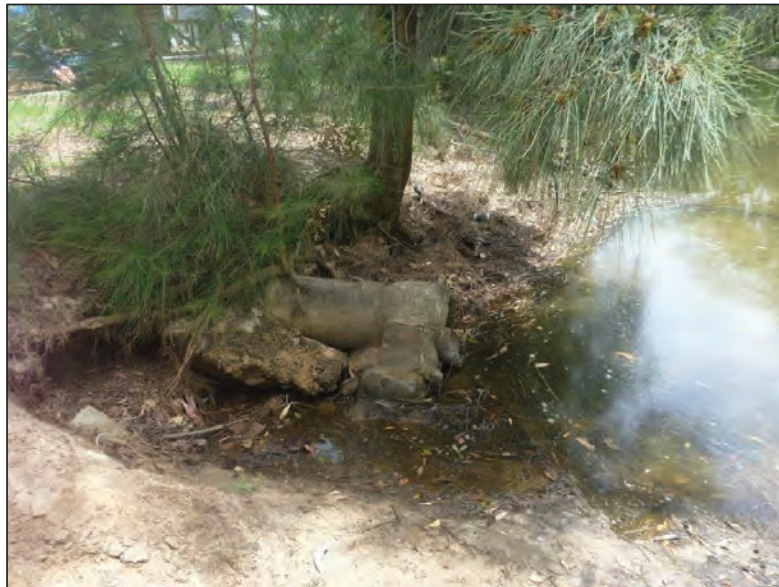
**Figure 26: Seven Mile Beach Holiday Park kayak launch site, stormwater outlet**

There is the opportunity to develop more formalized kayak / canoe launching facilities to assist in protecting bank areas and provide ease of access to the public. One proposed site is the current canoe / kayak access in the Seven Mile Beach Holiday Park. Currently an informal 'sand' beach area is utilized and is seasonally washed away by floods and tide. A properly designed formalized access would help protect the bank from erosional forces related to pedestrian access, flood and stormwater scour (Figure 26). Another potential location is at the end of Park Road Gerroa, near to the path under the road bridge.

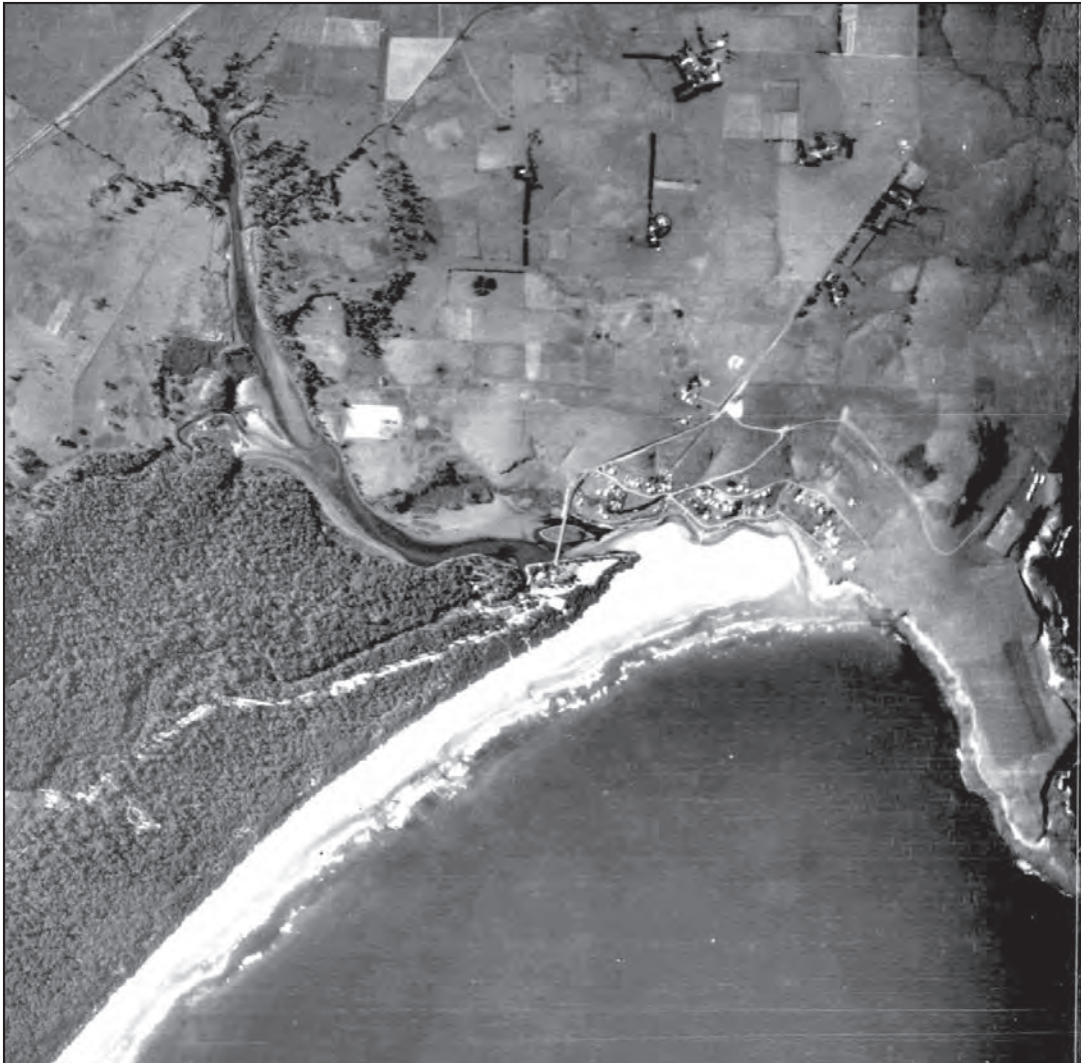
### **Crooked River Estuary 1949**

Estuary open to the ocean

Large sections of the upper estuary foreshore and catchment cleared, as pre present day

Entrance channel alignment along the northern foreshore

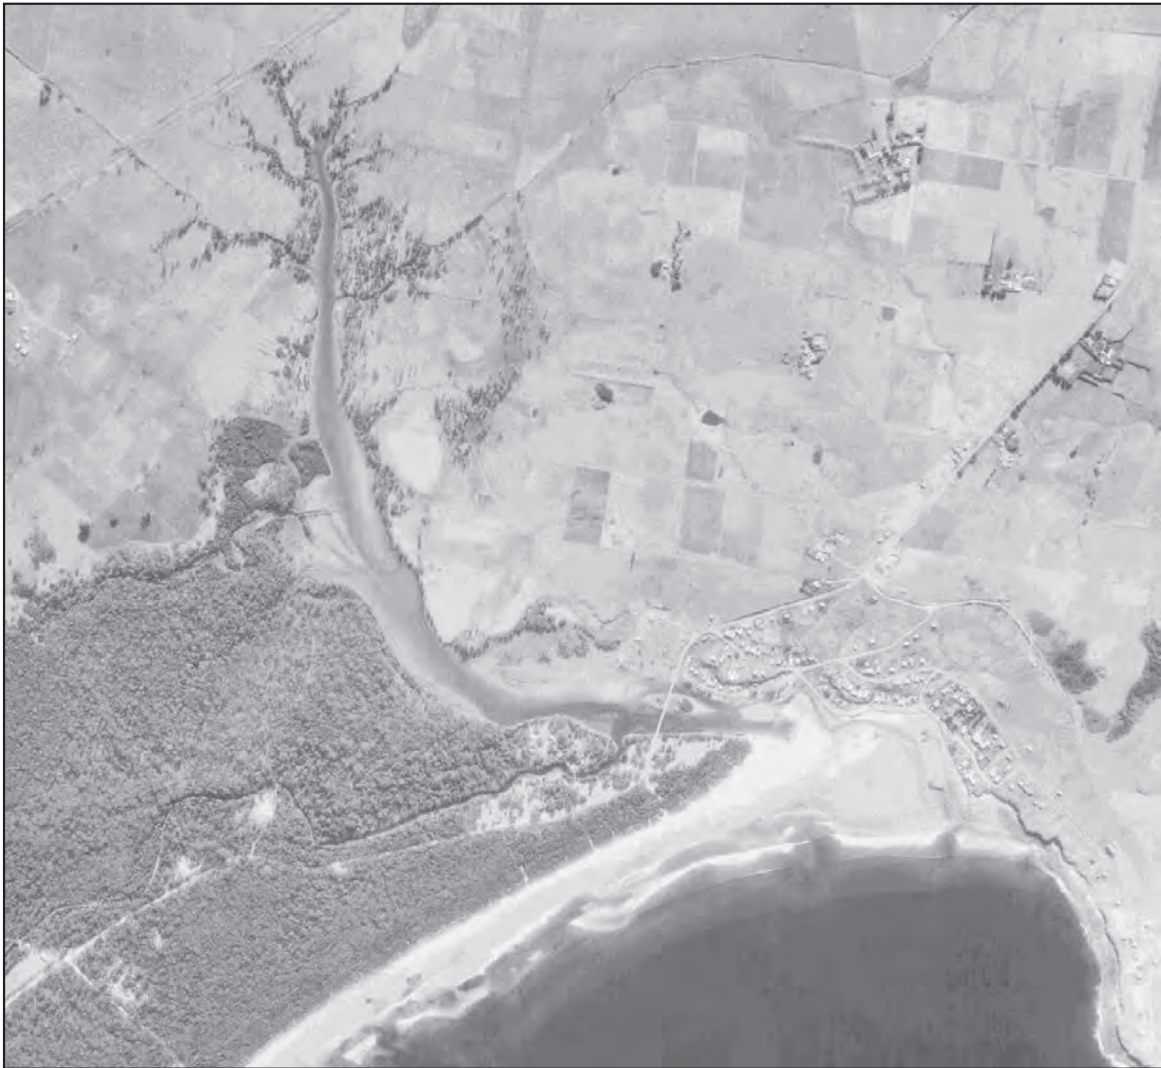
**Crooked River Estuary 1963**

Estuary barely open to the ocean

Seagrass appears to be present in the lower estuary around Blue Angel Creek, reduction in extent of seagrass in the mid to upper estuary

Development of southern and northern caravan park sites apparent

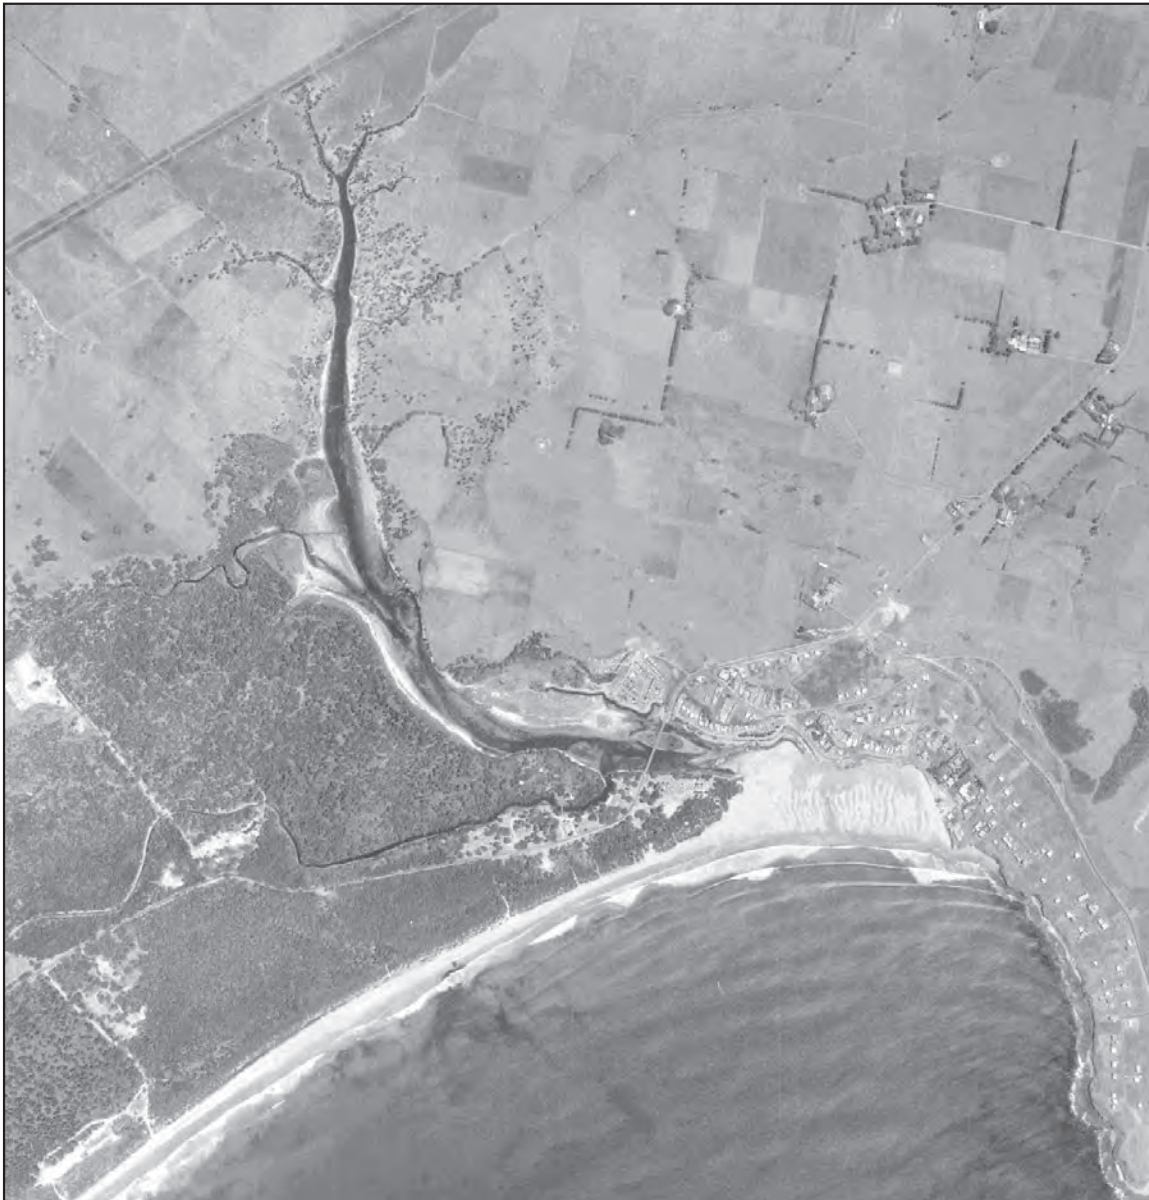
**Crooked River Estuary 1969**

Seagrass appears to be present through much of the estuary

Estuary closed to the ocean by wide sand berm

Development of both southern and northern caravan parks clearly visible

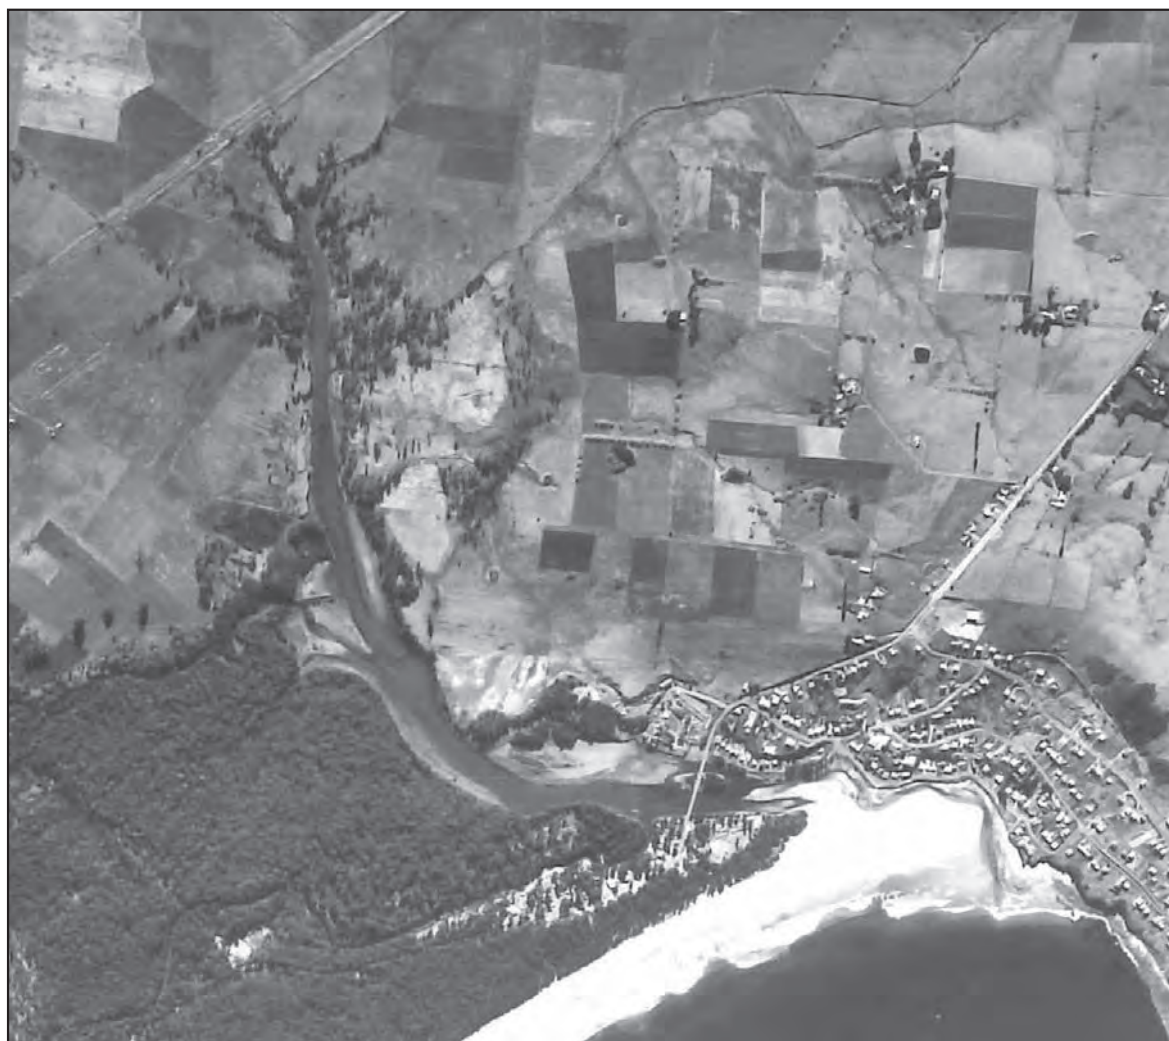
**Crooked River Estuary 1979**

Estuary open to the ocean

Seagrass appears to be sparse throughout the system, most noticeably around mid to lower estuary
