### KIAMA MUNICIPAL COUNCIL COASTAL PROTECTION ACT 1979

# COASTAL ZONE MANAGEMENT PLAN FOR THE CROOKED RIVER ESTUARY

Final Version November 2015

Crooked River Coastal Zone Management Plan

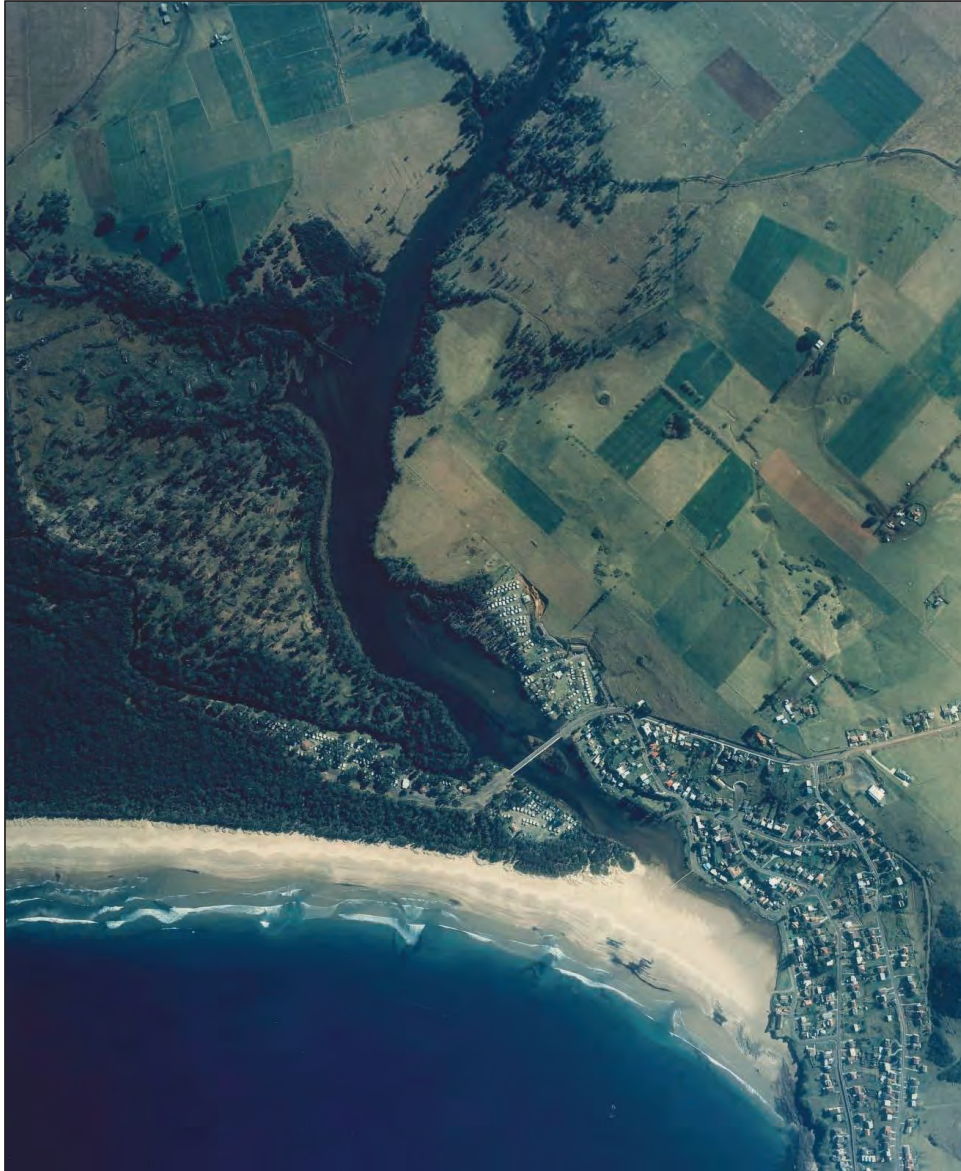
**Crooked River Estuary 1987**

Entrance closed to the ocean

Seagrass appears to be present in the mid and upper parts of the estuary

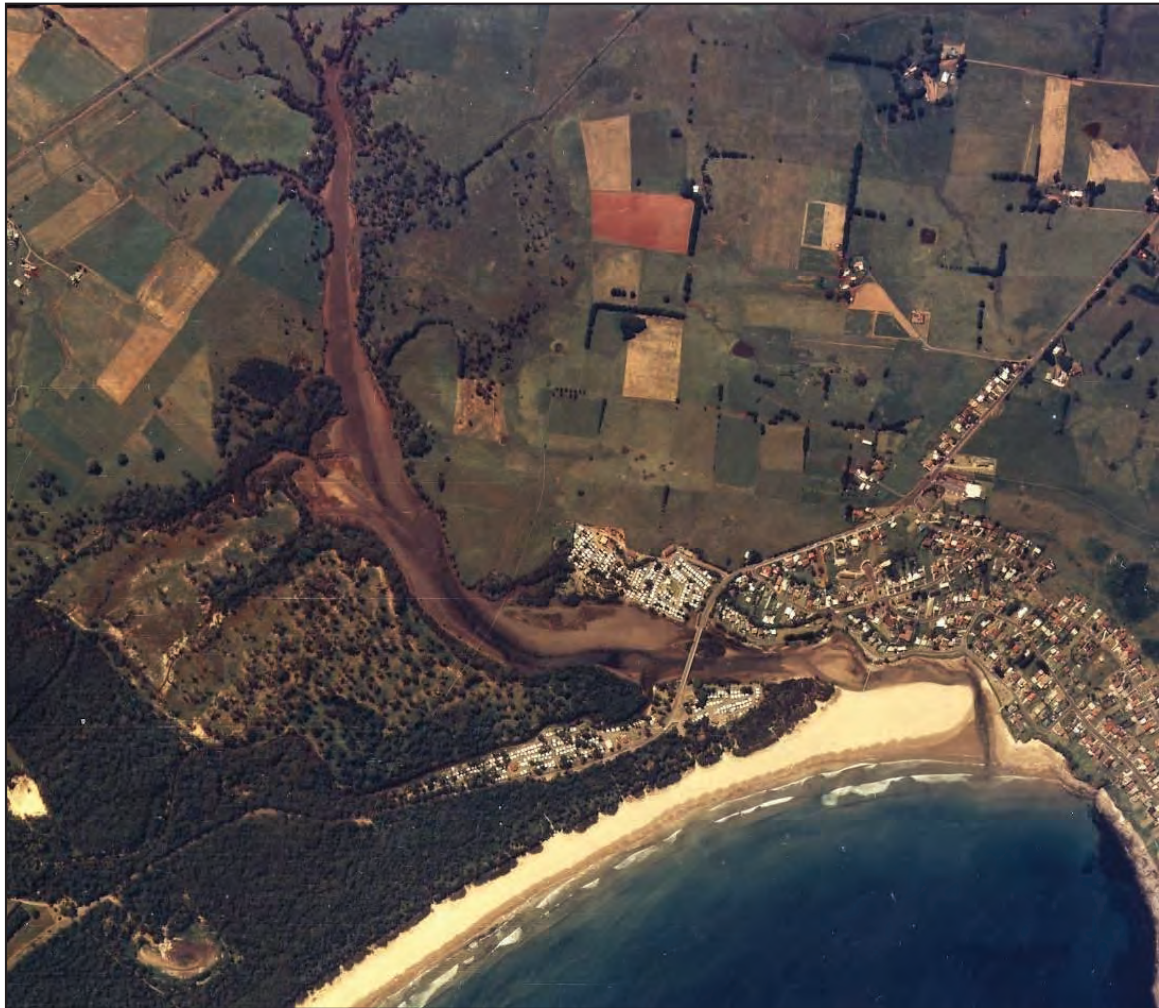
**Crooked River Estuary 1993**

Estuary open to the ocean

Landfill site very visible

Further extension of northern caravan park

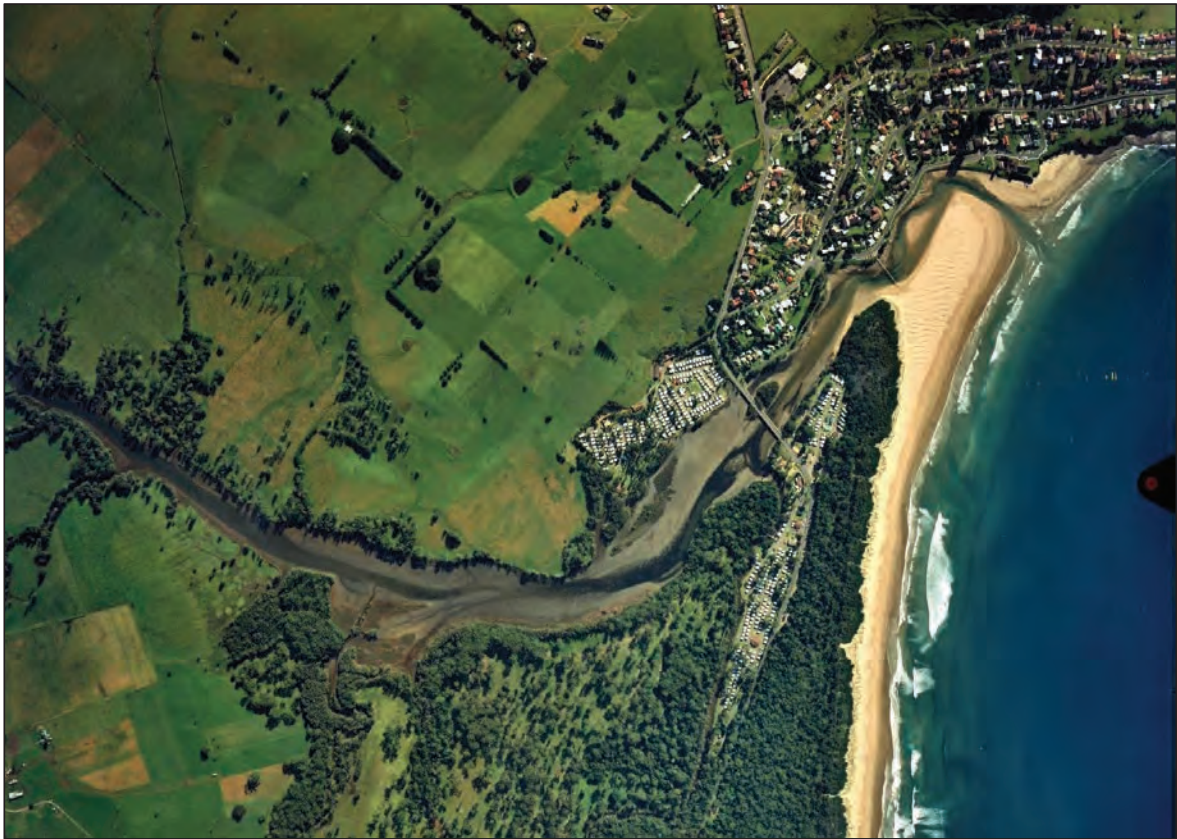
**Crooked River Estuary 1999**

Entrance open to the ocean

Sediment beds apparent in the mid estuary]

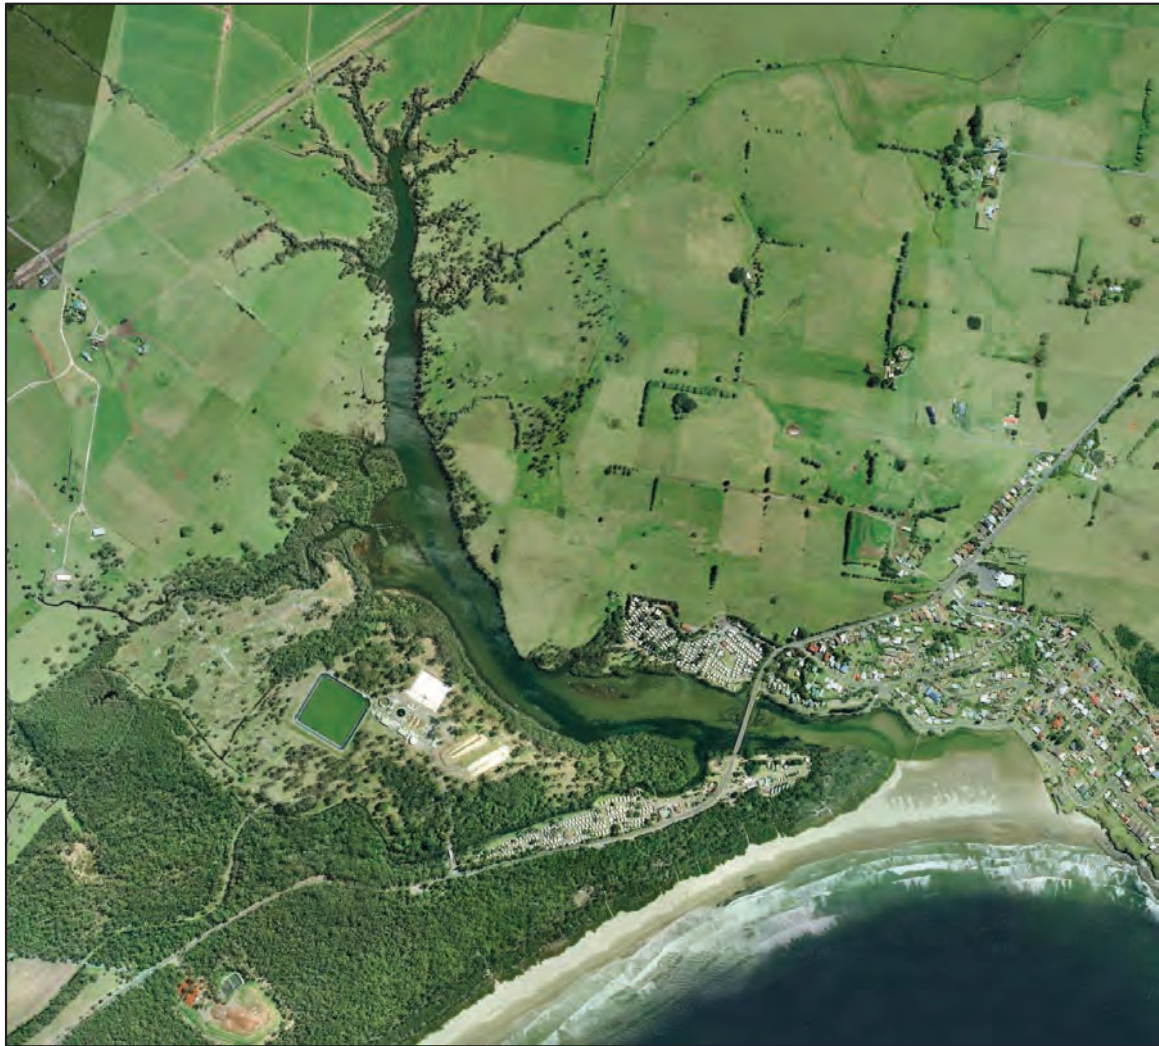
**Crooked River Estuary 2003**

Estuary practically closed to the ocean

Landfill site under remediation

Seagrass appears to be present in the mid and lower estuary

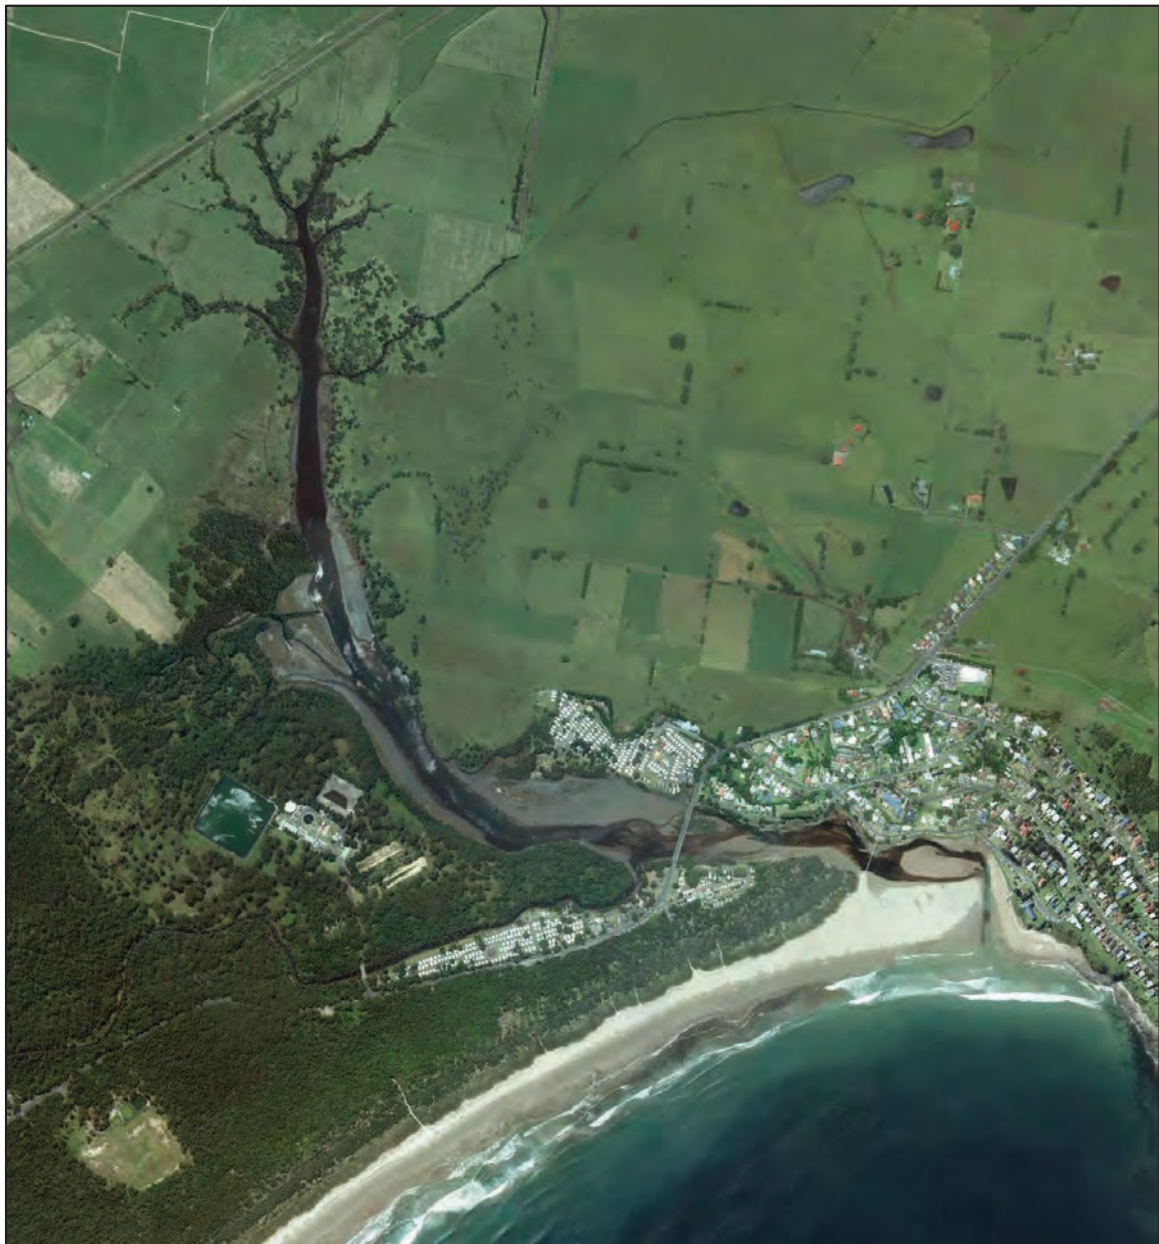
**Crooked River Estuary 2012**

Estuary open to the ocean

Seagrass beds visible in the mid and lower estuary

Noticeably turbid in the upper estuary

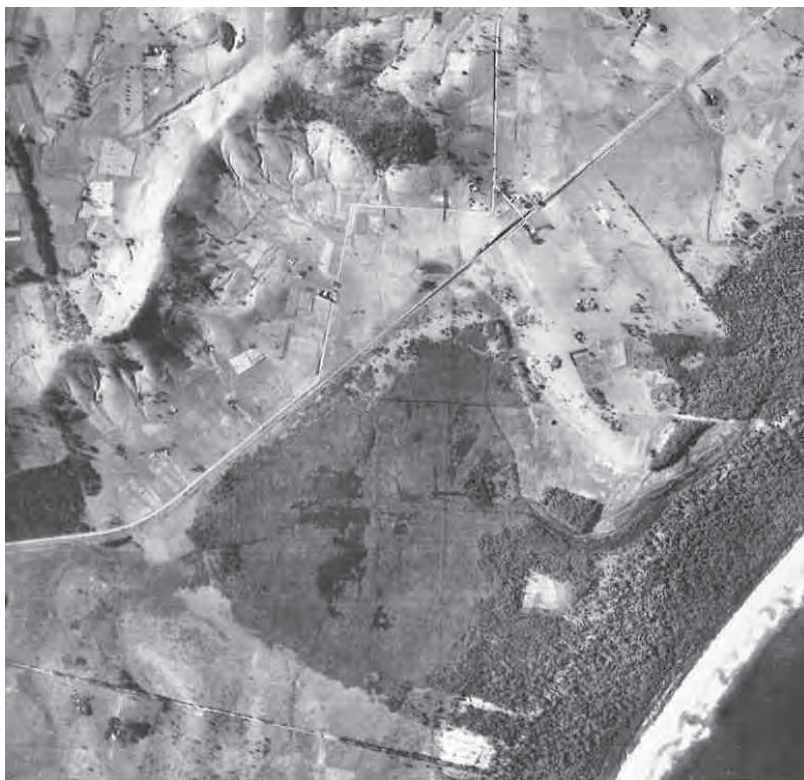
**Foys Swamp 1949**

Largely intact, northern part starting to get drained

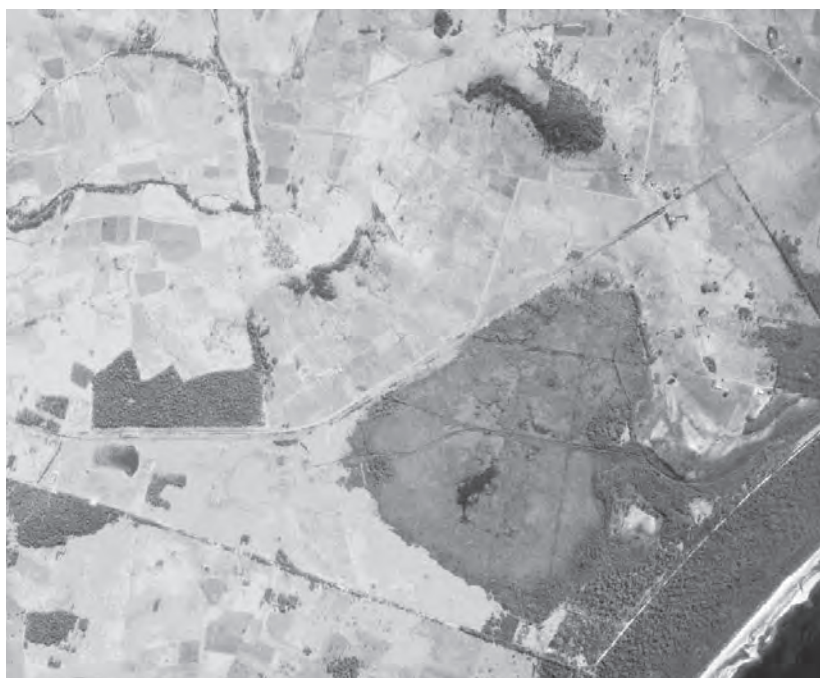
**Foys Swamp 1963**

Drains evident through middle of the swamp

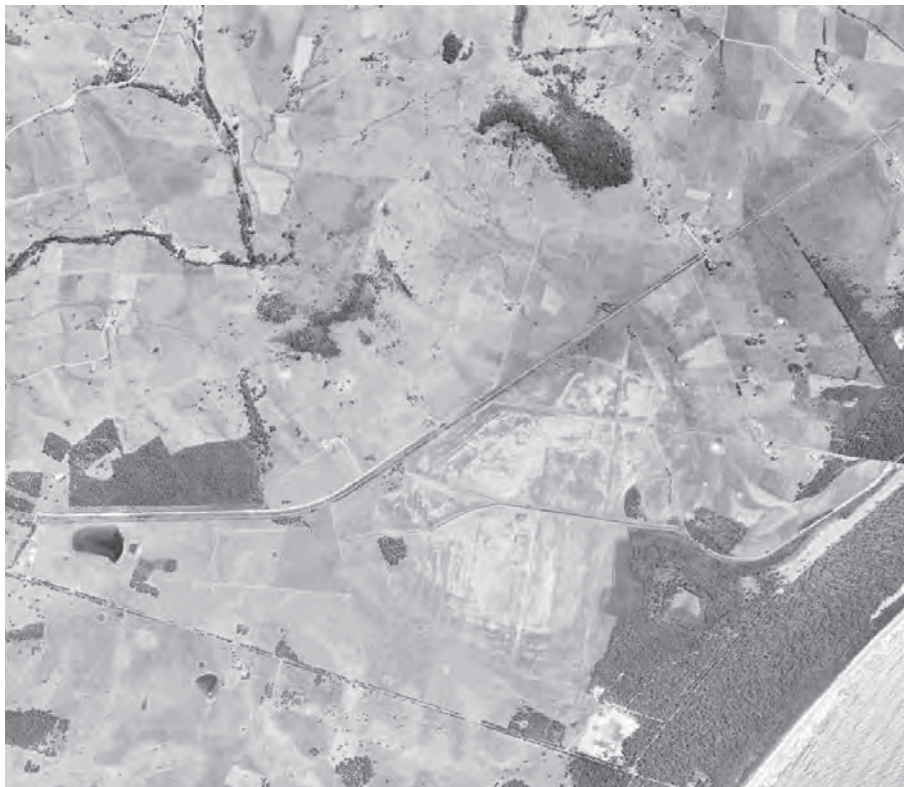
**Foys Swamp 1969**

Clearing of Swamp started

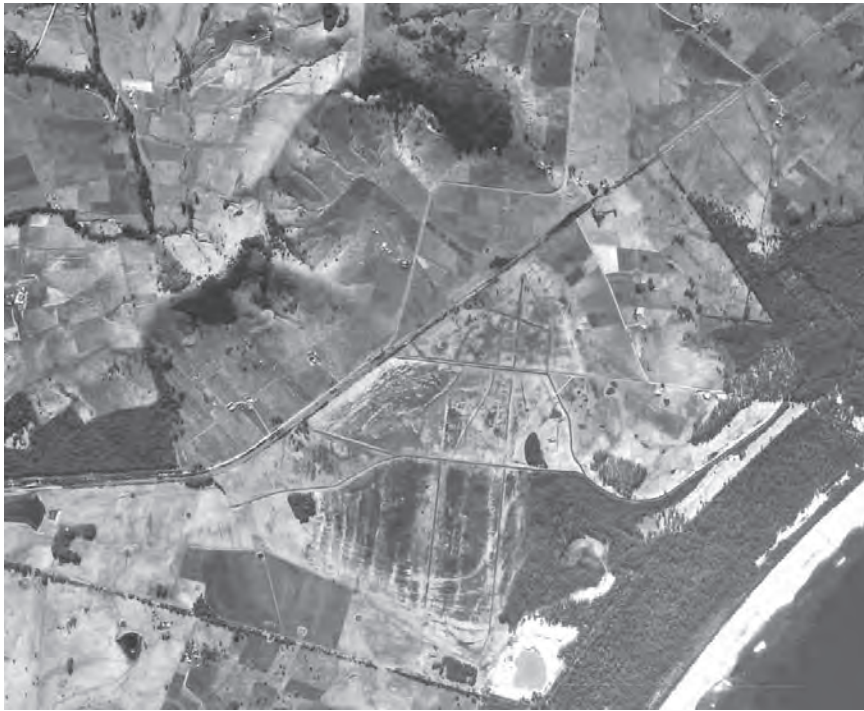
**Foys Swamp 1974**

Most of swamp clear, sand mining starting

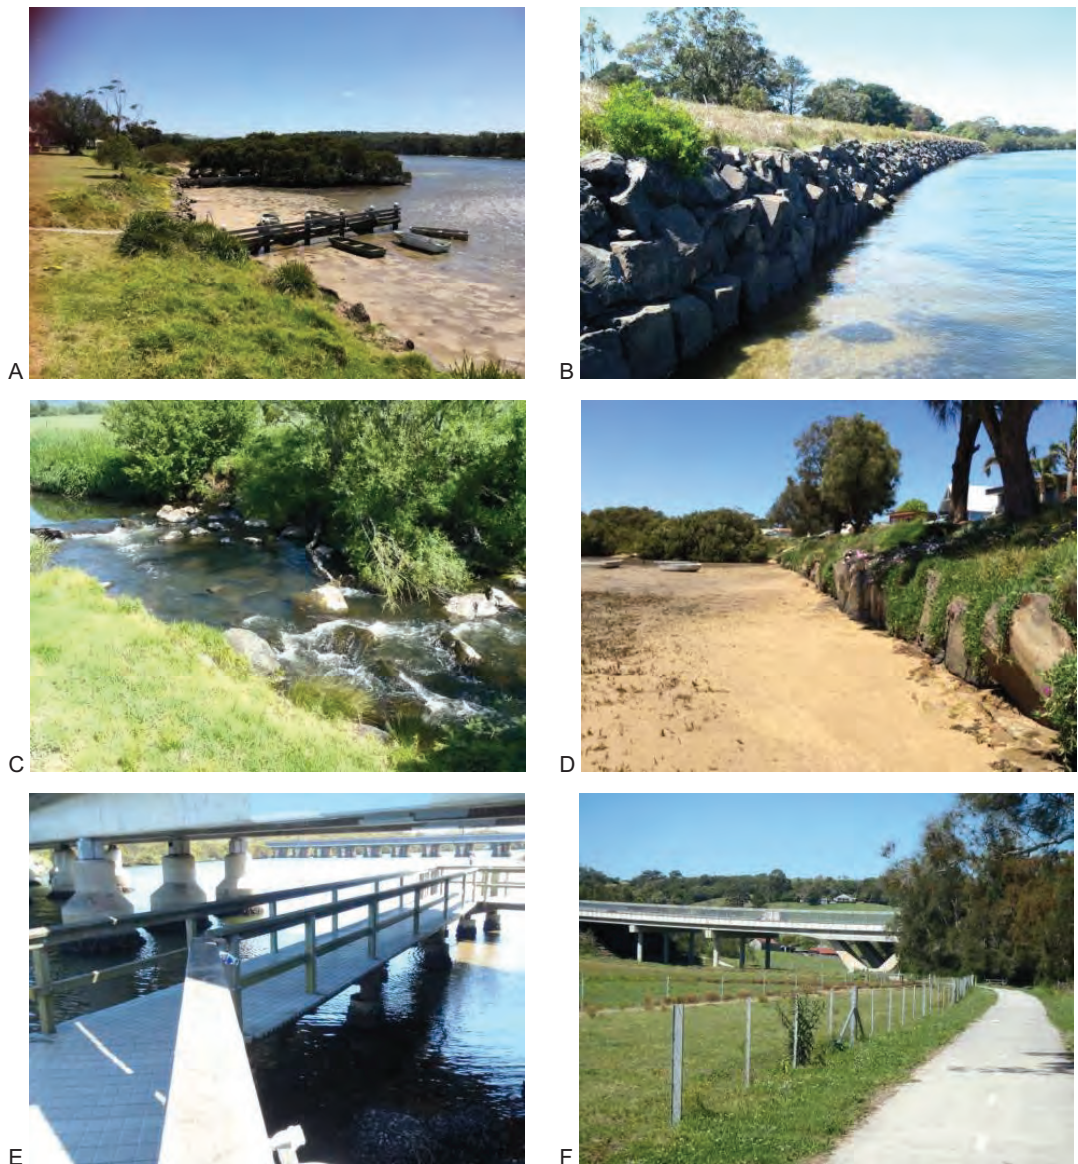
**Figure 6: Completed on-ground actions from the 1995 EMP and 2003 EMP review**

A – Timber groynes, Charles Avenue, B – Rock revetment – Riverside Drive, C - Rock ramp – Terragong Drain, D – rock revetment - Charles Avenue foreshore (D. Wiecek, 2014), E – fishing jetty and shared path, F – Swamp Road cycleway (D. Wiecek, 2014).

Following the 1995 EMP a small pilot area along Charles Avenue was chosen for a trial management strategy of timber groynes to control the bank erosion (refer Figure 6 in Section 4). The groynes have since deteriorated with rotting timber rails and detached sediment fencing. Some of the groynes are licensed mooring points for private boats.

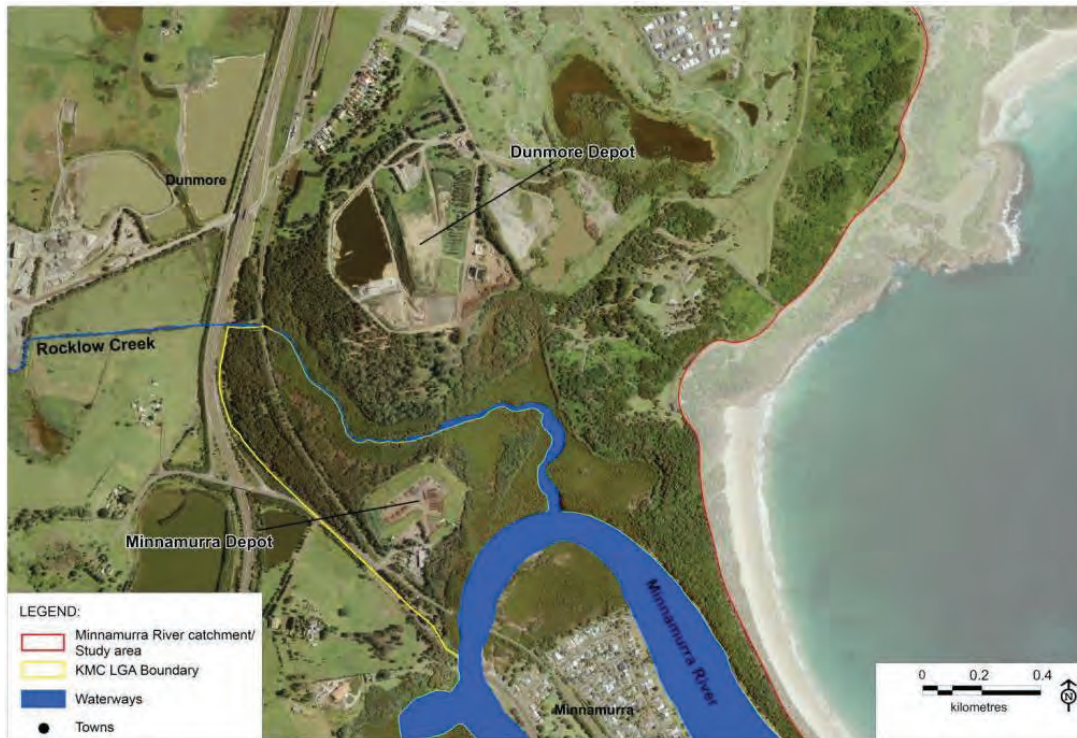
**Figure 15: Waste depot locations**

The Minnamurra Depot is situated on the northern side of the Minnamurra River Estuary between Riverside Drive and Rocklow Creek (Figure 15) and was owned and operated by KMC as a Solid Waste Class 1 Landfill until its closure in 2006. Between 1945 and 1998 the landfill also accepted 'night soil' waste (liquid pump-out sullage from on-site sewage management systems). The Minnamurra Depot covers an area of approximately 20 ha and includes (E2W, 2012):

The Dunmore Depot is situated approximately 500 m north of Minnamurra Depot (on the opposite side of Rocklow Creek) on Buckleys Road, Dunmore (Figure 15). The Dunmore Depot was established in 1945 and SCC has managed the site since 1983. Before the mid-1980s there was no control on the disposal locations or the types of waste disposed of at the landfill. In the mid-1980s the landfill operations became better controlled (Environmental Earth Sciences, 2013) and is now operated under two Environmental Protection Licences (EPL) administered by the EPA.

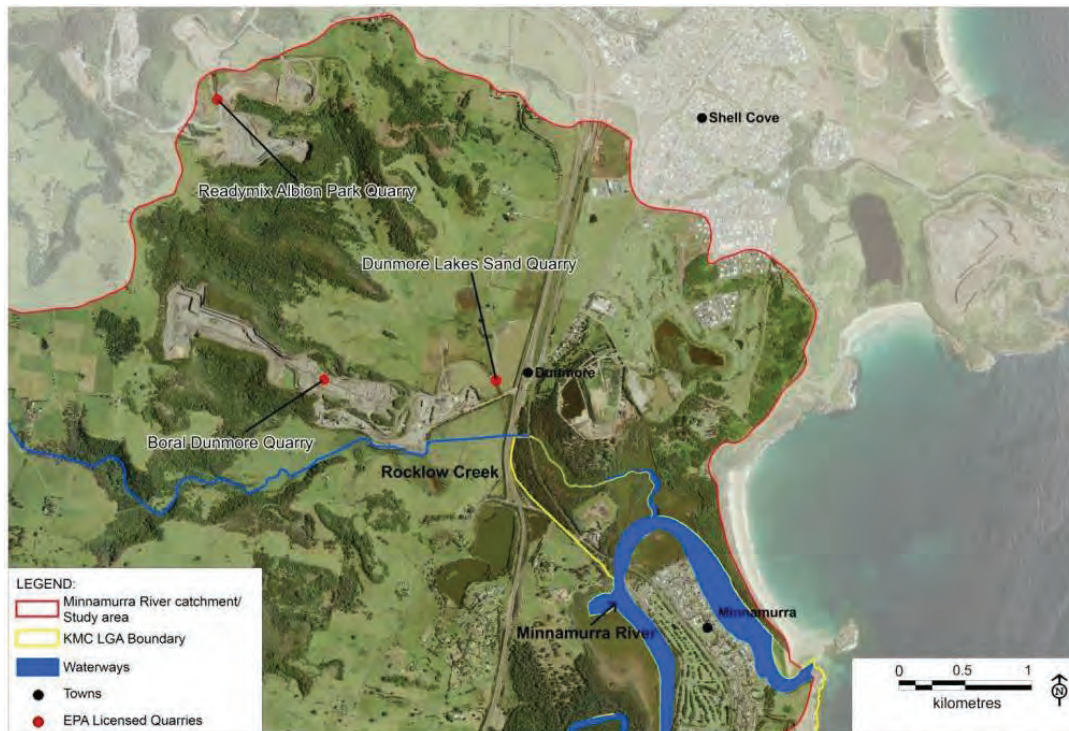
**Figure 16: Extractive industry locations**

The Dunmore Quarry is located approximately 2.5 km north-west of Minnamurra within the Rocklow Creek catchment and within the SCC LGA (Figure 16). Boral operates the quarry within its total land holding of 8.5 km<sup>2</sup> to produce a range of fine and coarse aggregates, which are used mainly in concrete and asphalt production (DIPNR, 2004). The resource at the quarry is latite, a fine grained volcanic rock similar to basalt. The quarry is regulated by an EPL issued by the EPA under which Boral is licenced to extract a maximum of 2 million tonnes of material.

There are several other latite quarries within the vicinity of Albion Park (Figure 16). The Holcim Albion Park Quarry is partially located within the Minnamurra River Catchment approximately 1 km north of the Dunmore Quarry.

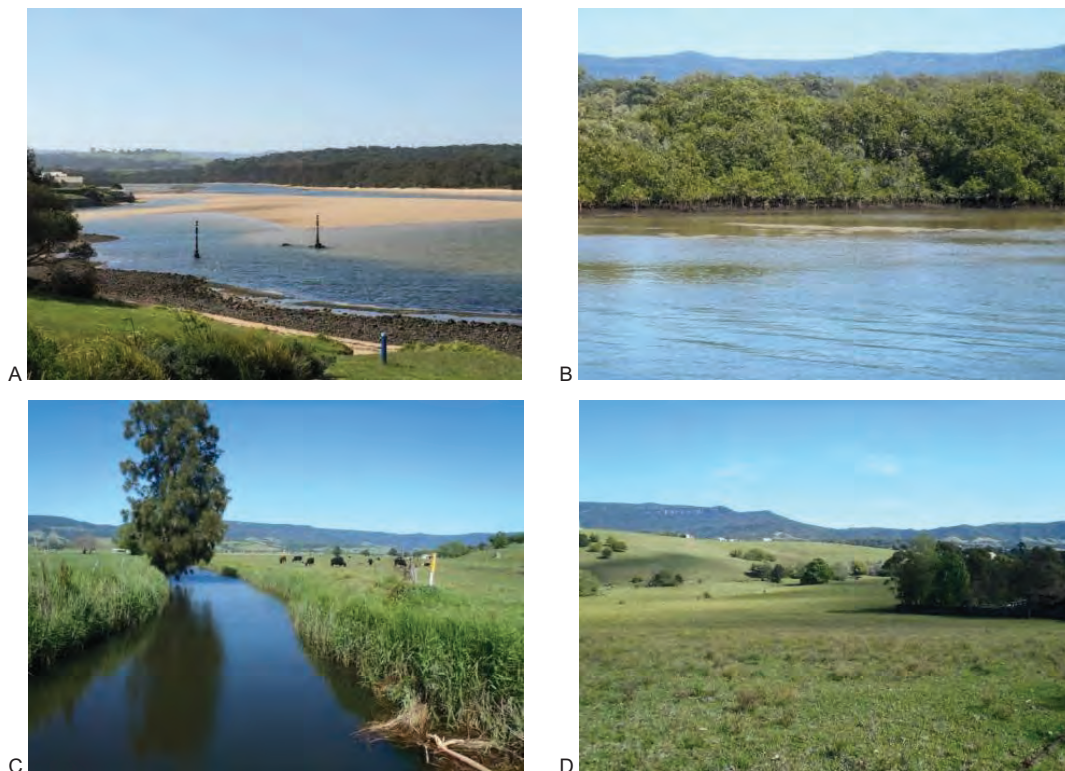
**Figure 17: Minnamurra River Estuary geomorphological features**

A - Minnamurra Beach sand spit and flood tide delta, B - Vegetation and intertidal sand flats along the western bank of the straight between the first and second meander (D. Wiecek, 2014), C - Alluvial floodplain and artificially straightened channel (D. Wiecek, 2014), D – floodplain and Illawarra escarpment.

The riverine channel/alluvial plain zone extends upstream from Swamp Road bridge encompassing the entire floodplain up to the township of Jamberoo. The main channel of Minnamurra River in this reach is an artificially straightened, narrow deep channel. The floodplain (Terragong Swamp) was drained for dairy farming and the main channel of the river shifted to the northern side of the swamp to where it is located today. Relicts of the previous meandering channel are visible as cut-off embayments on the floodplain, south of the current channel. The river channel in this section was enlarged in the 1950s and 1970s.

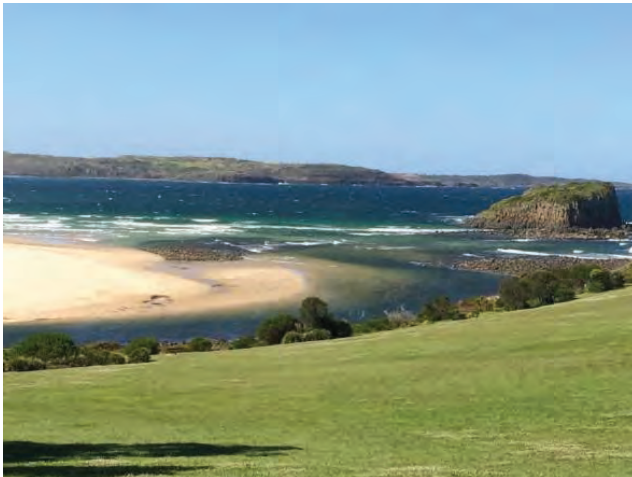
**Figure 18: Minnamurra River entrance and Stack Island (view from Minnamurra Point)**

- There are no anecdotal or written records of the entrance having closed (refer to Appendix 3 for an analysis of historical aerial photographs);
- During sustained periods of low swell activity, it would be expected that sediment deposition would occur in the lee of Stack Island;
- During storms and floods this material would erode and then re-accumulate during 'normal' conditions; and
- An entrance bed level that broadly fluctuates with seasons and storms constitutes the natural behaviour of the entrance.

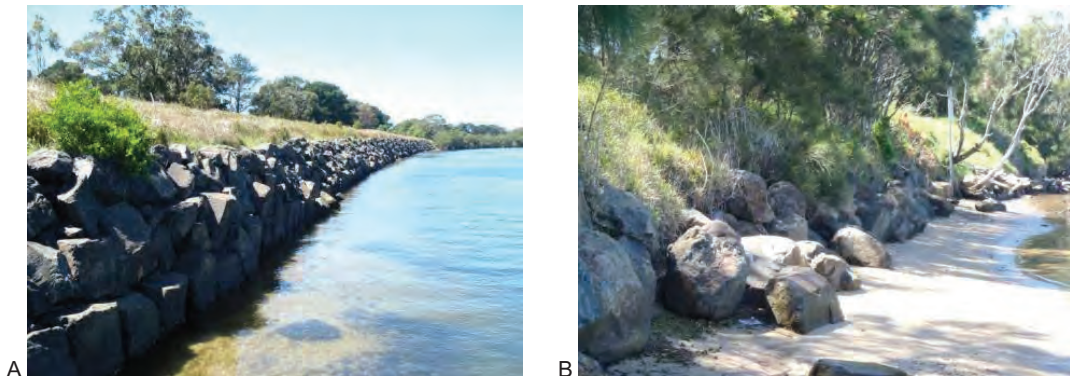
**Figure 31: Riverside Drive erosion controls**

The riverbank in the vicinity of the picnic and parking area along Riverside Drive has been stabilised with rock revetment and a fishing jetty has been installed. The rock revetment in this area is steep with displacement of some large boulders (Figure 31). A lower rock revetment has also been constructed downstream of the timber access stairs.

A – Rock revetment, B – Downstream of timber stairs

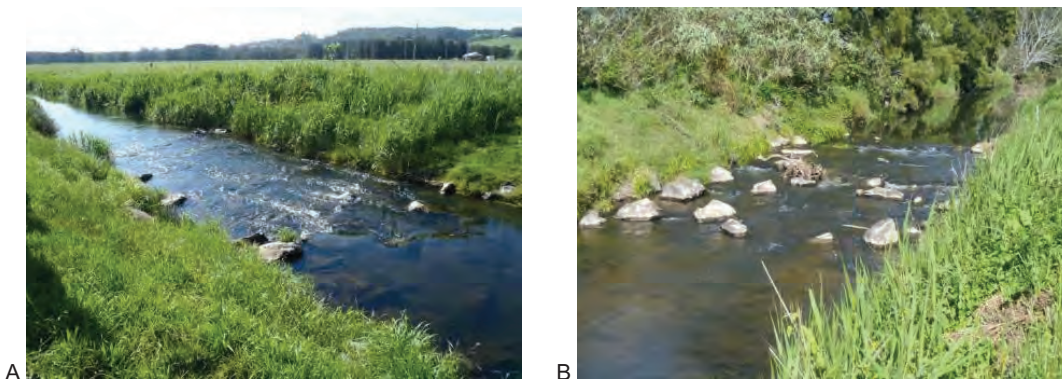
**Figure 32: Terragong Drain rock ramps**

The SRCMA, in partnership with local landholders and the Terragong Drainage Union (TDU) installed three additional rock ramp structures with integrated fish ways in 2011. The ramps were designed to act in concert with previously installed upstream grade control structures to slow floodwaters, stop bed erosion and also aid in retaining channel sediments post floods. SRCMA (2012) reports that the works have been tested by numerous high flows and have proven able to withstand floods.

At each rock ramp, rock revetment was also installed to stabilise the banks and vegetation has since covered most of the banks. Stock exclusion fencing has also been installed at the second ramp (upstream from Swamp Road) with Casuarina planted along the fence line along the southern bank. Weeds (e.g. tobacco weed) have since colonised the buffer strip (approximately 2 metres wide) and follow-up work is required.

A – Downstream ramp near Swamp Road, B – Second ramp between Swamp Road and Browns Lane

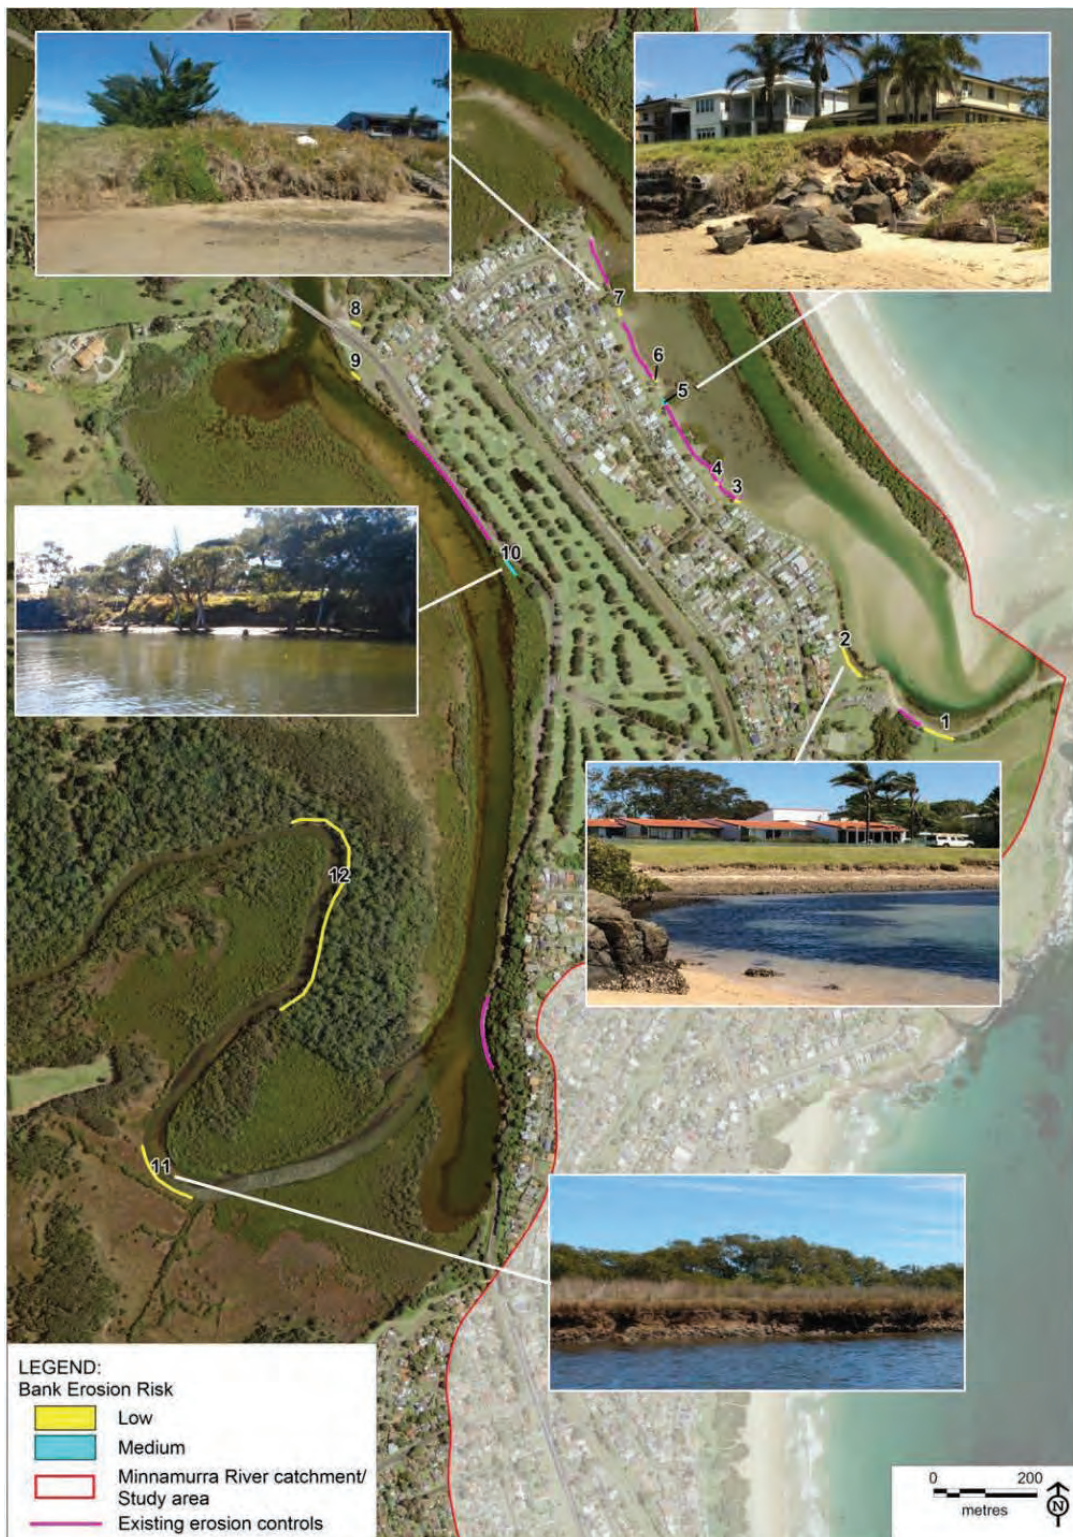
Figure 33: Locations of bank erosion sites in the lower to mid-estuary

The current erosion sites, their assessed risk and example photos are shown on Figure 33, Figure 34 and Figure 35. Further detail is provided in Appendix 7.

Preliminary identification and assessment of the current erosion sites has been undertaken for this CZMP based on the catchment assessment undertaken by KMC and OEH (refer Appendix 7). The assessment does not cover the entire catchment but focusses on the estuary, Terragong Swamp and areas of known erosion. Erosion is also occurring in many of the tributaries of the upper catchment due to a combination of poor condition of riparian vegetation, livestock access and grazing, steepness of banks, flooding and natural river meander. Further investigation will be required to identify upper catchment areas which require remediation.

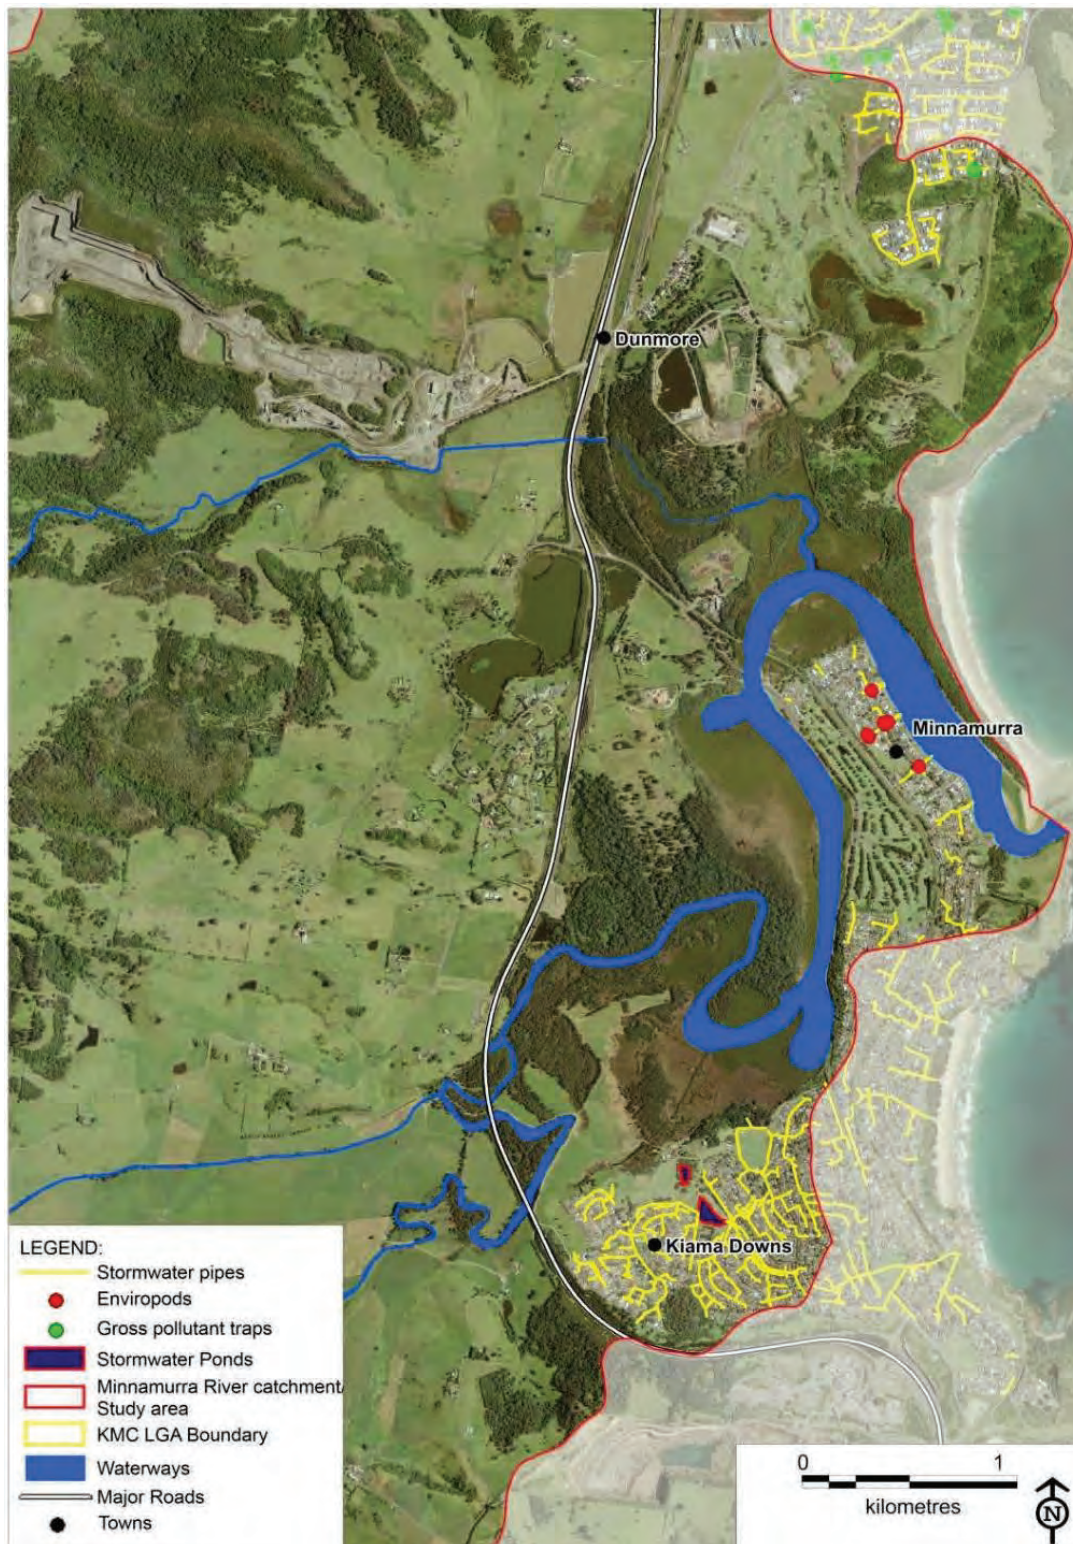
Figure 38: Minnamurra and Kiama Downs urban stormwater systems

There are three main urban stormwater catchments within the study area in primarily residential areas – Minnamurra and Kiama Downs (Gainsborough) shown on Figure 38 and Jamberoo shown on Figure 39.

KMC has installed stormwater pollution control devices in the Minnamurra and Jamberoo catchments although these are not regularly maintained by Council. The stormwater outlet at the end of Rangoon Reserve no longer has a litter capture net. Litter has also been observed near stormwater outlets (refer Section 6.12). From the available water quality data it is not possible to separate stormwater influences from diffuse catchment runoff and other potential point sources of pollution in the catchment.

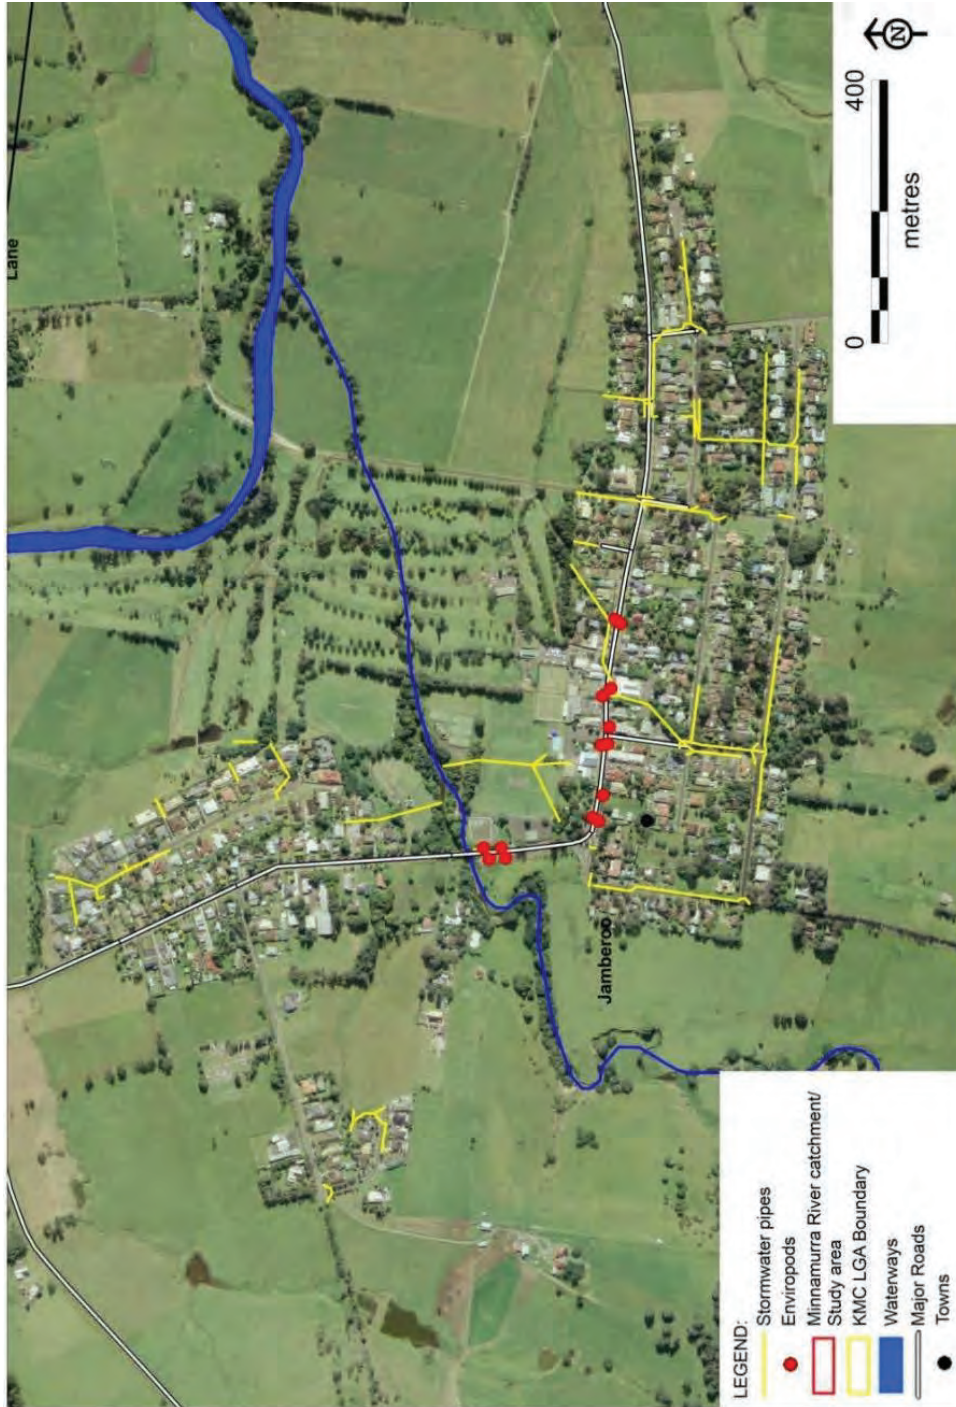
**Figure 39: Jamberoo urban stormwater systems**

Stormwater asset mapping provided by KMC and SCC. Note that mapping of infrastructure may not be complete.

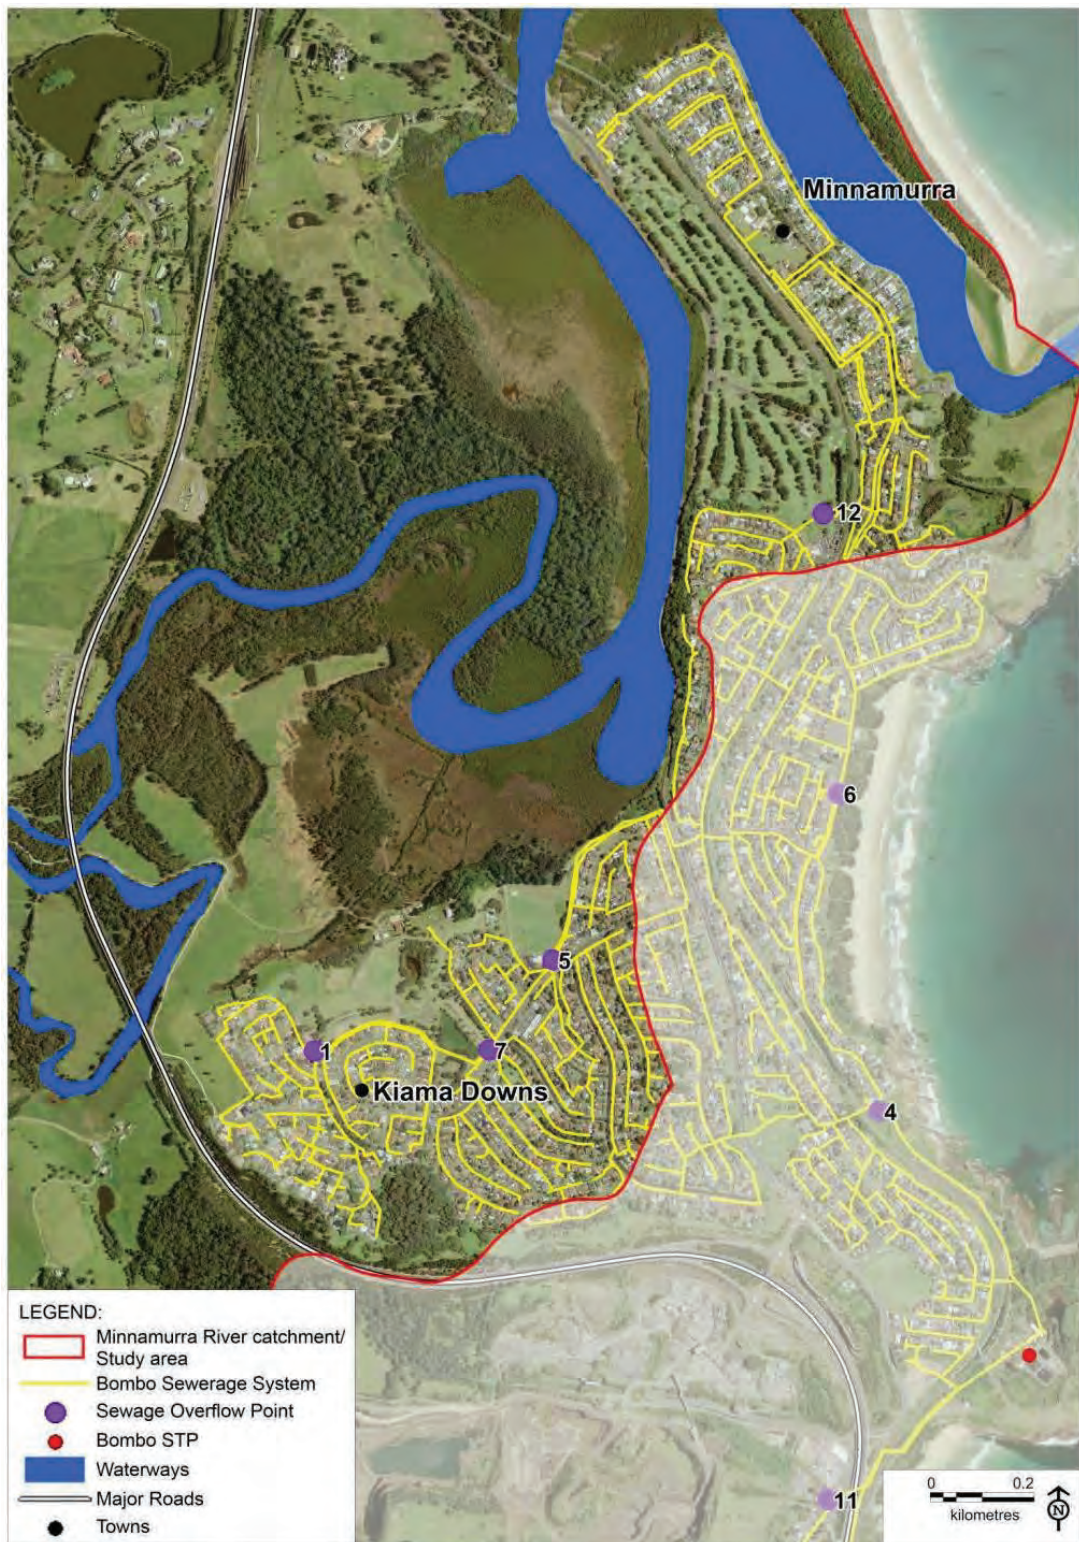
Figure 40: Minnamurra and Kiama Downs sewerage system

A centralised sewage treatment plant situated at Bombo (located outside the Minnamurra River Catchment) services all urban areas in the central and eastern Minnamurra River Catchment (Jamberoo, Kiama Downs and Minnamurra) as shown in Figure 40 and Figure 41. The Bombo STP provides secondary treatment, denitrification and disinfection. After disinfection the majority of the secondary treated water is returned to the environment through direct ocean discharge off the rock shelf on Bombo Headland (1,705 ML in 2012/13). A proportion of the treated effluent from the Bombo STP is re-used for irrigation purposes at the Kiama Golf Club with 81 ML re-used at the club during 2012/13 (Sydney Water, 2013). The small urban area in the north eastern corner of the catchment (southern area of Shell Cove) within the SCC LGA is serviced by a centralised STP located at Shellharbour.
