### KIAMA MUNICIPAL COUNCIL COASTAL PROTECTION ACT 1979

# COASTAL ZONE MANAGEMENT PLAN FOR THE CROOKED RIVER ESTUARY

Final Version November 2015

Crooked River Coastal Zone Management Plan

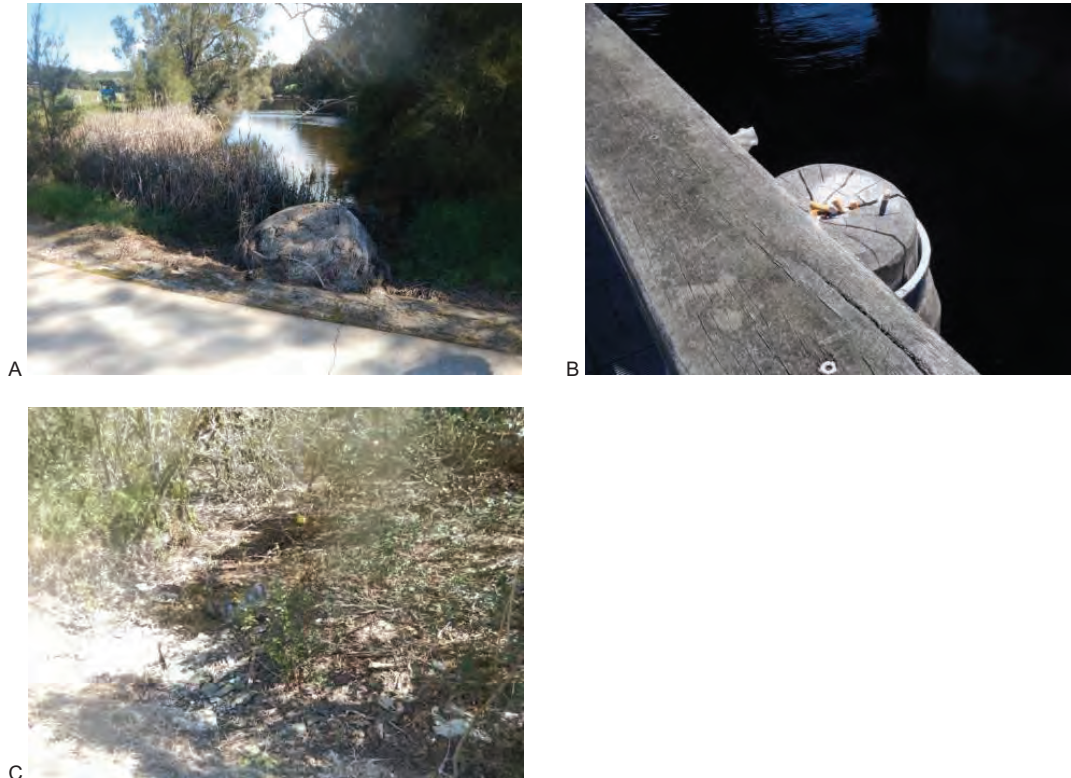
**Figure 43: Litter**

Feed bales and silage wrap and baling twine can be seen in some areas of the estuary (Figure 43A). Feed bales may be washed into the river in flood conditions, creating a relatively localised issue but efforts should be made to remove these due to high biological oxygen demand of the decomposing feed and the remaining twine and silage wrap. Silage wrap is present in many locations along the river in both estuarine and freshwater reaches, caught in riparian vegetation and on in-stream structures.

There is also litter (and cigarette butts) present at many of the public foreshore areas including the new fishing jetty (Figure 43B). Litter (from stormwater drains along Riverside Drive) is also present in mangrove areas adjacent to the golf course (Figure 43C).

A – silage wrap (D. Wiecek, 2014), B – fishing jetty, C – litter in mangroves near stormwater outlet, Riverside Drive (D. Wiecek, 2014)

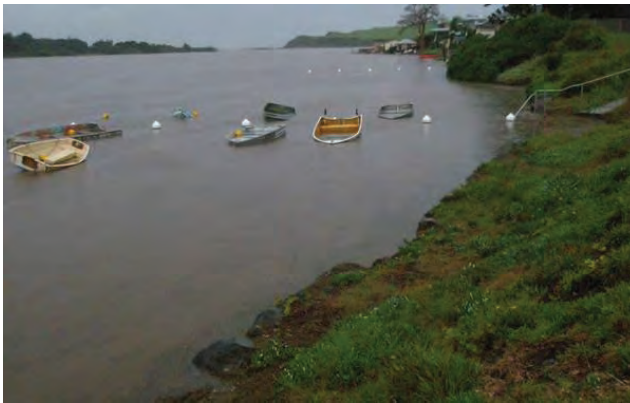
**Figure 44: High river levels at Charles Avenue foreshore during floods (11/3/2011)**

Inundation of low-lying land is caused by a range of factors which can act either individually or in combination and can have differing effects in terms of the frequency and extent of inundation, event duration, predictability and type of impact. The key causes of inundation of the Minnamurra River floodplain are:

- Minnamurra River catchment flooding;
- Tidal/storm surge inundation; and
- Poor site drainage.

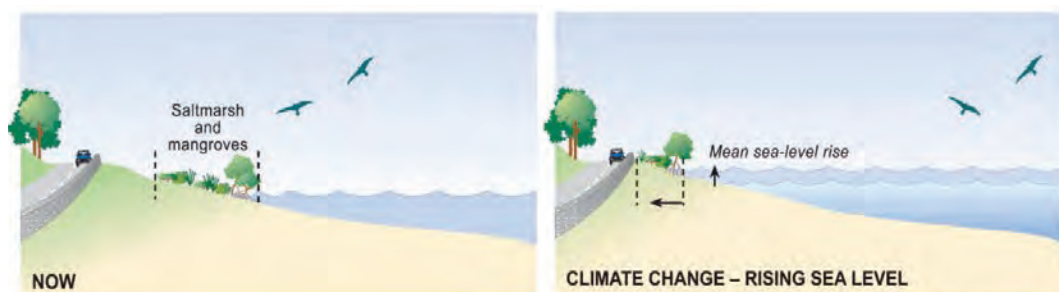
**Figure 48: ‘Coastal squeeze’ under sea level rise: impact of development**

Sea level rise is expected to increase the average water depth and extend tidal propagation in the Minnamurra River Estuary with associated changes in salinity regime. It is anticipated that sea level rise will result in the landward recession of fringing estuarine wetland systems. The location of estuarine habitats such as mangrove stands and saltmarsh are controlled principally by tidal range and salinity influence and will gradually respond to changes in average water levels and salinity. There is a risk that natural upslope migration of these wetlands will be curtailed by anthropogenic constraints such as roads, rock walls, retaining walls and urban development on the landward side (DECC, 2009). This impact has been named “Coastal Squeeze” by the Department of Climate Change (now OEH, DECC, 2009) (refer Figure 48 below). Under these conditions the landward side of these important habitats will be fixed but the lower margin will gradually be pared away, leading to a loss of habitat area.

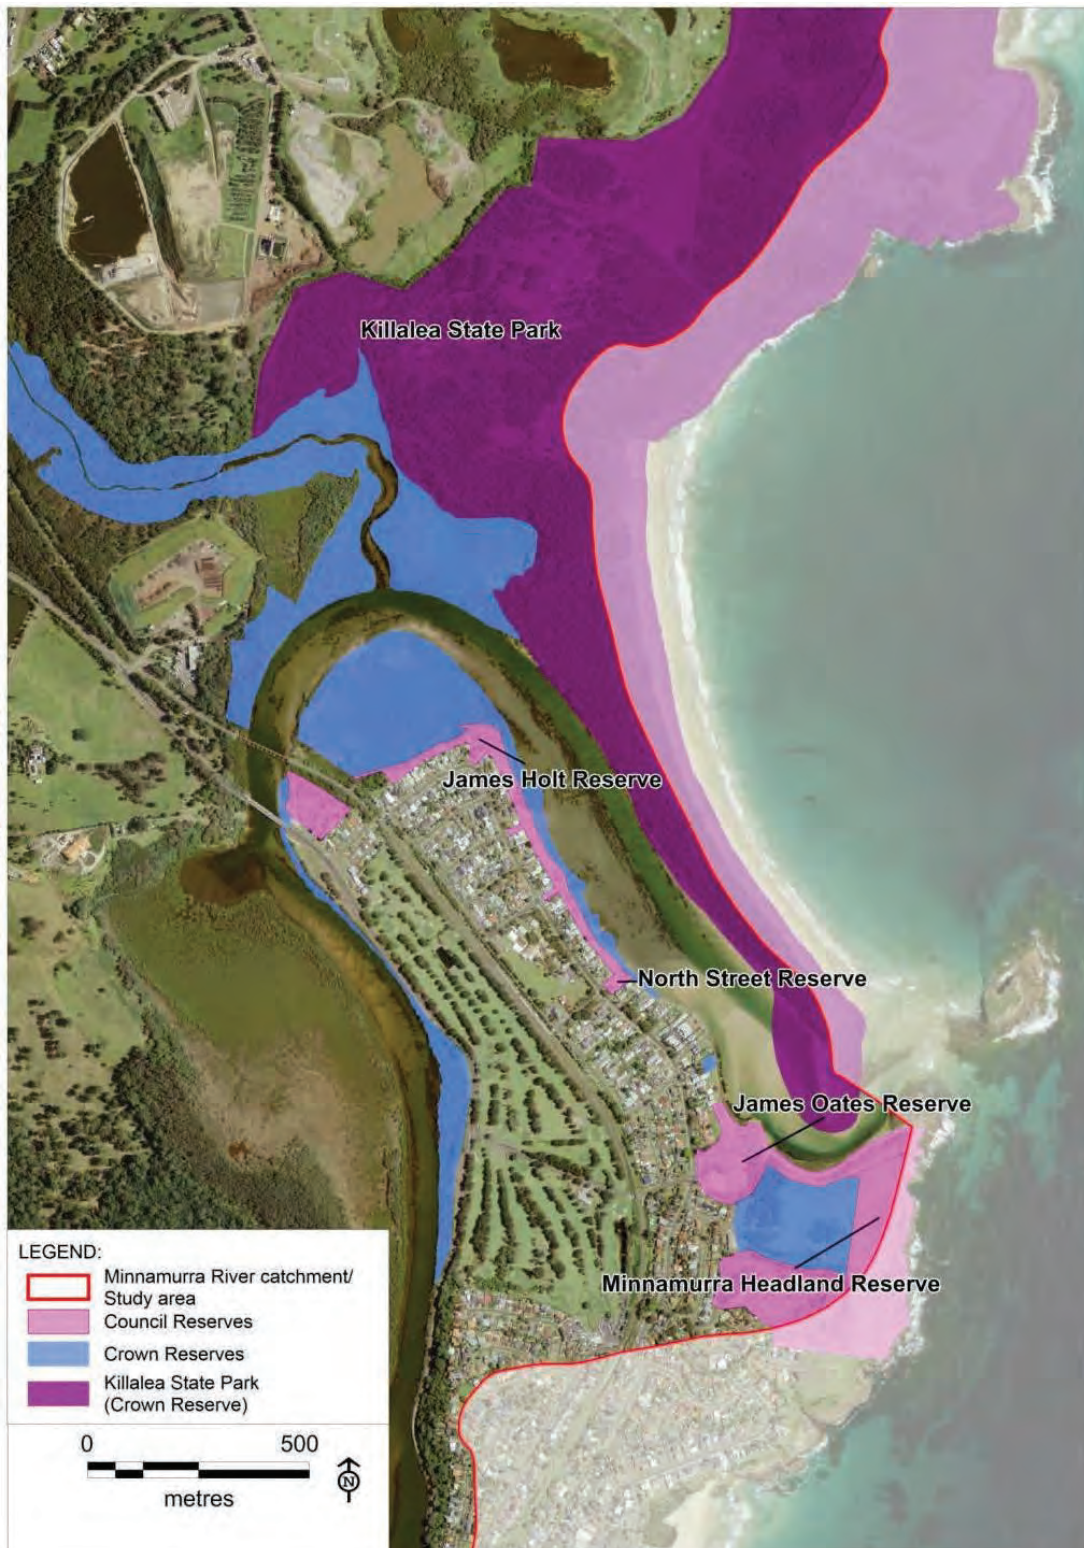
Figure 54: Lower Minnamurra River Estuary land tenure

Figure 54 illustrates the riverfront land tenure of the lower Minnamurra River Estuary:

- In general, private property encompasses all the riverfront land on the northern side of the river from the Riverside Drive bridge upstream to Swamp Road.

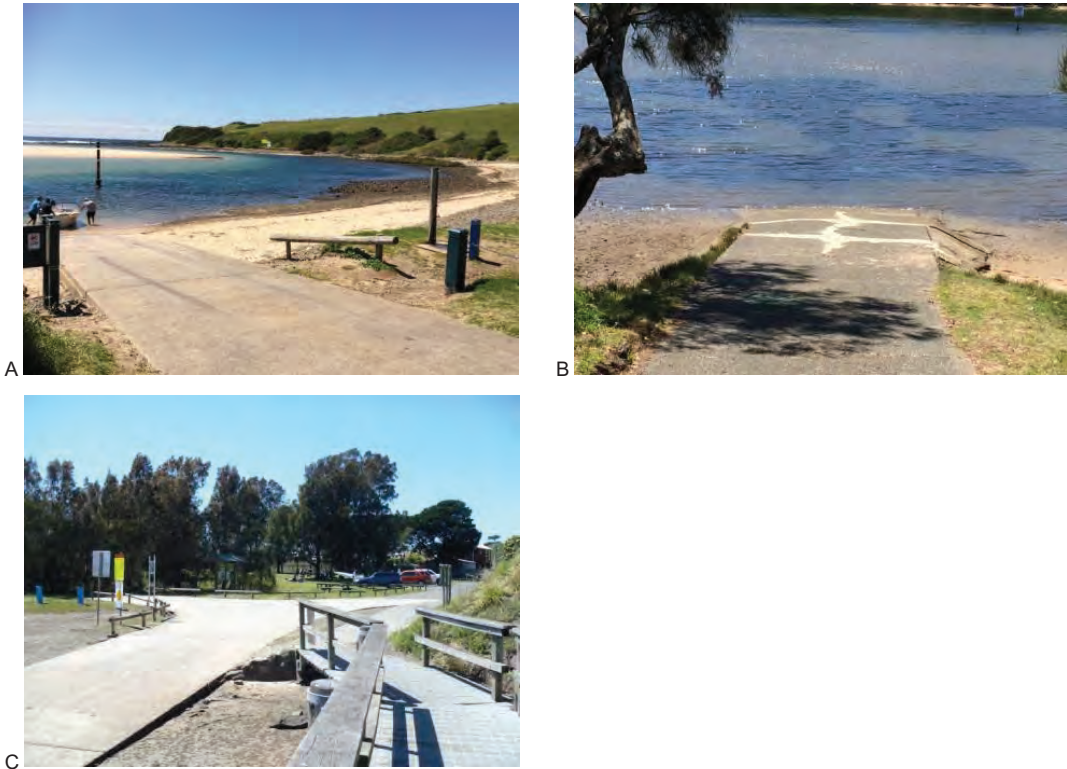
**Figure 57: Boat ramps**

- Into river at south-east end of Highway road bridge off Trevethan Street (single lane concrete, incline 1V:20H, ample parking, no facilities). The ramp, picnic facilities and car parking areas at Trevethan Reserve were upgraded in 2000. Due to the low gradient, access during high tides is limited due to boats grounding on the lower sections of the ramp. A public jetty has been installed at Trevethan reserve for fishing access.

A – Entrance, James Oates Reserve, B – James Holt Reserve, C - Trevethan Reserve

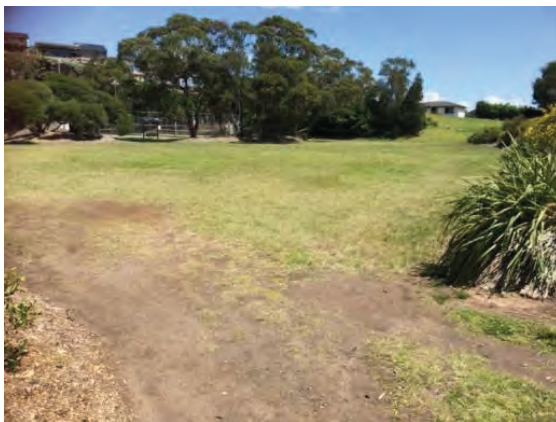
**Figure 59: Potential area for additional car parking at James Oates Reserve**

There is insufficient parking for boat trailers and cars at James Oates Reserve during peak periods (weekends and holidays). Additional car parking facilities could be provided between the entrance road and tennis courts (Figure 59). An upgrade to this area could include additional facilities such as rubbish bins, fish cleaning tables, wash down areas, toilets/showers and information/regulatory signage.

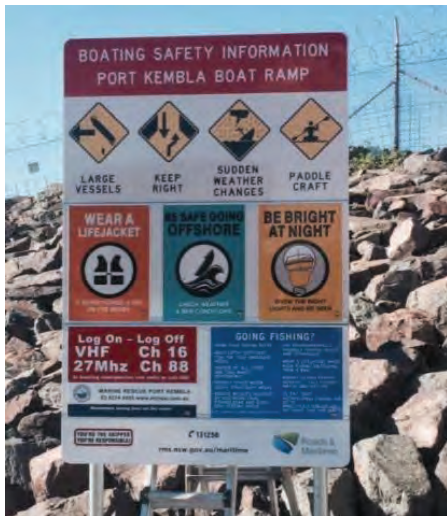
Figure 60: RMS integrated boating signage

Boating speed and conflict with passive recreational uses is a key concern for the lower estuary. Regional actions such as current RMS boating programs and Transport for NSW initiatives are considered to be the appropriate mechanism to address this. Additional signage at key boat ramps (such as James Oates Reserve) would also assist with boating education. Given the RMS resource constraints, reserve signage could include a hotline phone number to report boating issues. RMS has introduced integrated signs that contain information specific to each site and can be modified to suit local circumstances (Figure 60).

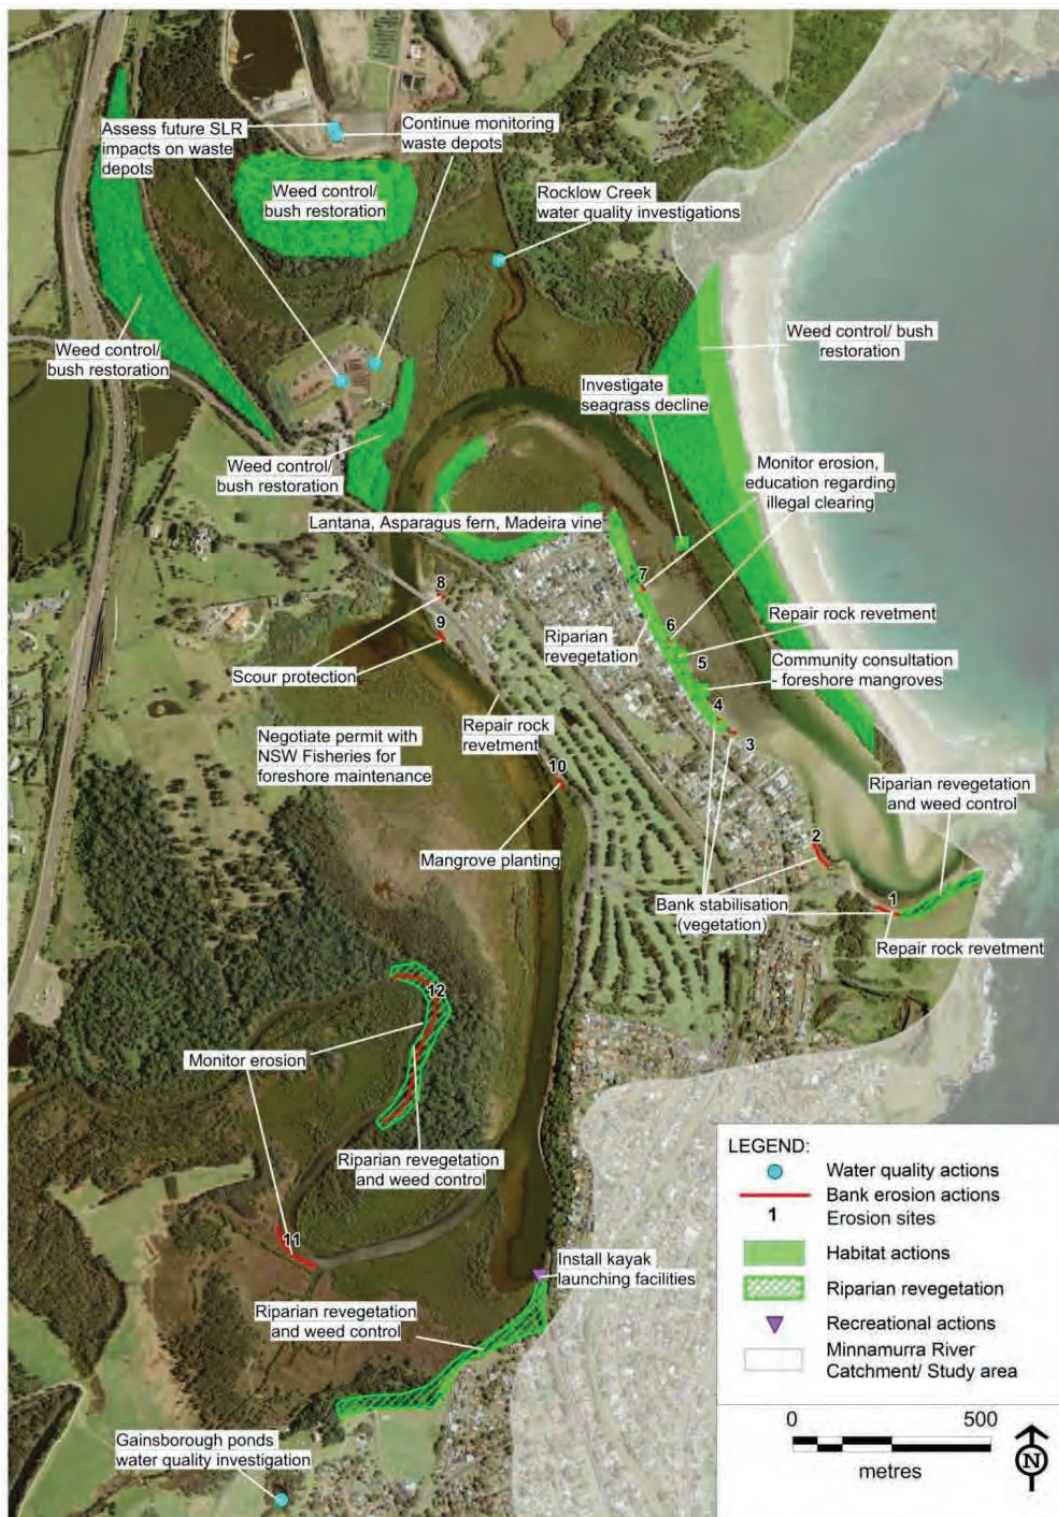
Figure 61: CZMP Management Actions – Lower-Mid Estuary

Note – Site 5 rock revetment has been repaired

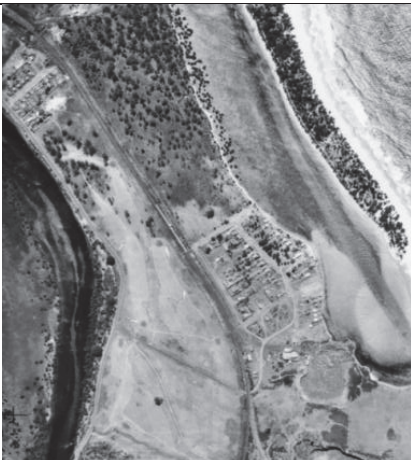
<p>1948 (Lands Department):</p> <ul style="list-style-type: none"> <li>• Start of the Minnamurra development concentrated near the entrance.</li> <li>• Sparse vegetation on entrance spit.</li> <li>• Possible seagrass meadows present.</li> <li>• Sparse mangroves along future Charles Avenue foreshore.</li> </ul>

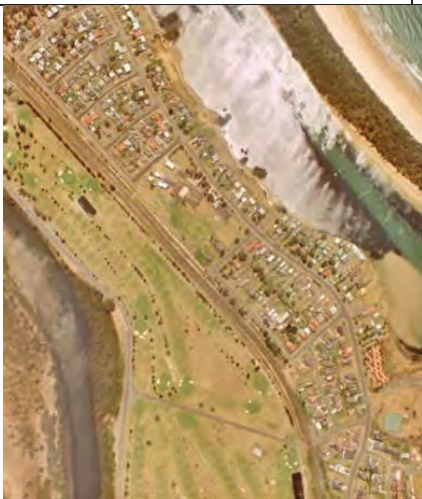
<p>1981 (BHPAIR):</p> <ul style="list-style-type: none"> <li>• Golf course is present.</li> <li>• Seagrass meadows present adjacent to Charles Avenue and along northern bank inside the spit.</li> <li>• Limited change in mangroves along Charles Avenue foreshore.</li> <li>• Vegetation on southern end entrance spit has reduced in area on the ocean side.</li> </ul>

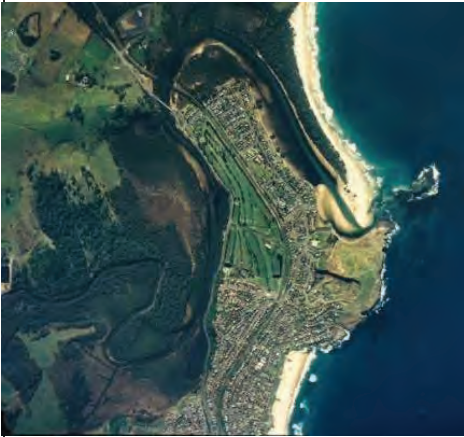
<p>1988 (BHP Engineering):</p> <ul style="list-style-type: none"> <li>• Channel through lower estuary and entrance appears to be deeper and more defined.</li> <li>• Well defined main channel opposite Charles Avenue with prolific seagrass meadows on each side.</li> <li>• Seagrass meadows also prolific opposite the entrance to Rocklow Creek and along the straight adjacent to the golf course.</li> <li>• Seagrass is evident as far upstream as the bends.</li> <li>• Kiama landfill is visible.</li> <li>• Limited change in mangroves along Charles Avenue foreshore</li> </ul>

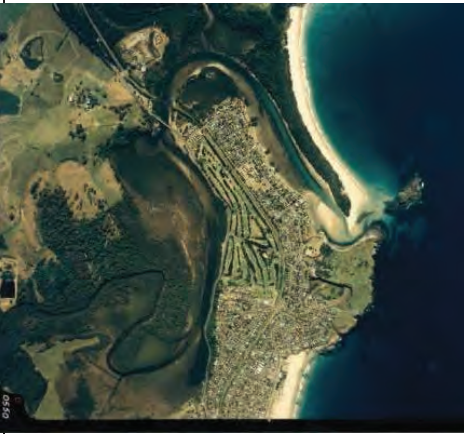
<p>1997 (BHP):</p> <ul style="list-style-type: none"> <li>• Entrance spit vegetation appears to have migrated south which may be due to revegetation work undertaken between 1991 and 1993.</li> <li>• Entrance channel upstream to opposite James Oates Reserve appears shallower, narrower and less defined than in 1988.</li> <li>• Sandbank near James Oates Reserve appears to have migrated further upstream.</li> <li>• Seagrass distribution throughout the estuary appears to have reduced since 1988.</li> <li>• Limited change in mangroves along Charles Avenue foreshore</li> </ul>

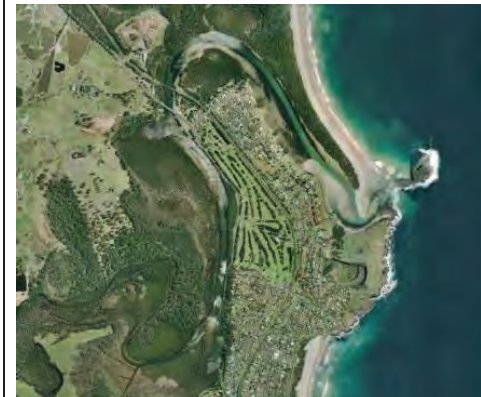
<p>2003 (Google Earth):</p> <ul style="list-style-type: none"> <li>• Seagrass meadows adjacent to Charles Avenue have expanded since 1997.</li> <li>• Seagrass opposite the entrance to Rocklow Creek and in the straight adjacent to the golf course have returned.</li> <li>• Limited change in mangroves along Charles Avenue foreshore</li> </ul>

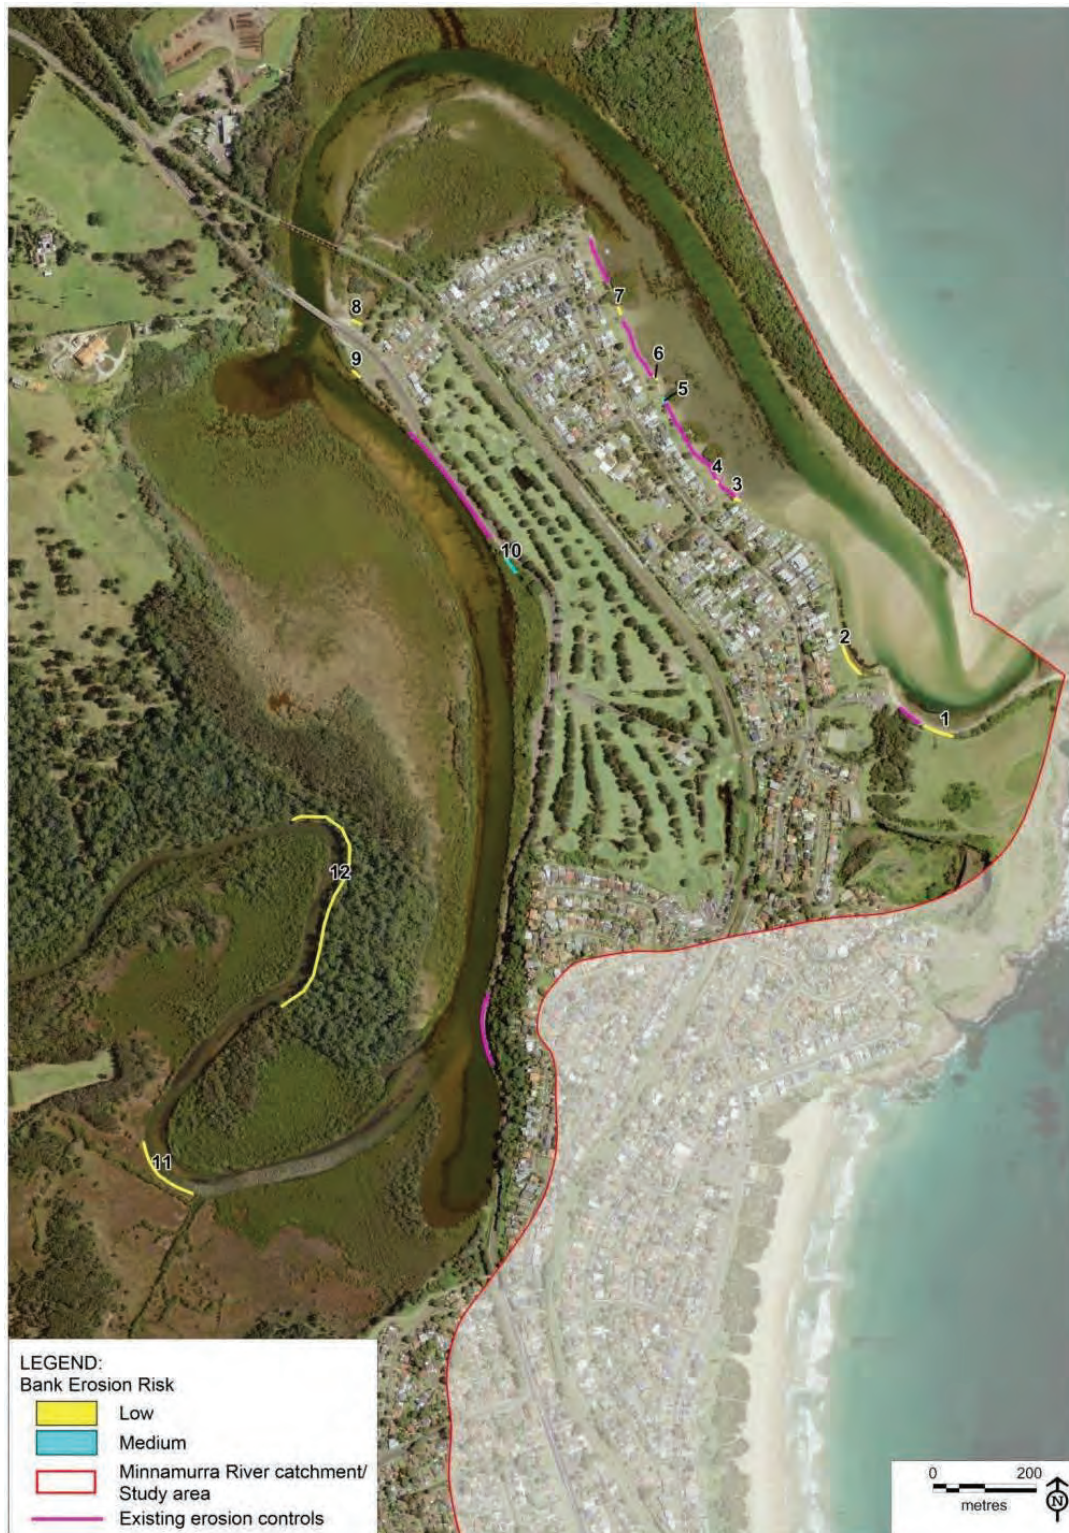
Figure 67: Locations of bank erosion sites in the lower to mid-estuary

Erosion controls (rock revetment and vegetation) have been installed along Minnamurra Headland, the Charles Avenue foreshore and Riverside Drive. While this has been largely successful and localised, erosion is occurring at the upstream and/or downstream extents of these controls (Sites 1-7 and 10). The erosion at Sites 8 and 9 appears to be scour caused by stormwater runoff. Sites 11 and 12 are located on the outside bends of the river and are due to natural river meander. Site 11 was identified as an erosion site in the 1995 EMP.

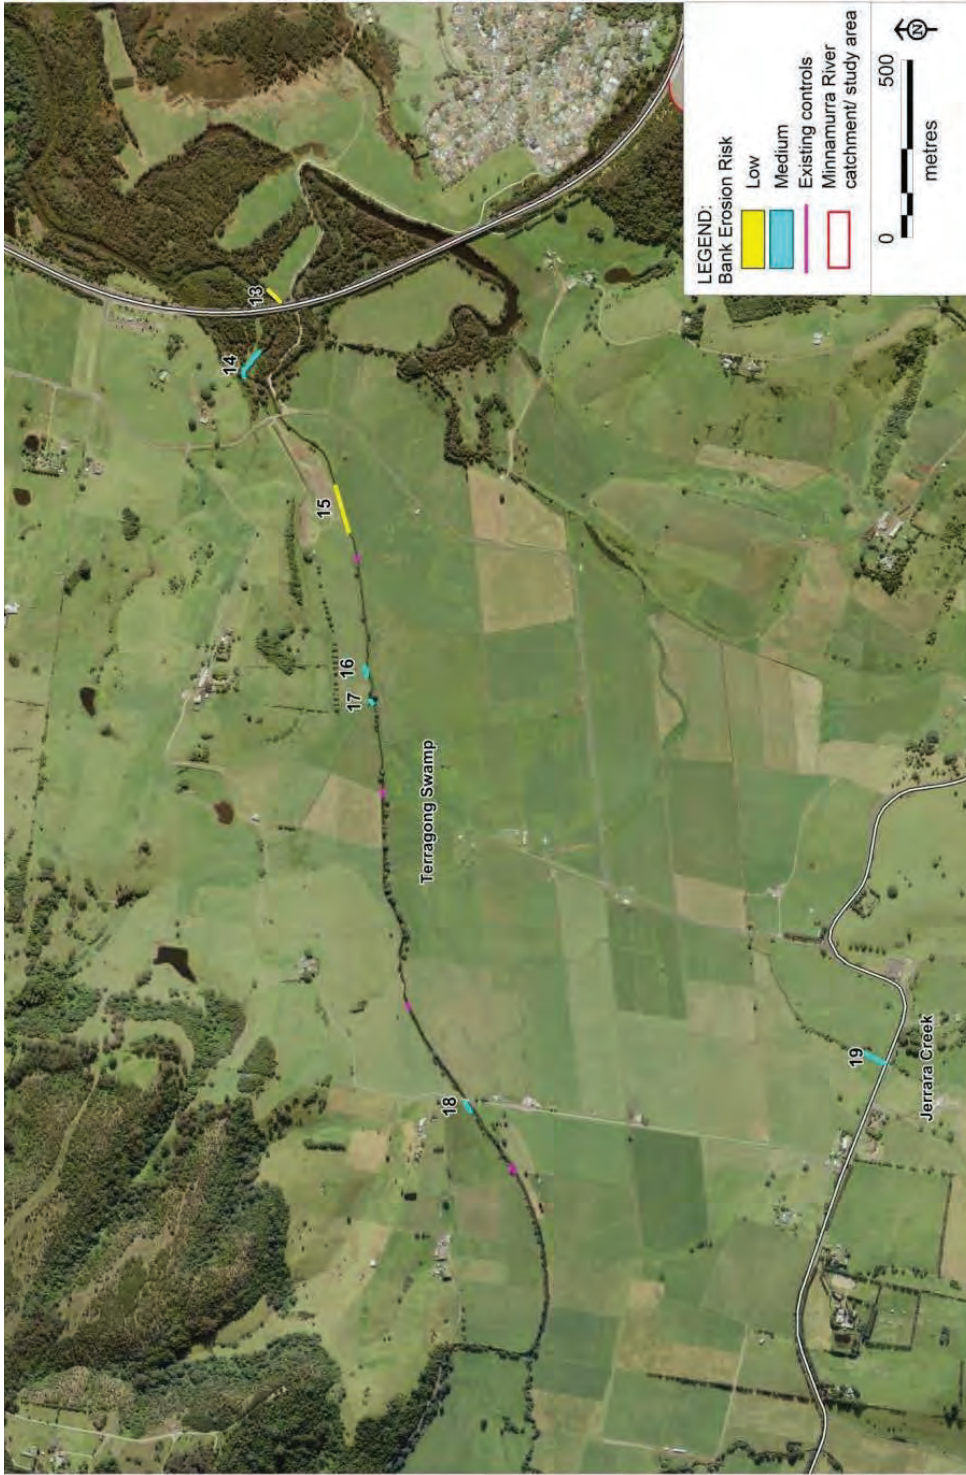
Figure 69: Locations of bank erosion sites in the upper estuary and lower Terragong swamp

Sites 13 and 14 are located on the outside bends of the river and are due to natural river meander and the lack of stabilising vegetation.

The formalised channel through Terragong Swamp (sites 15-18) is a narrow V-shaped incised channel with steep grade and steep banks which are prone to erosion. The rock ramps have reduced the grade of the channel, however, the channel attempts to naturally migrate as a morphological reaction to draining of the swamp (which straightened, shortened and steepened the channel and increased runoff due to catchment clearing). Bank erosion is exacerbated by stock access and fallen trees which cause flow obstructions. Much of the channel shows signs of slumping or erosion.

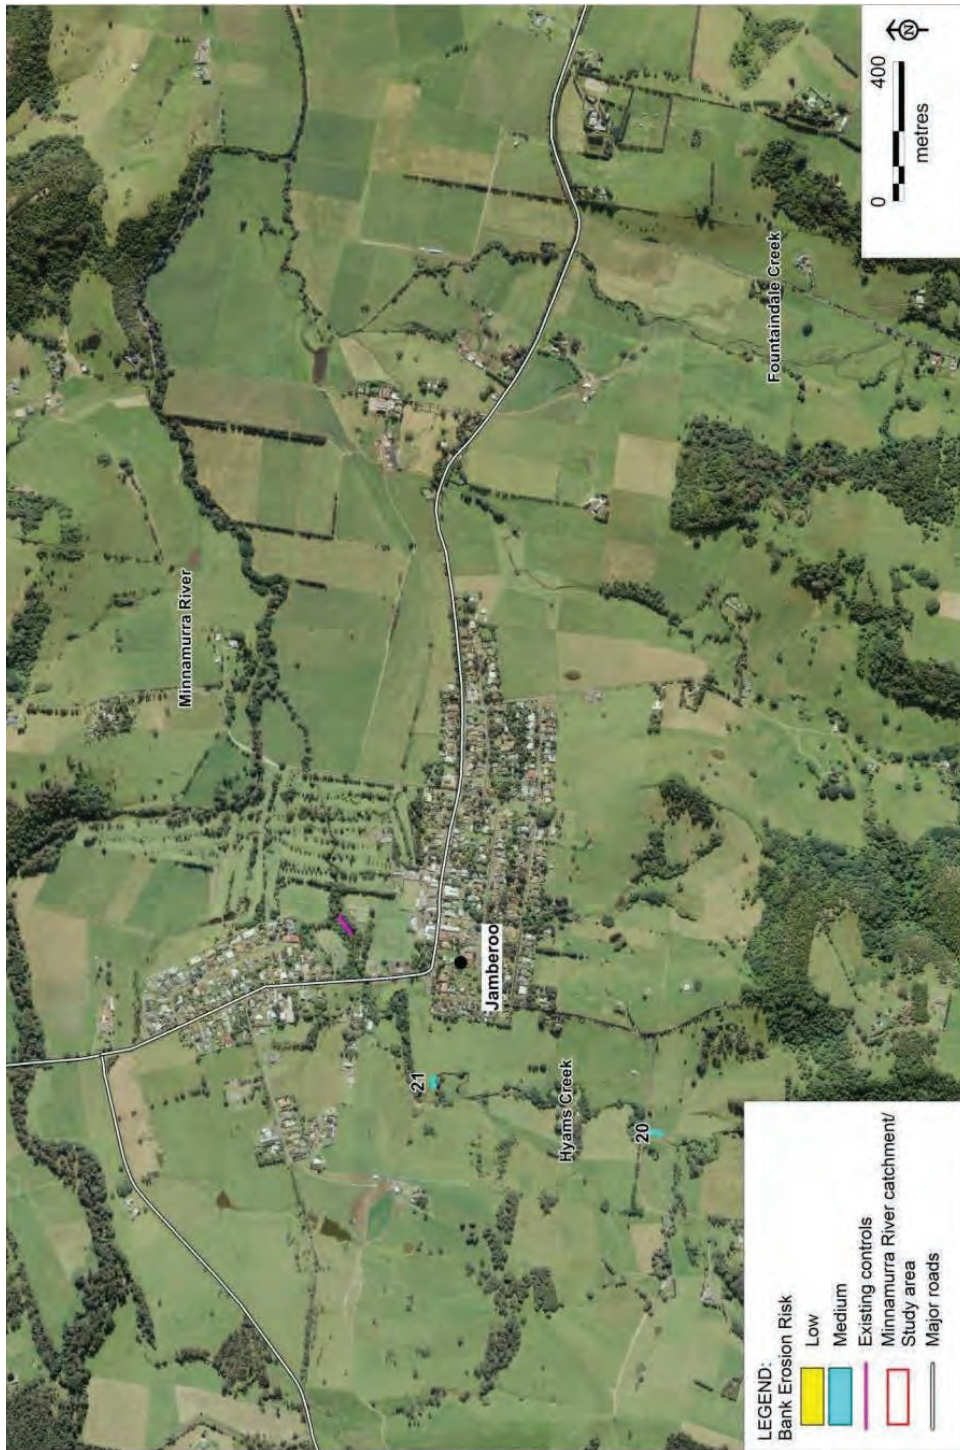
Figure 71: Locations of bank erosion sites in Hyams Creek

Erosion at sites 20 and 21 on Hyams Creek is caused by the poor condition of bank vegetation, flood scour and natural river meander.
