Gazettal and Commencement of a Coastal Zone Management Plan

Sandy Point/Conroy Park Foreshore

Erosion and Drainage Management Plan

Prepared for Port Stephens Council

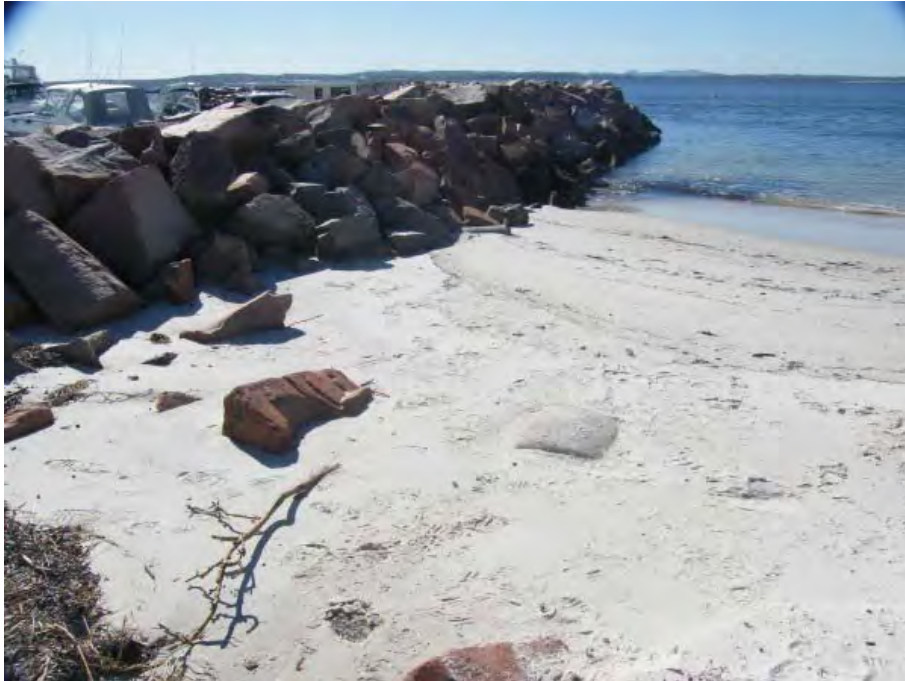
Figure 2 Western end of Precinct 1. Sand accretion against the Anchorage marina wall is burying stormwater outlets. *Photo Source: D Lord, 8th May 2015*

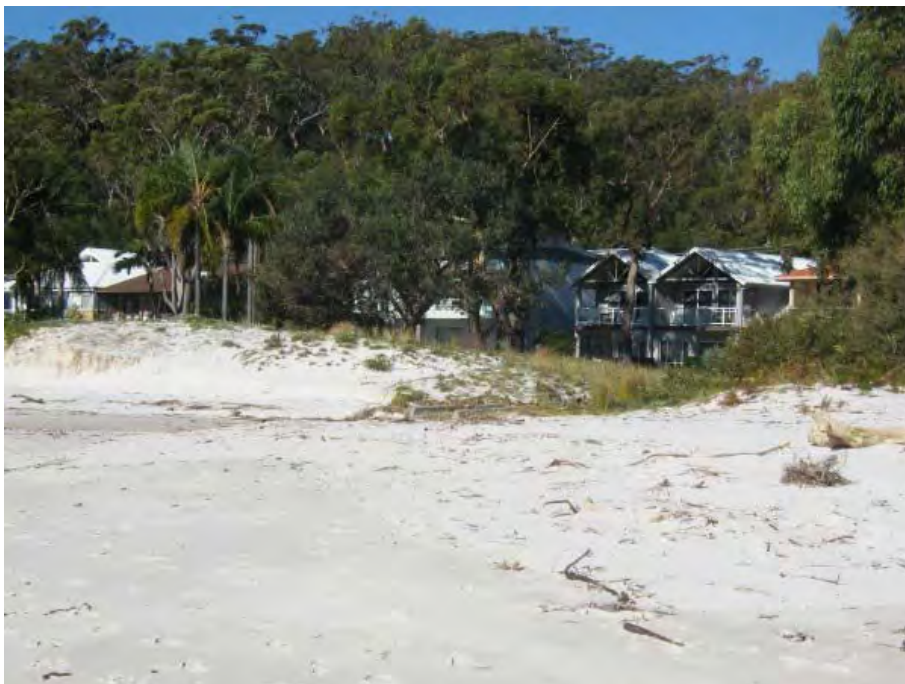
Figure 3 Eastern end of Precinct 1. Sand accretion extends to the west of the stormwater drain across Corlette Point Park. *Photo Source: D Lord, 8th May 2015*

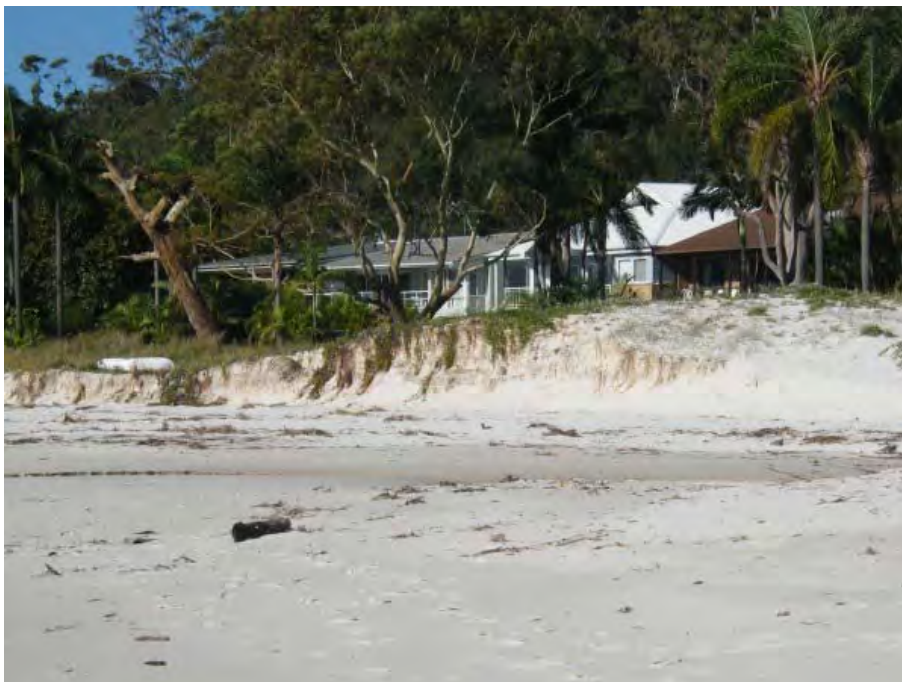
Figure 4 Western end of Precinct 2 where accretion of the beach finishes east of the stormwater outlet and erosion of the back beach commences through to Conroy Park. Photo Source: D Lord, 8th May 2015

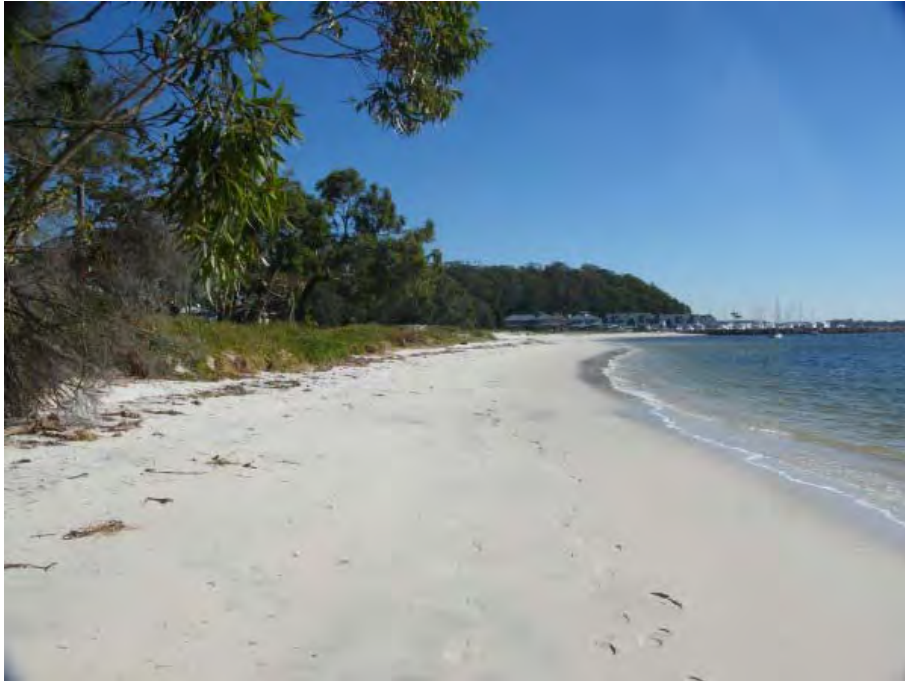
Figure 5 Looking west along precinct 2 from Conroy Park. A sandy beach remains at mid to low tides and is a popular walking area between Conroy Park and the Anchorage.

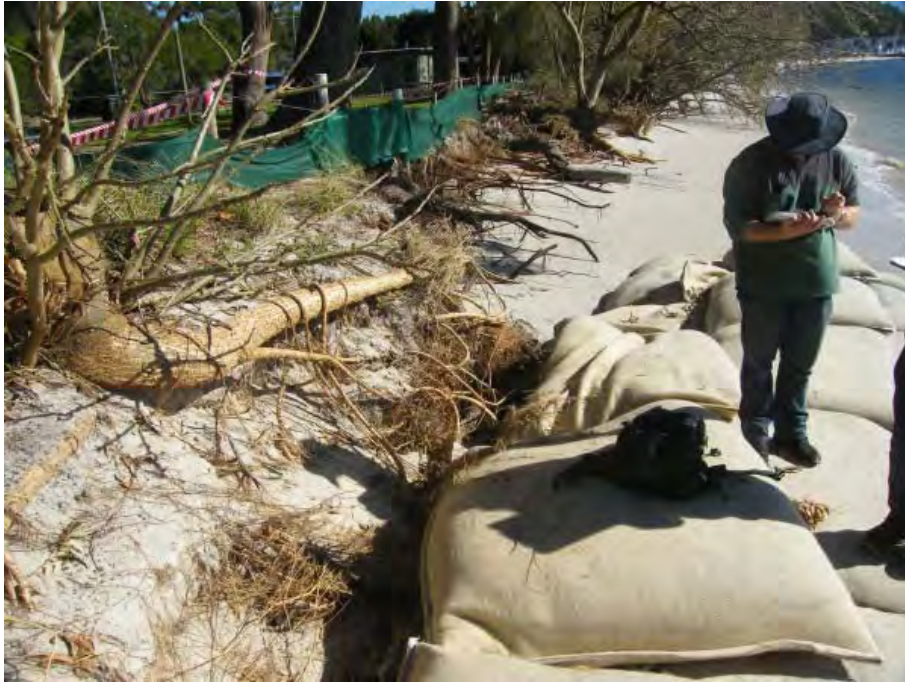
Figure 6 Precinct 2 eastern end. Geotextile containers have been employed for emergency beach protection along the eastern end of Conroy Park. Increased erosion west of the end of the protection is evident. Additional containers have been placed to extend the wall since this photo. There is little sandy beach width remaining at this location and no beach at mid to high tides. Access to the beach from the park has been affected.

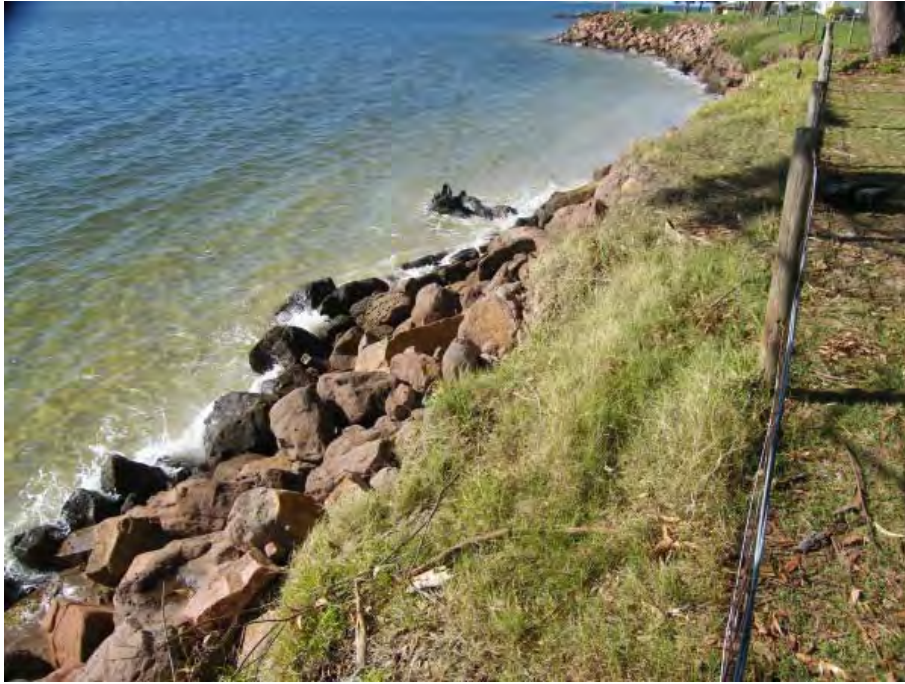
Figure 7 Precinct 3 eastern end Conroy Park. Rock protection has been placed along this section of the foreshore to the western most groyne. *Photo Source: D Lord, 8th May 2015*

This precinct includes the shoreline from the east end of Conroy Park (adjacent to #70 Sandy Point Road) to the rock groyne adjacent to the reserve immediately west of #46 Sandy point Road at the tip of Sandy Point. The shoreline within this precinct is relatively straight and faces NNE. It is more protected from ocean swells passing through the entrance to Port Stephens than the area further to the east, but has exposure to winter westerly wind waves. The foreshore is mostly protected by tipped rock walls which have not been designed and which vary in their current state of repair and effectiveness. The 12 dwellings behind this foreshore are set back between 13m (western end) and 25m (at #60 Sandy Point Road). The average setback is around 20m. The reserve seaward of the properties is wide and accessible with lawns and some planting maintained by the residents.

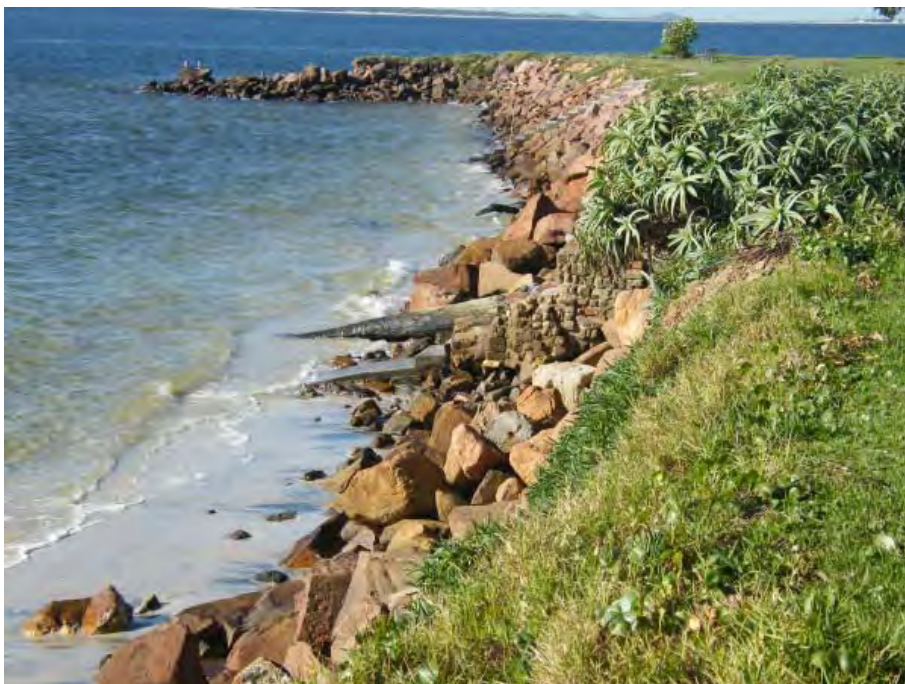
Figure 8 Precinct 3 looking east to the western groyne. Various access stairs of differing design cross the revetment. The wall is generally steep, with some slumping and loss of armour near the crest, exposing the erodible bank behind. Armour stone size is variable. The western groyne and Port Stephens entrance are at the top of the photo. *Photo Source: D Lord, 8th May 2015*

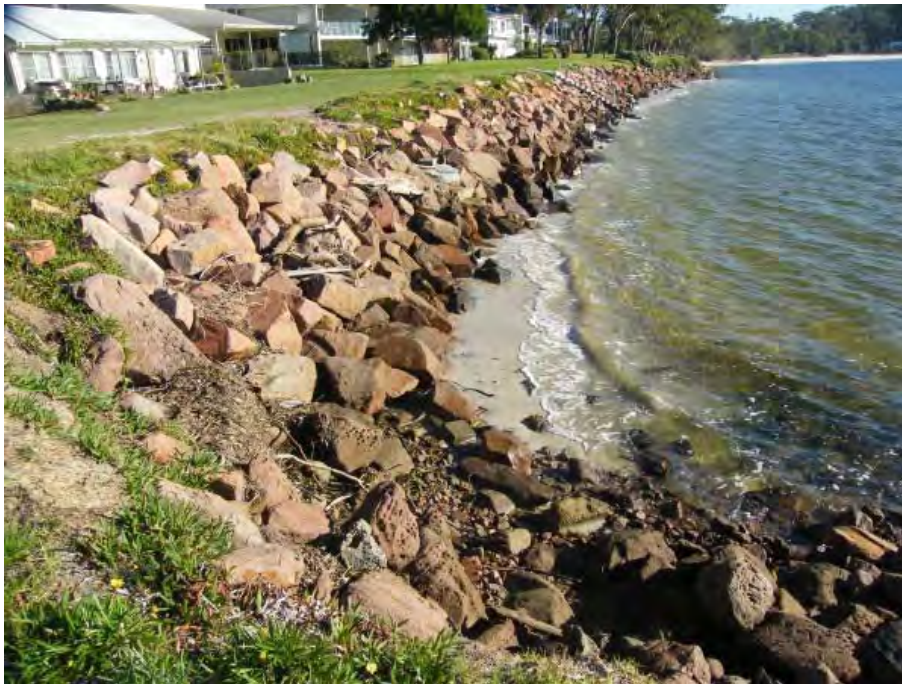
Figure 9 Precinct 3 looking west from the western groyne to Conroy Park.
Photo Source: D Lord, 8th May 2015

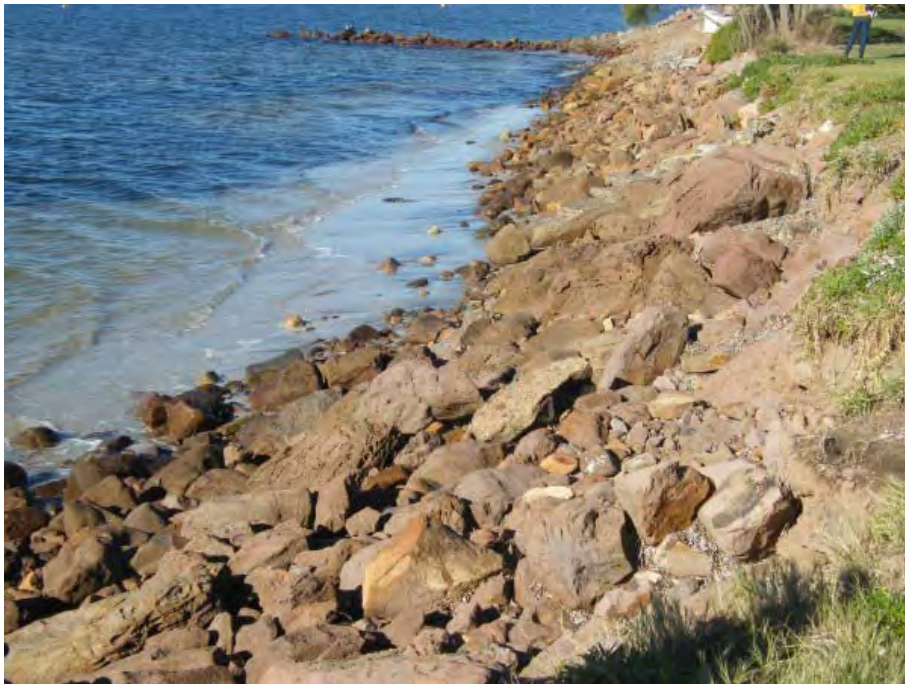
Figure 10 Precinct 4 looking east along the revetment face from the western groyne to the next groyne east. Rock armour sizes along this section are variable with significant slumping and loss of armour near the crest, exposing the erodible bank behind. The accreted sand fillet is visible in the lower left hand corner of the photo

While this shoreline is less exposed to the ocean swells than precinct five (to the east), there is a need to reconsider the effectiveness of the existing protection which is generally undersized and failing.

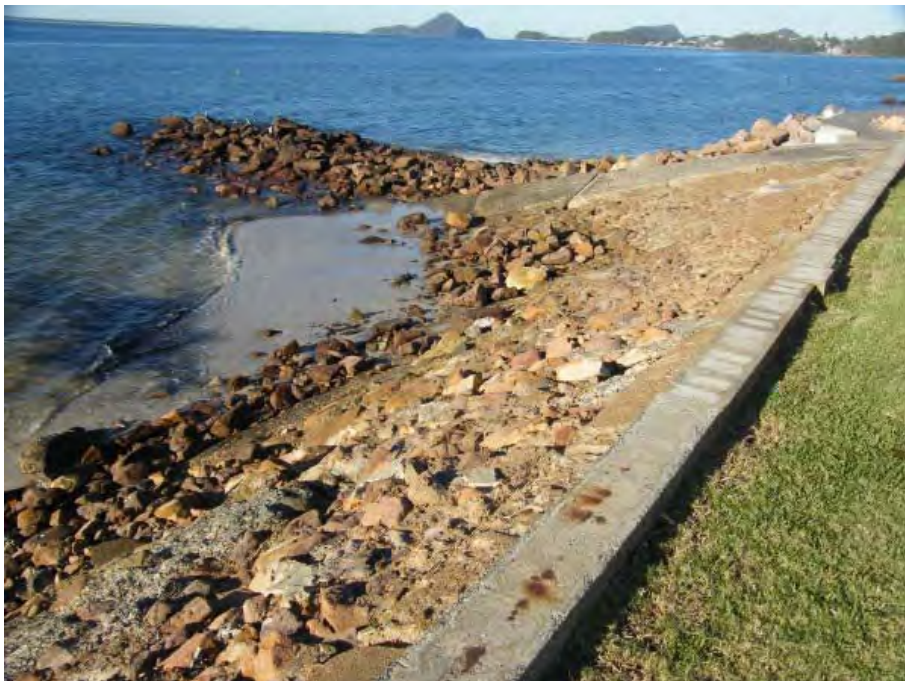
Figure 11 Eastern end of Precinct 4. A boat ramp is located west of the groyne. Rock armour has been grouted to form a smooth wall. The rock groyne has slumped and is too short and low to anchor the beach or provide significant protection. A concrete apron can be seen beyond the groyne in Precinct 5. *Photo Source: D Lord, 8th May 2015*

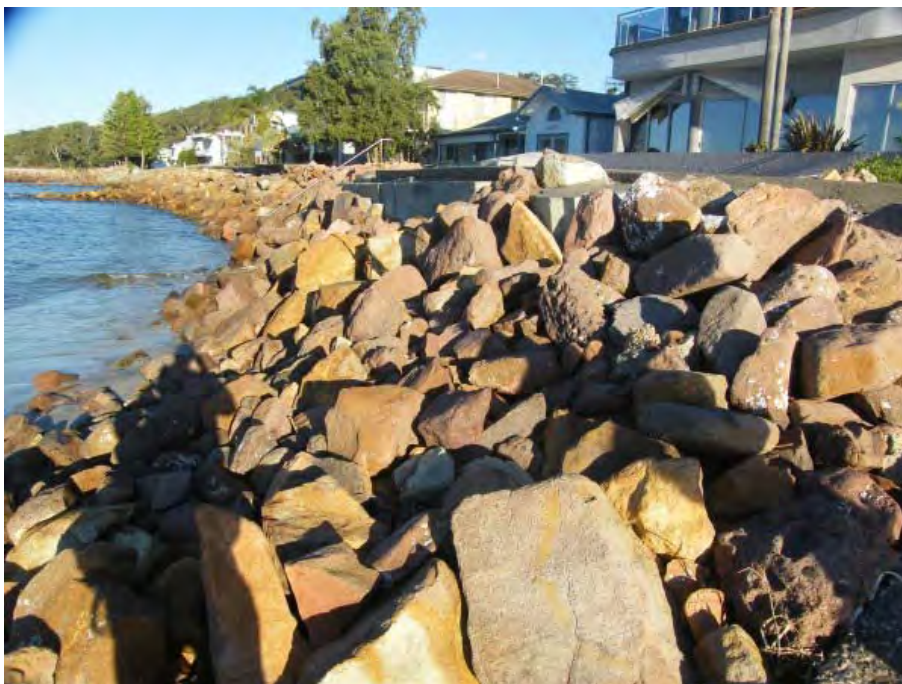
Figure 12 Western end of Precinct 5. A vertical concrete block wall has been constructed in the centre but this precinct is predominantly tipped rock. Little or no sandy beach remains, even at low tide. The public access through Precinct 5 is compromised and wave overtopping during storms is resulting in damage and inundation of property landward of the wall.

This limited setback has compromised the alongshore access which is integrated into the seawall crest across some properties and varies in height, width and construction. Following the April 2015 storms the access alongshore through this precinct was unusable in some locations, with damage to the path surface, scour holes and dislodged rocks resulting in sections being taped off to restrict access, pending repair. This section is the most at risk with regular damage to the revetment, and extensive overtopping of the varied protection structures. The effect of wave overtopping is notably exacerbated by boat ramps, with low crest levels and poor drainage from behind the wall also causing issues.

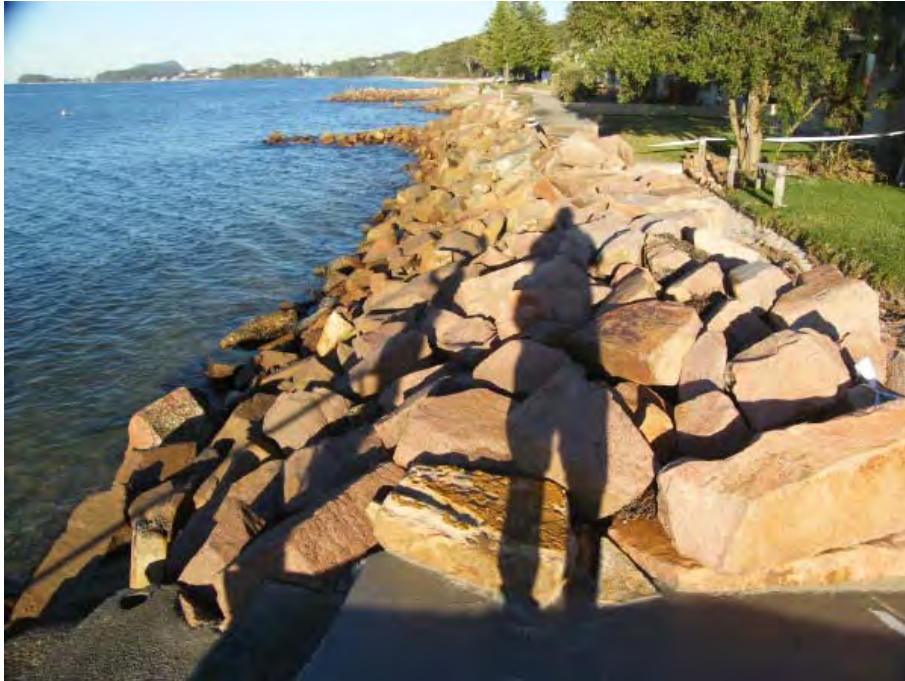
Figure 13 Much of the rock wall along Precinct 5 comprises substantial sized stone at a flatter slope. This is the most exposed section of the study area receiving ocean swells entering the Port during storms. At the time of inspection damage to the wall including loss of armour from the face and crest was observed. Scour holes under slabs and through the wall from overtopping was evident at a number of locations. The alongshore access was closed (SES tapes) along several sections. *Photo Source: D Lord, 8th May 2015*

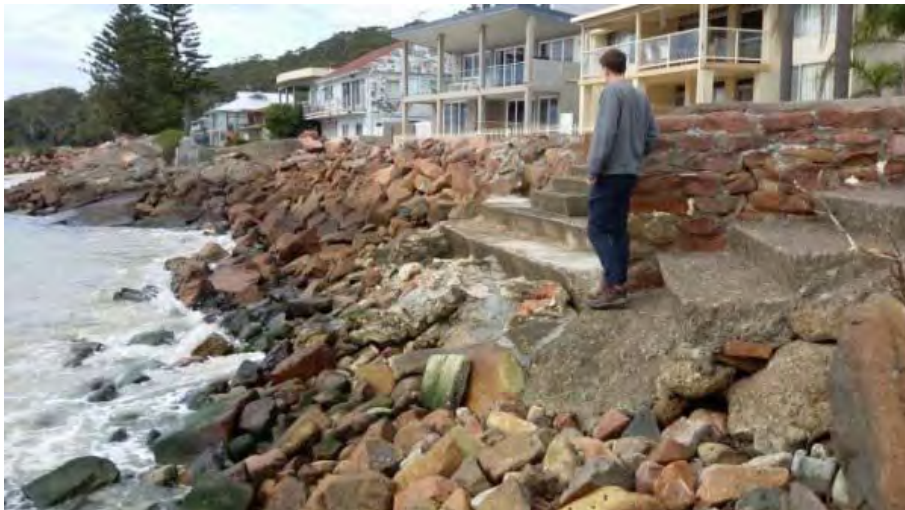
Figure 14 Eastern end of Precinct 5. Sections of the wall have undersized armour, grouted stones and various access stairs and ramps across them. Precinct 5 is the most exposed section of the foreshore and the protection provided is poor for the level of exposure. *Photo Source: D Wainwright, 12th May 2015*

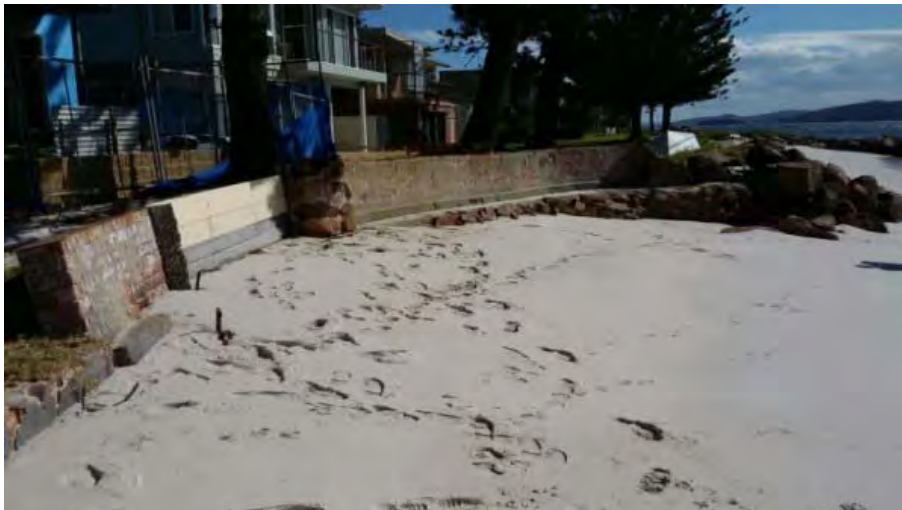
Figure 15 Precinct 6. Located to the east of the eastern most groyne, this section just west of Bagnalls Beach is more sheltered than areas westward (Precinct 5) with generally lower protection structures and a build-up of sand on the eastern side of the groyne. The groyne was lengthened and upgraded to carry the stormwater outlet beyond the beach. The type and standard of back beach protection is variable. Overtopping is experienced right along this precinct although much of the development is set further back from the shoreline. *Photo Source: D Wainwright, 12th May 2015*

Precinct 6 is more sheltered than areas to the west but is still subject to wave erosion and overtopping as evidenced by the existence of substantial sections of revetment of varying design along the foreshore. The groyne is effectively retaining sand to the east and a sandy beach area fronts the seawall along this precinct under most conditions. Even so, the presence of boat ramps along this precinct allows waves to easily run up and inundate the area behind the foreshore.

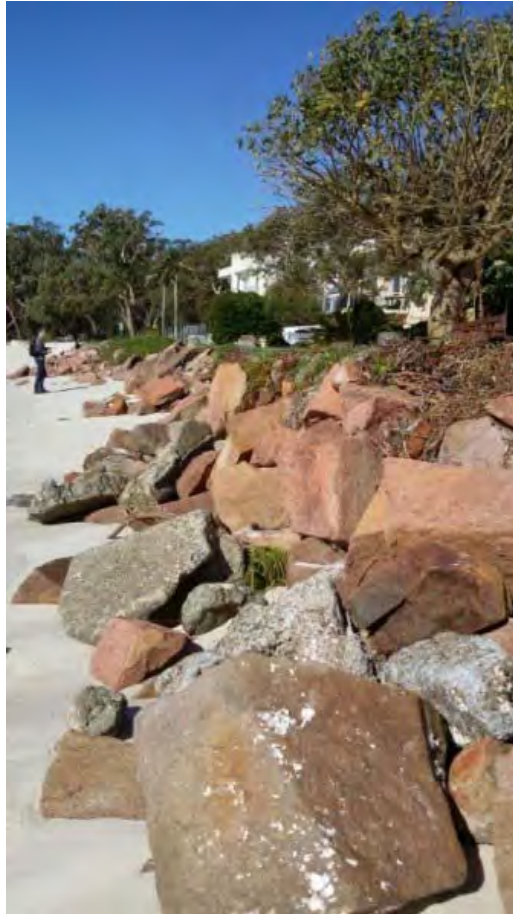
Figure 16 Precinct 6. Some larger rock has been placed along sections of this precinct and a sandy beach remains seaward of this protection work.
Photo Source: D Wainwright, 12th May 2015

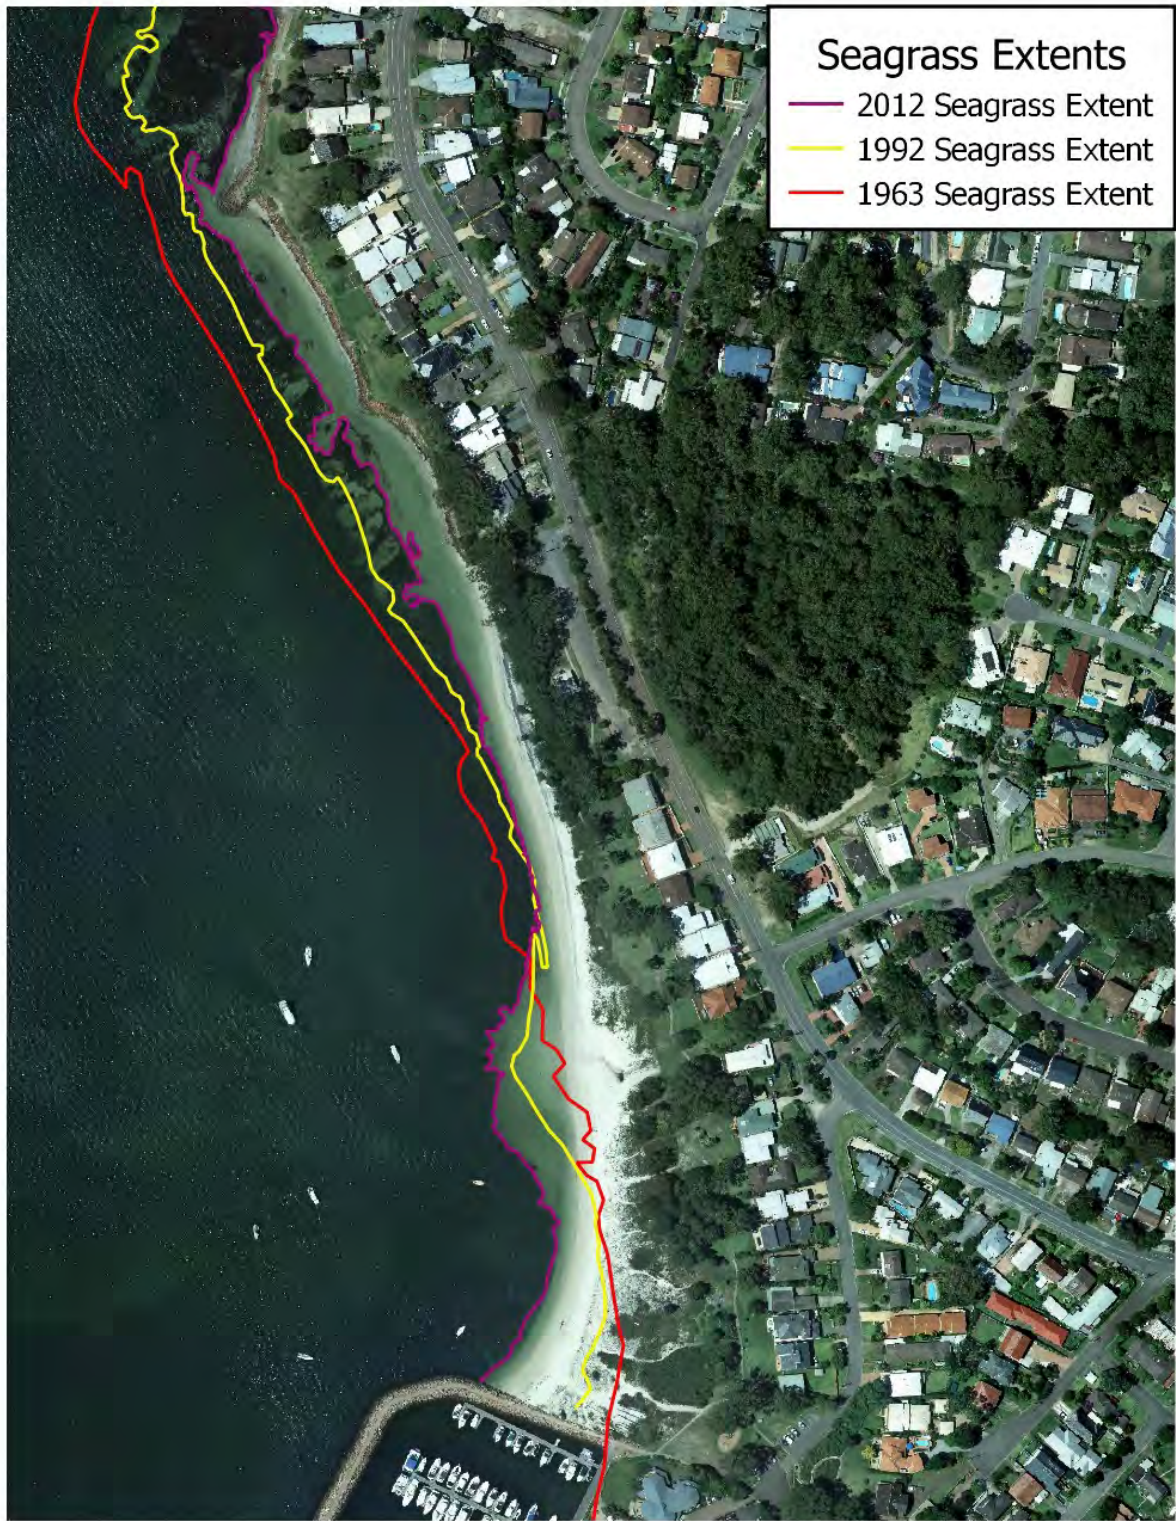
Figure 17: Movement of Landward Edge of Seagrass Beds Over Time

Figure 17 presents the landward extent of seagrass beds from 1963, 1992 and 2012. The figure indicates that erosion of the eastern end of Corlette Beach, and Accretion of the western end has been ongoing since the 1960's. Of particular interest is the presence of a point about which the beach appears to have "pivoted" around 250m to the east of the present day Marina Breakwater. To the east of that point, Corlette Beach has eroded, and to the west, it has accreted. The key finding from this analysis is that this process has been occurring since *before the Anchorage Marina was constructed*. We do not believe that construction of the Marina has contributed in any significant way to the erosion of eastern end of Corlette Beach. Furthermore, the pattern of less sand being present in the nearshore zone continues around Sandy Point, and indicates that ongoing erosion is largely a function of less sand being available from an *updrift* direction (i.e. Bagnalls Beach or the flood tide shoal).

From Figure 17 a pivot point about which the beach has apparently "rotated" can be identified around 250m east of the breakwater. To the west of this point, the beach has accreted, and to the east of this point, the beach has eroded. The rate of sand accumulation to the west of the pivot point has been estimated, and this used to estimate the average annual sand transport rate between 1992 and 2012.

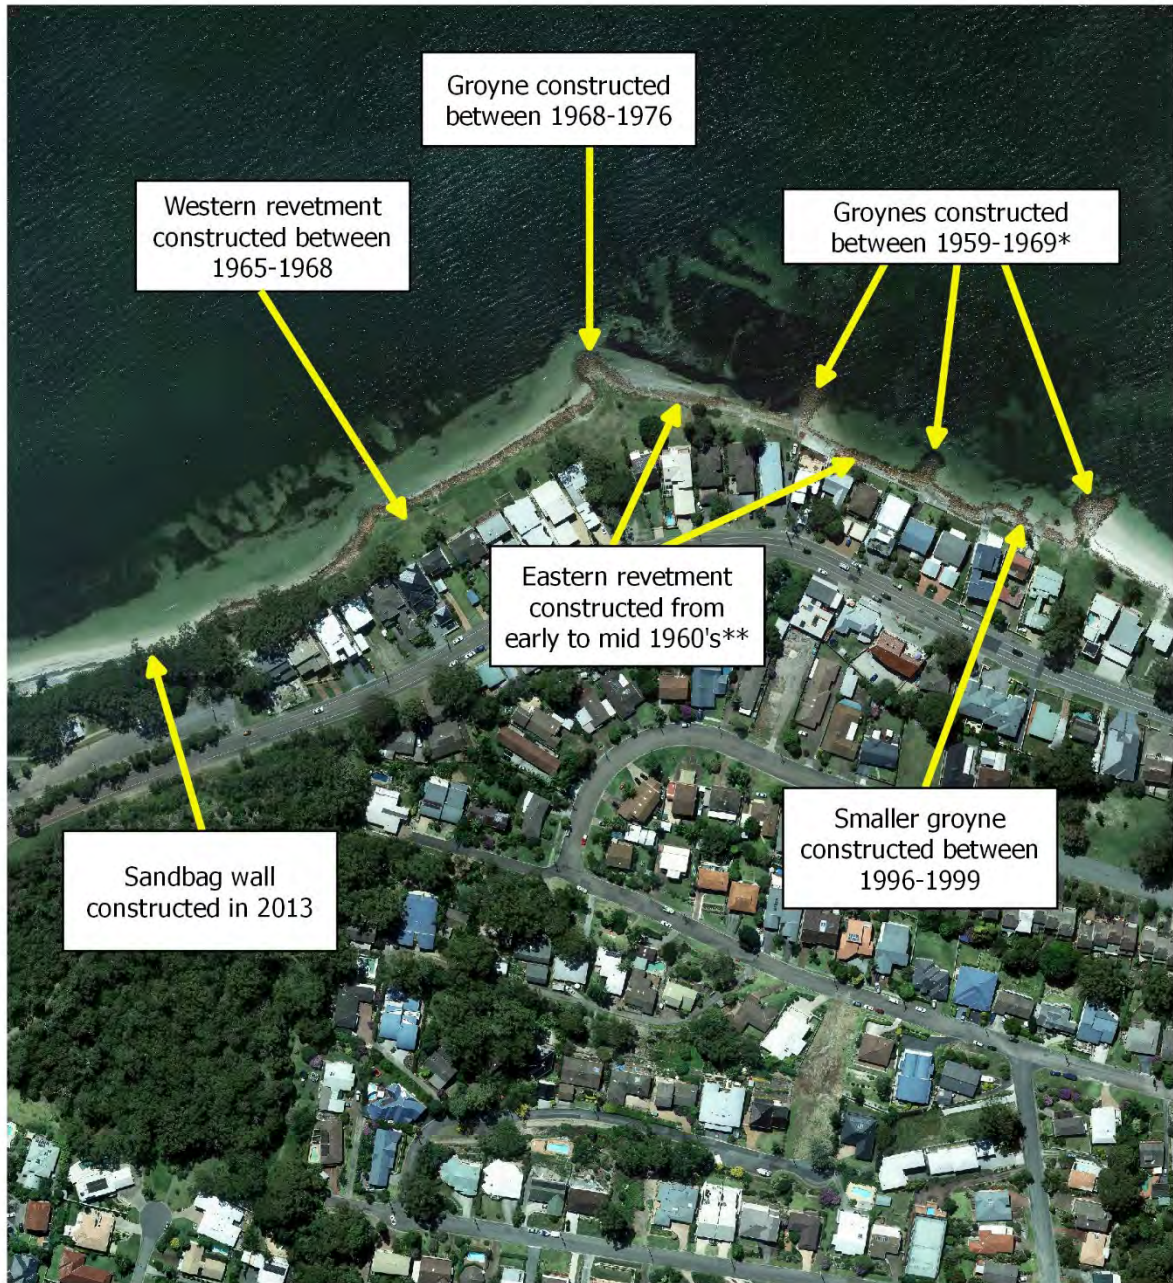
Figure 18: Approximate Construction Dates for Foreshore Structures

Figure 18 indicates the approximate dates at which different foreshore protection works have been constructed. Over time, the nature, configuration and alignment of different elements of the constructed works have changed, in response to storms or ongoing erosion. However, it is clear that there were minimal structures present during the 1950's, with the progressive construction of foreshore works occurring from the early 1960's onwards. It appears that settlement of the area during the late 1940's and 1950's, following subdivision in 1945 occurred when the beach was particularly wide as a result of a pulse of sand moving from east to west around Sandy Point. However, in the late 1950's through to the 1970's, coastal storms resulted in a dramatic re-alignment of the shoreline around Sandy Point, as sand which was present in large lobes offshore of the site were progressively moved in a westerly direction, leaving the shoreline relatively denuded of sand and with a comparatively narrower beach.

*From shoreline alignment appears structures were here from 1963, however they become more prominent with time.
 **Progressive construction tended to be from east to west.

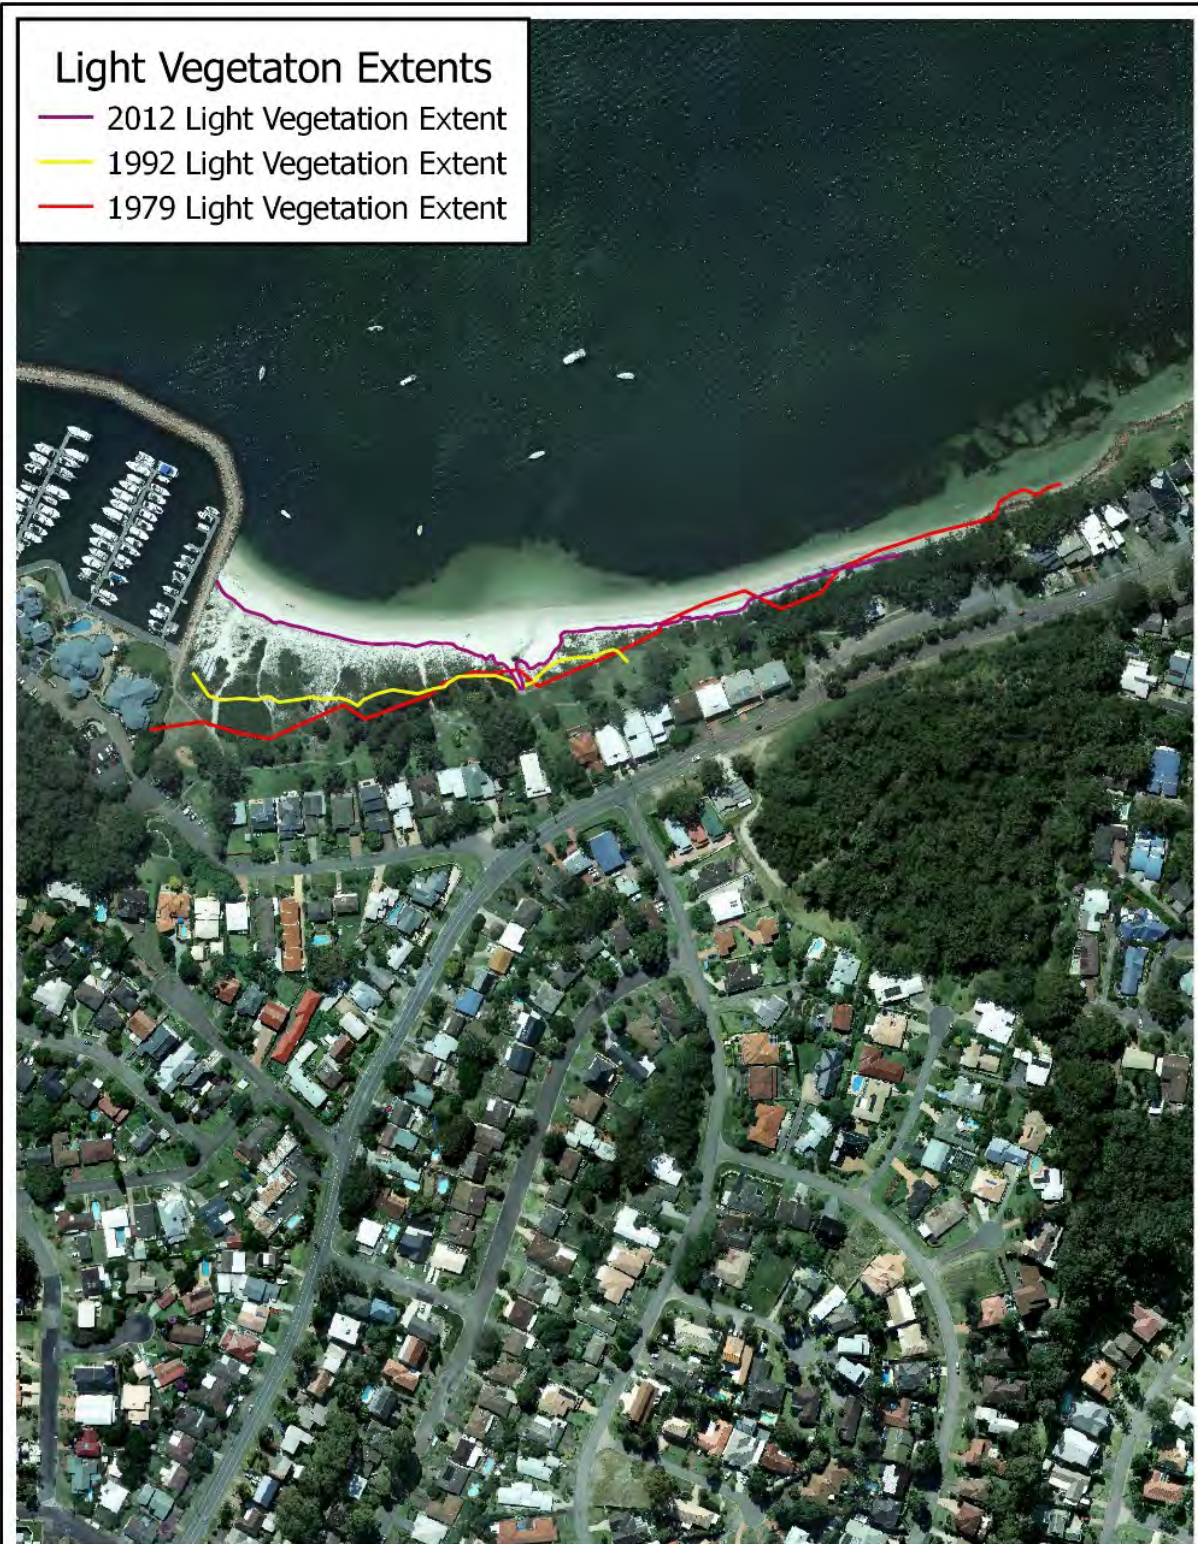
Figure 19: Change in Dune Vegetation Extent over Time
 Sandy Point/Conroy Park Foreshore Erosion and Drainage Management Plan

The evolution of an alternative proxy measurement for foreshore alignment is presented in Figure 19. In that figure, the “light” vegetation, which approximates the seaward location of the foredune along the western end of Corlette Beach, has been mapped for 1979, 1992 and 2012. Similarly to Figure 17, Figure 19 indicates that progradation of the Beach had begun in this location prior to the construction of the Anchorage. Similarly, there is an apparent point about which the beach has pivoted or “rotated” around 250m to the east of the Anchorage breakwater.

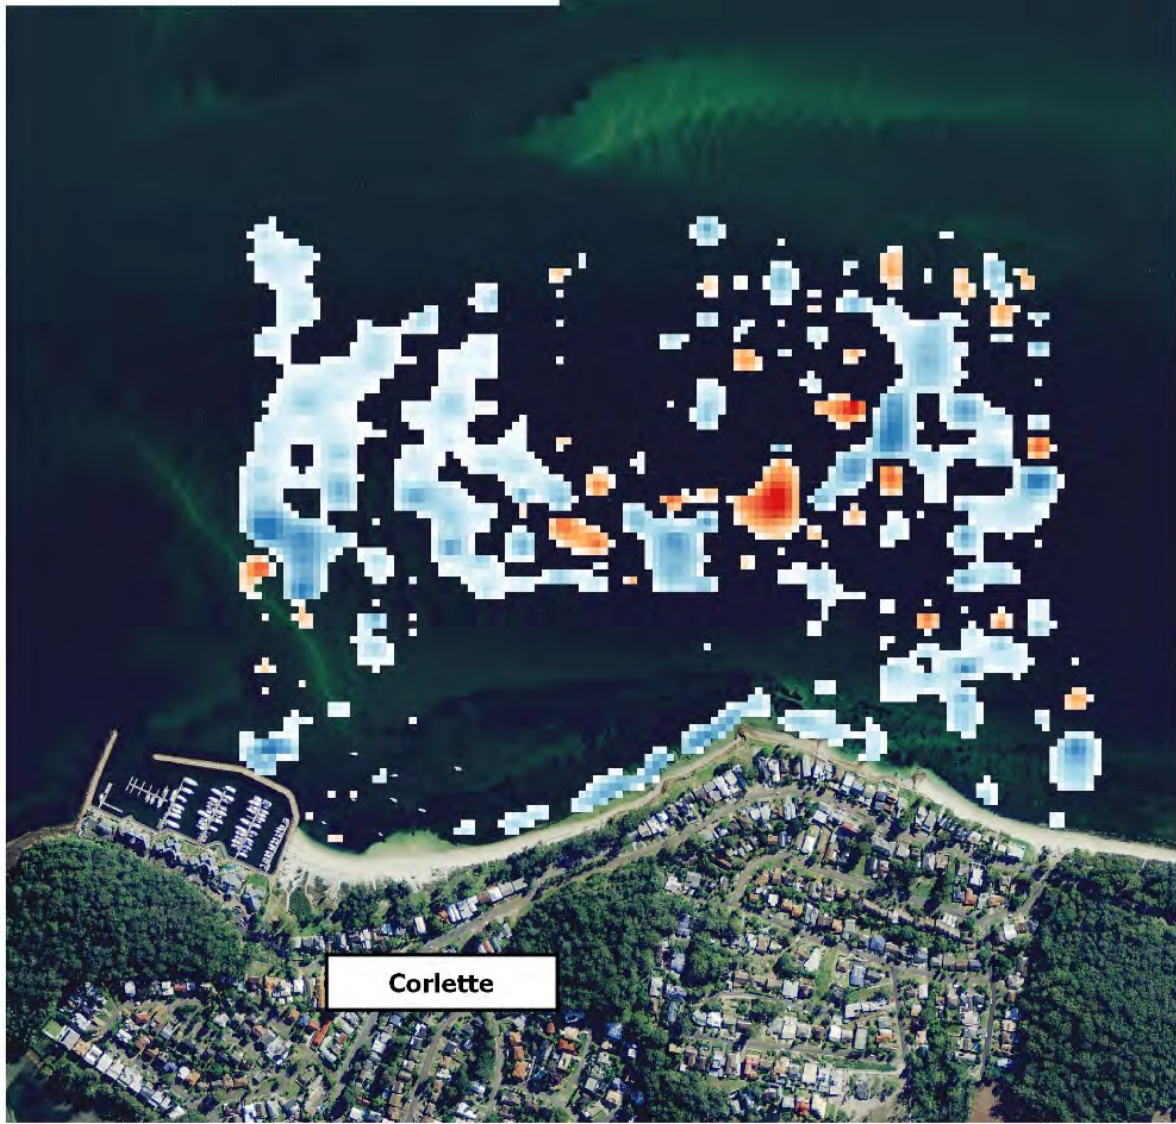
Figure 22: Change in Bed Elevations, 2007 to 2015

Secondly a more recent and localised analysis of elevation changes was made by subtracting the 2007 elevations model from the 2015 elevations model. The calculation was limited by the extent of the 2015 hydrosurvey. The resulting difference map is provided as Figure 22. Figure 22 indicates that any significant recent changes offshore of the study site show, almost uniformly, erosion. These include erosion adjacent to the foreshores of Sandy Point and Conroy Park, and further offshore, in the tidal channel. The pattern is consistent with the “lowering” of the ramp side of the flood tide delta, and transport of those sand westwards, likely depositing on the prograding face of the flood tide delta immediately to the north of Corlette Headland. We expect that the bed may continue to lower offshore of the study site in coming decades.

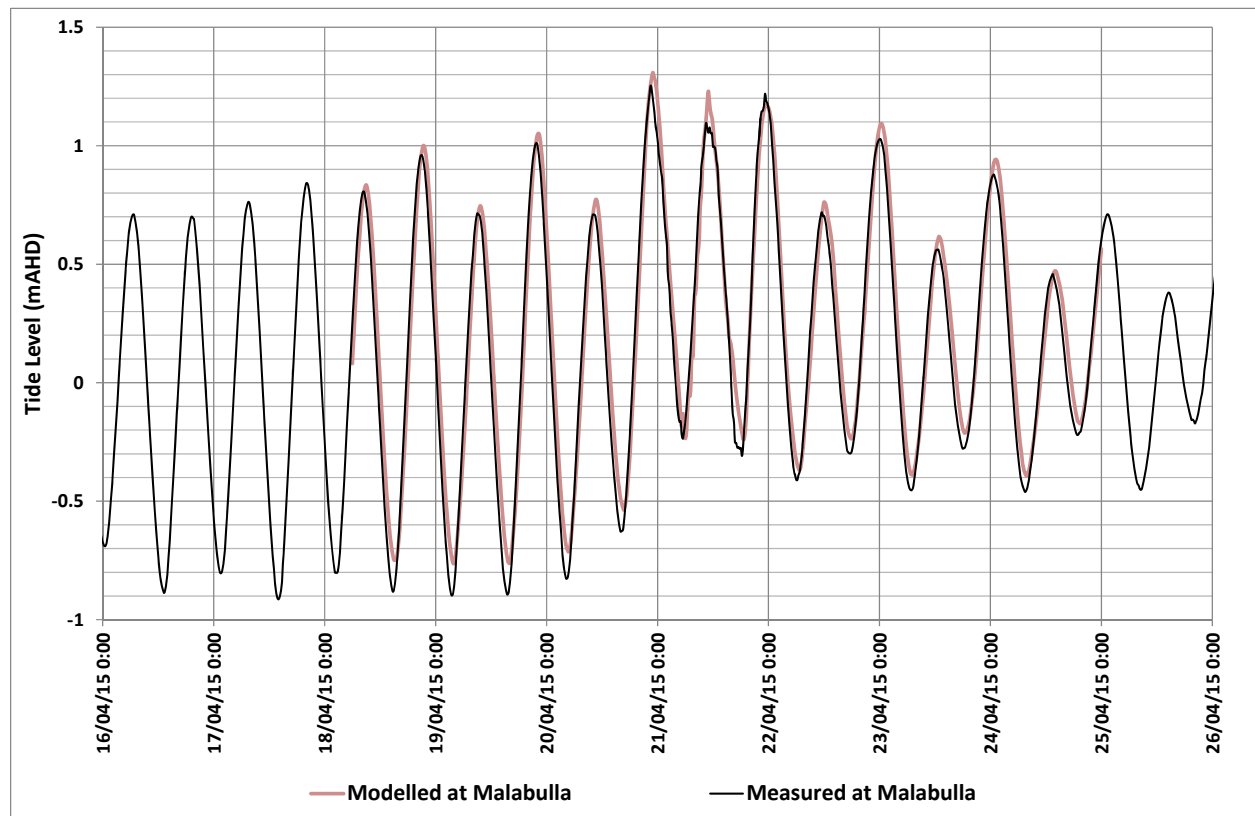
Figure 26 Modelled and Measured Tides at Mallabula Gauge, April 2015 Storm

A time step of 0.05 minutes was adopted to achieve stability. A comparison of the resulting modelled and measured tide levels at the Mallabula gauge site is provided in Figure 26 covering a range of tidal cycles over 9 days.

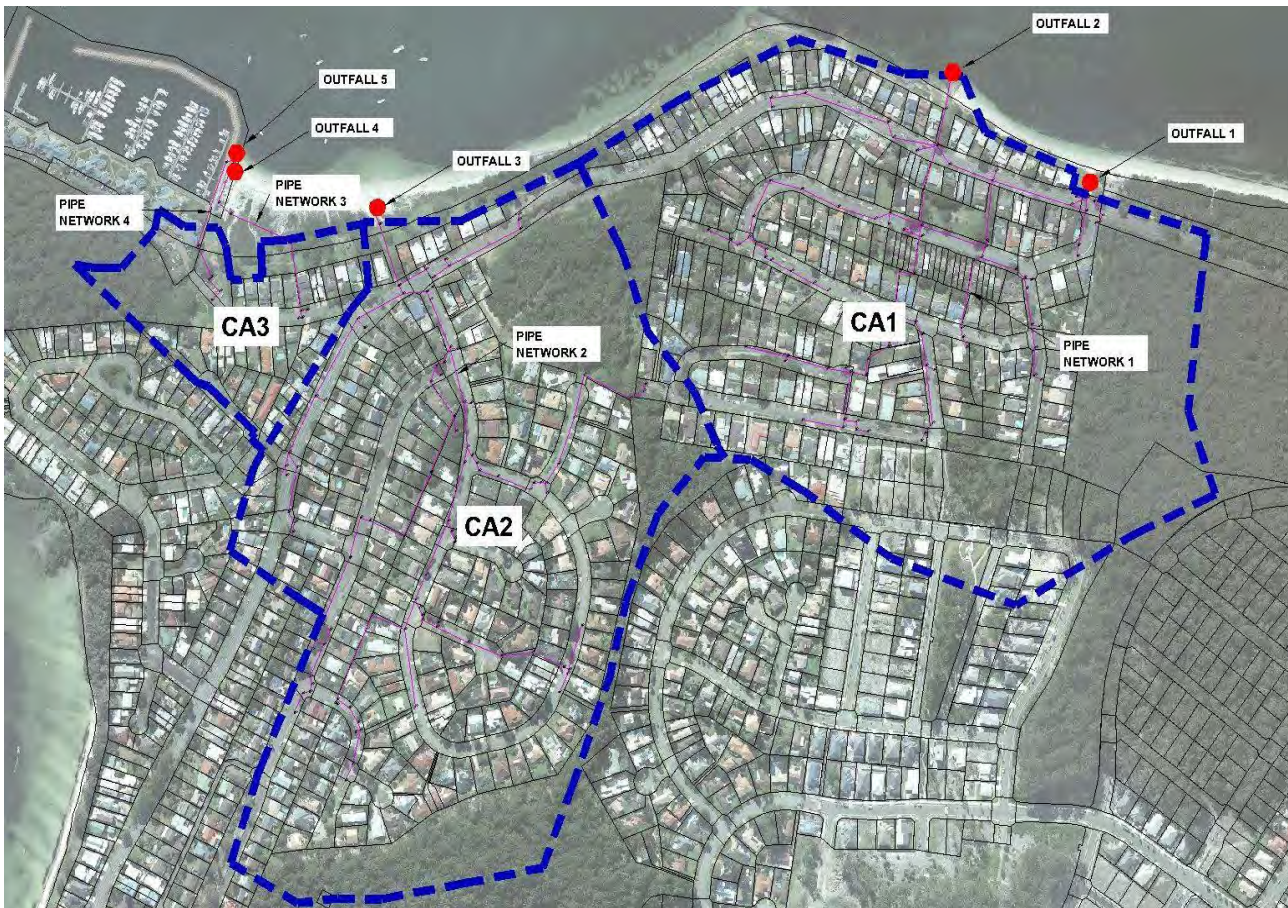
Figure 1 - Site Location & Catchment Plan

The study area is located within the township of Corlette (Figure 1). Corlette is located along the southern foreshore of Port Stephens. The terrain within the catchments of the study area ranges from moderately to very steep, but the foreshore area itself is almost flat.

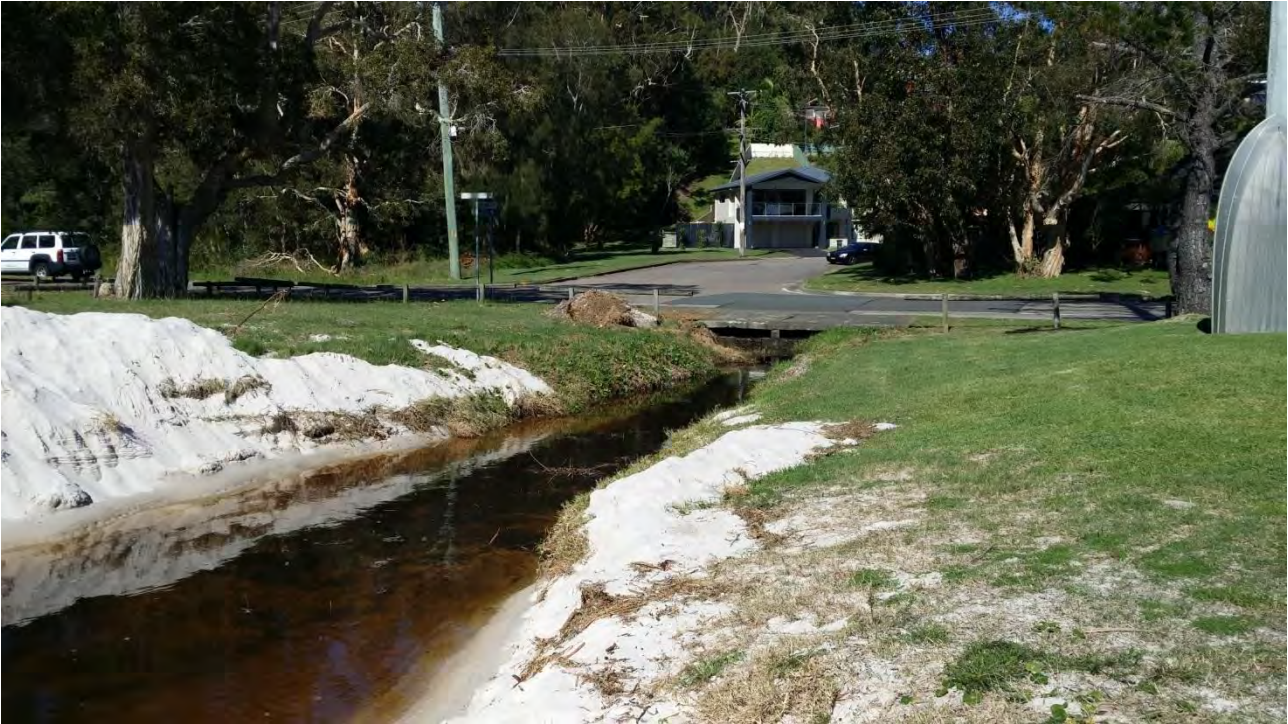
Outfall 1 is located within catchment CA1. It consists of a surcharge pit and overland flow path across the beach reserve (Photo 1). It is located at a lowpoint within Sandy Point Road and serves as a relief point during localised flooding of Sandy Point Road during large storm events. The surcharge path requires regular maintenance for it to work effectively and it had recently been cleaned out prior to our inspection.

Photo 1 - Looking south towards surcharge pit at Outfall 1 location.

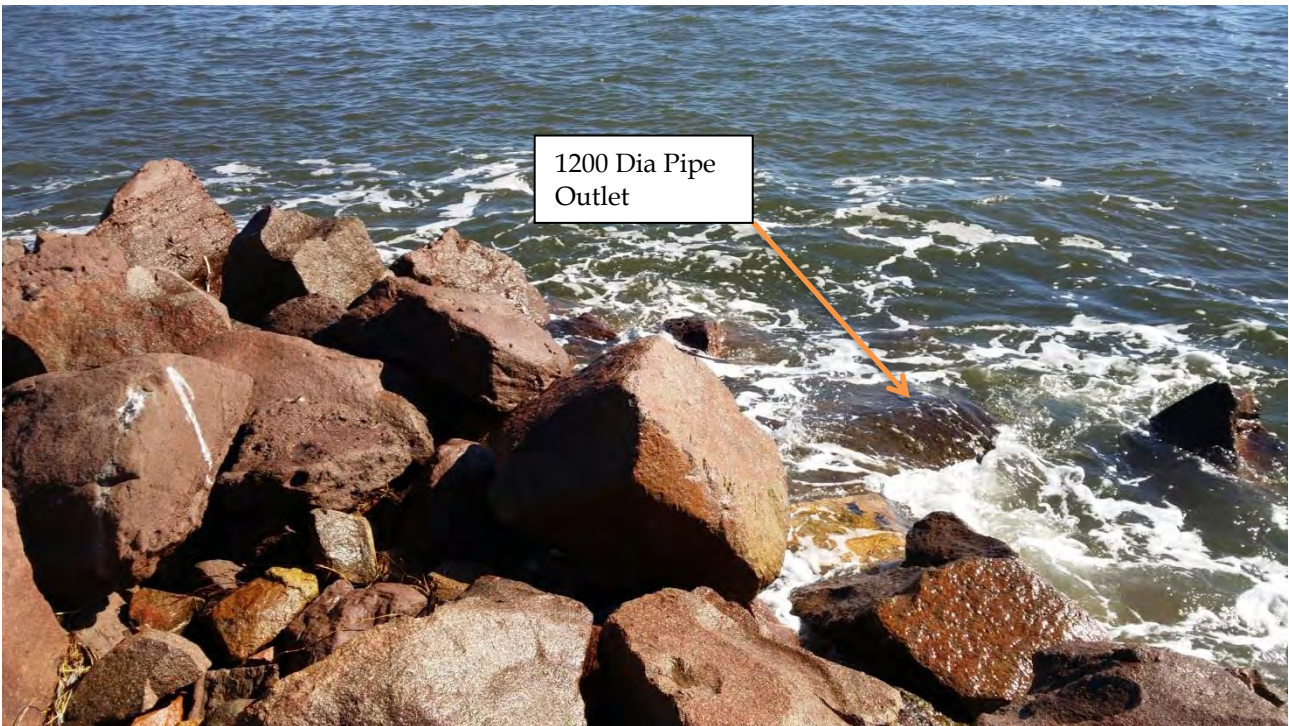
This is a major discharge point located within catchment CA1. It consists of two, 1200mm diameter reinforced concrete pipes under a rock groyne wall (Photo 2).

Photo 2 - Outfall 2 Looking north
