Gazettal and Commencement of a Coastal Zone Management Plan

Sandy Point/Conroy Park Foreshore

Erosion and Drainage Management Plan

Prepared for Port Stephens Council

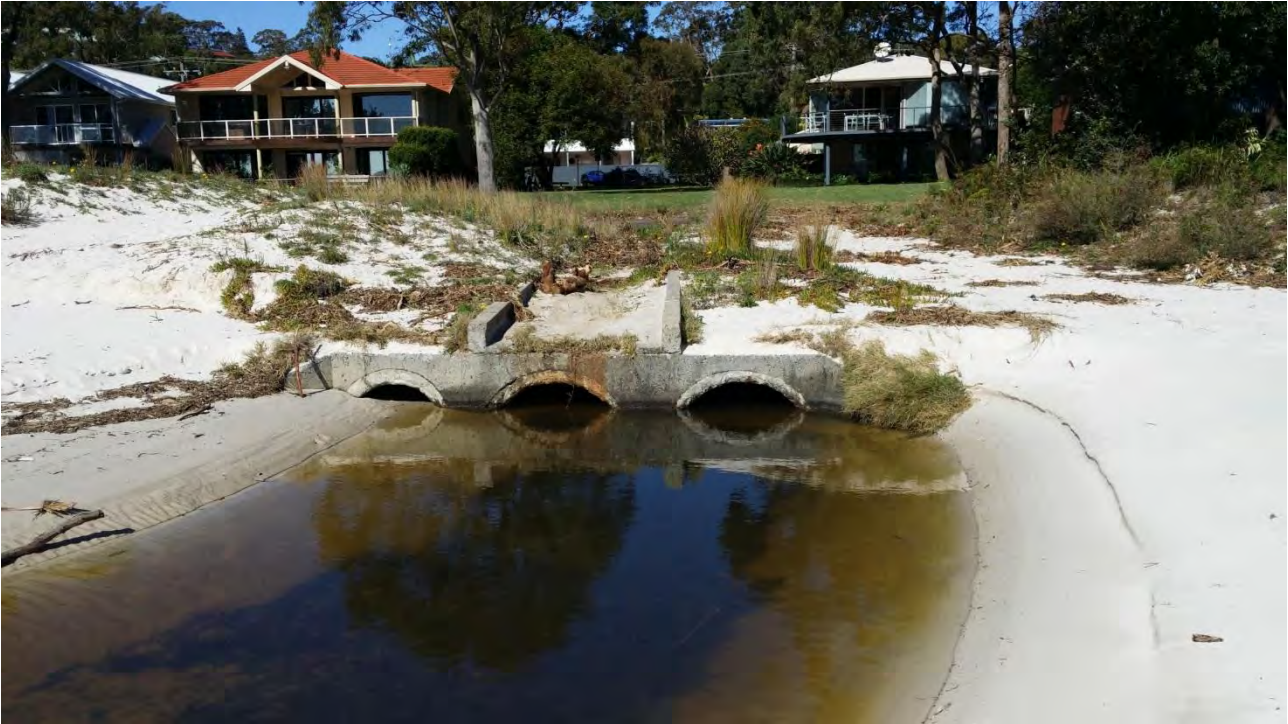
Outfall 3 is located within catchment CA2. It is a major discharge point consisting of three 1200mm diameter concrete pipes discharging directly onto Corlette Beach (Photo 3). The pit immediately upstream of the outlet contains a surcharge outlet, surcharging larger flows during major storms into an existing concrete apron.

Photo 3 - Outfall 3 Looking South East

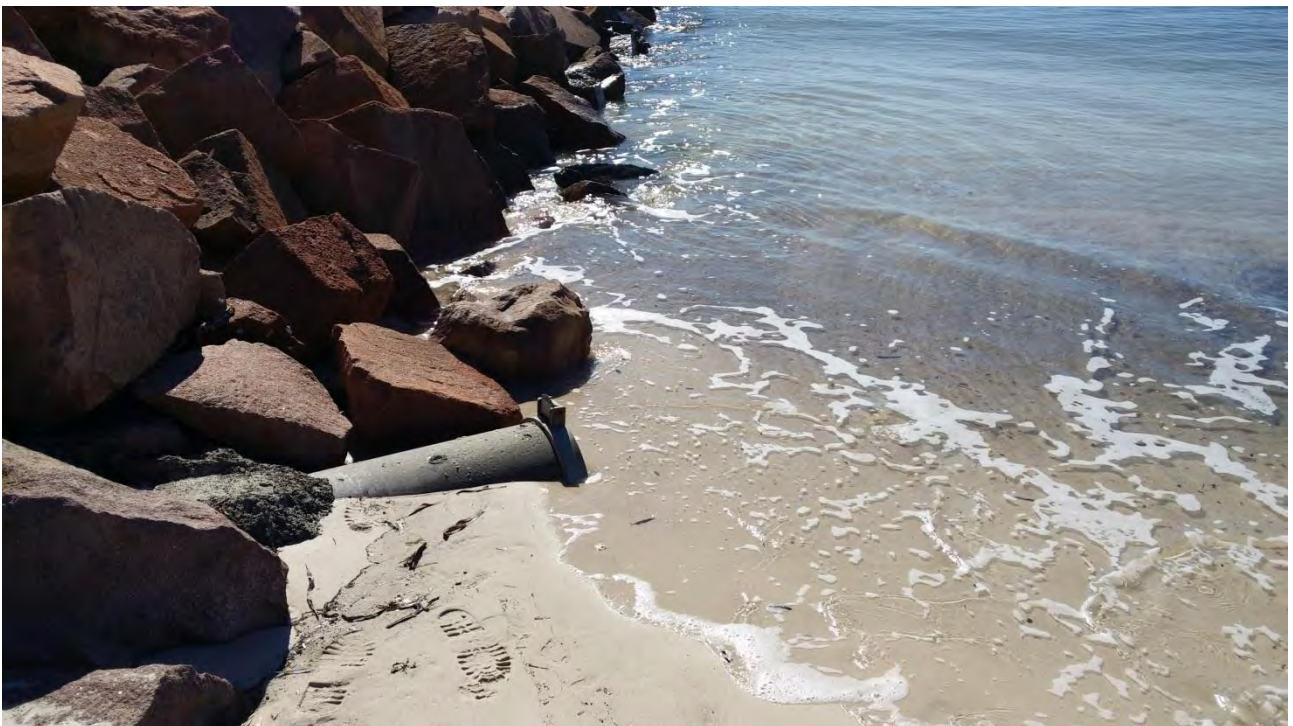
Photo 5 - Outfall 5, partially blocked with flap valve removed.

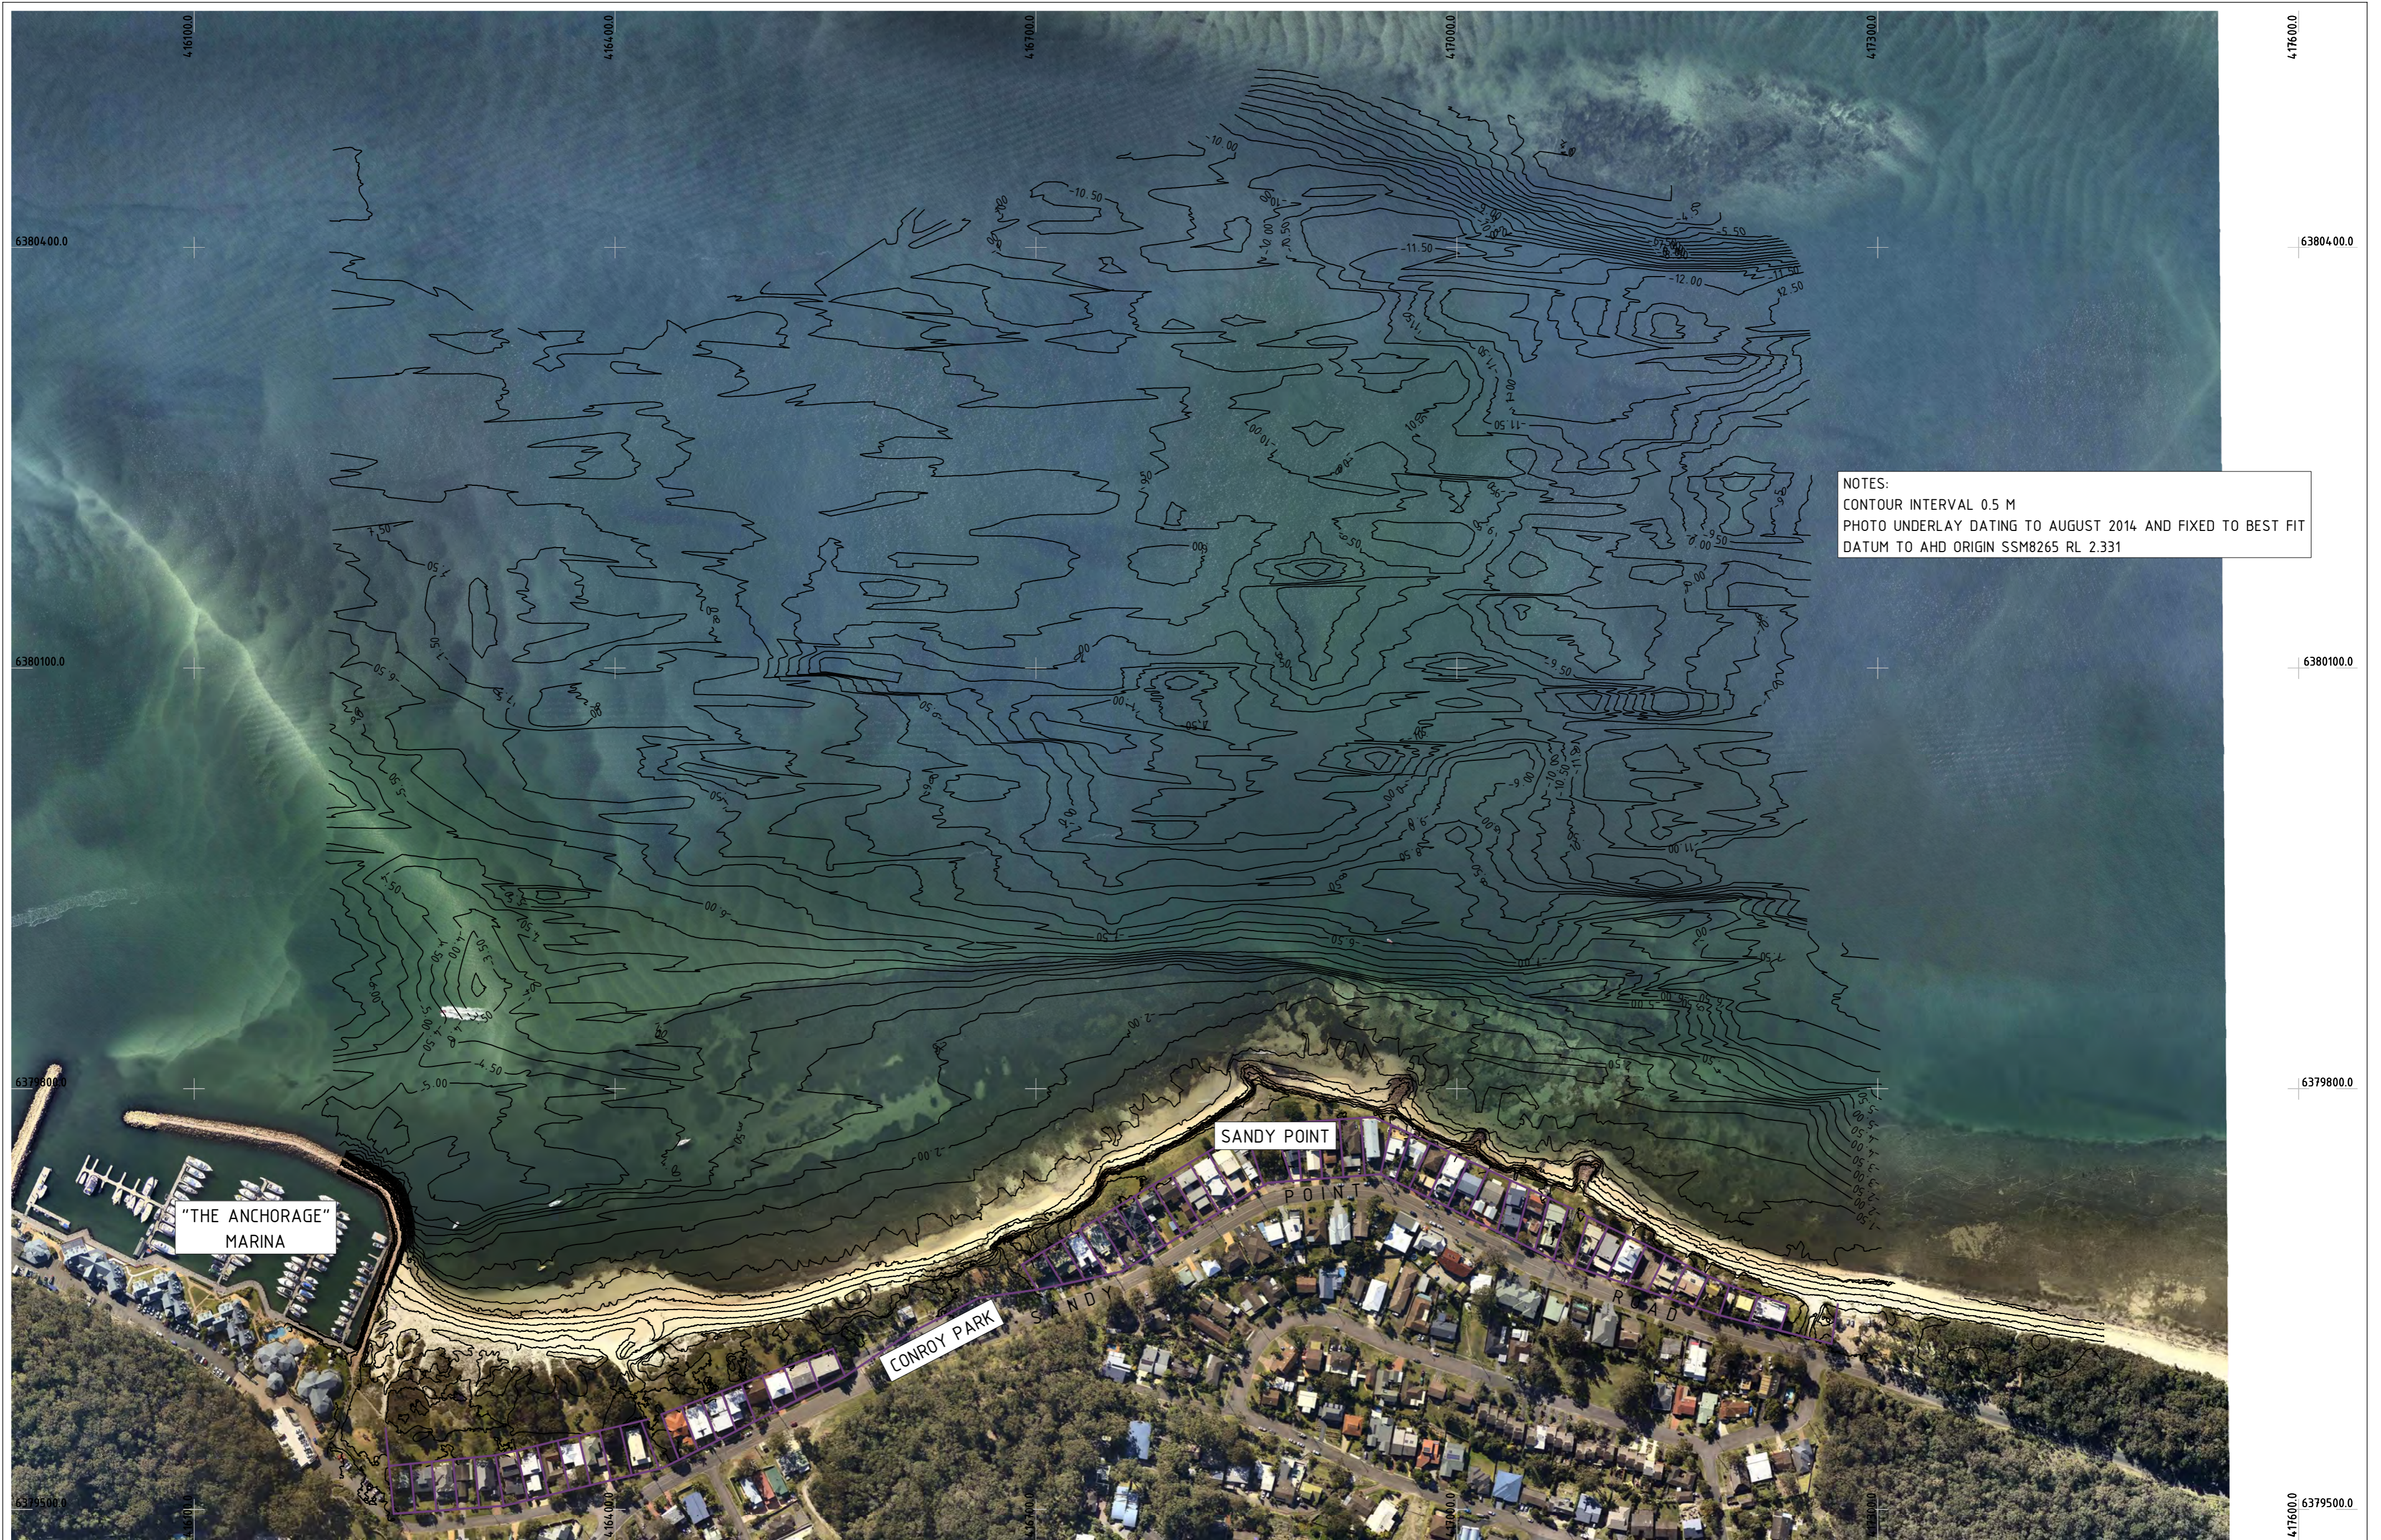
NOTES:
 CONTOUR INTERVAL 0.5 M
 PHOTO UNDERLAY DATING TO AUGUST 2014 AND FIXED TO BEST FIT
 DATUM TO AHD ORIGIN SSM8265 RL 2.331

TITLE
 PLAN SHOWING HYDROGRAPHIC & TOPOGRAPHIC CONTOURS
 BETWEEN SANDY POINT AND ANCHORAGE RESORT

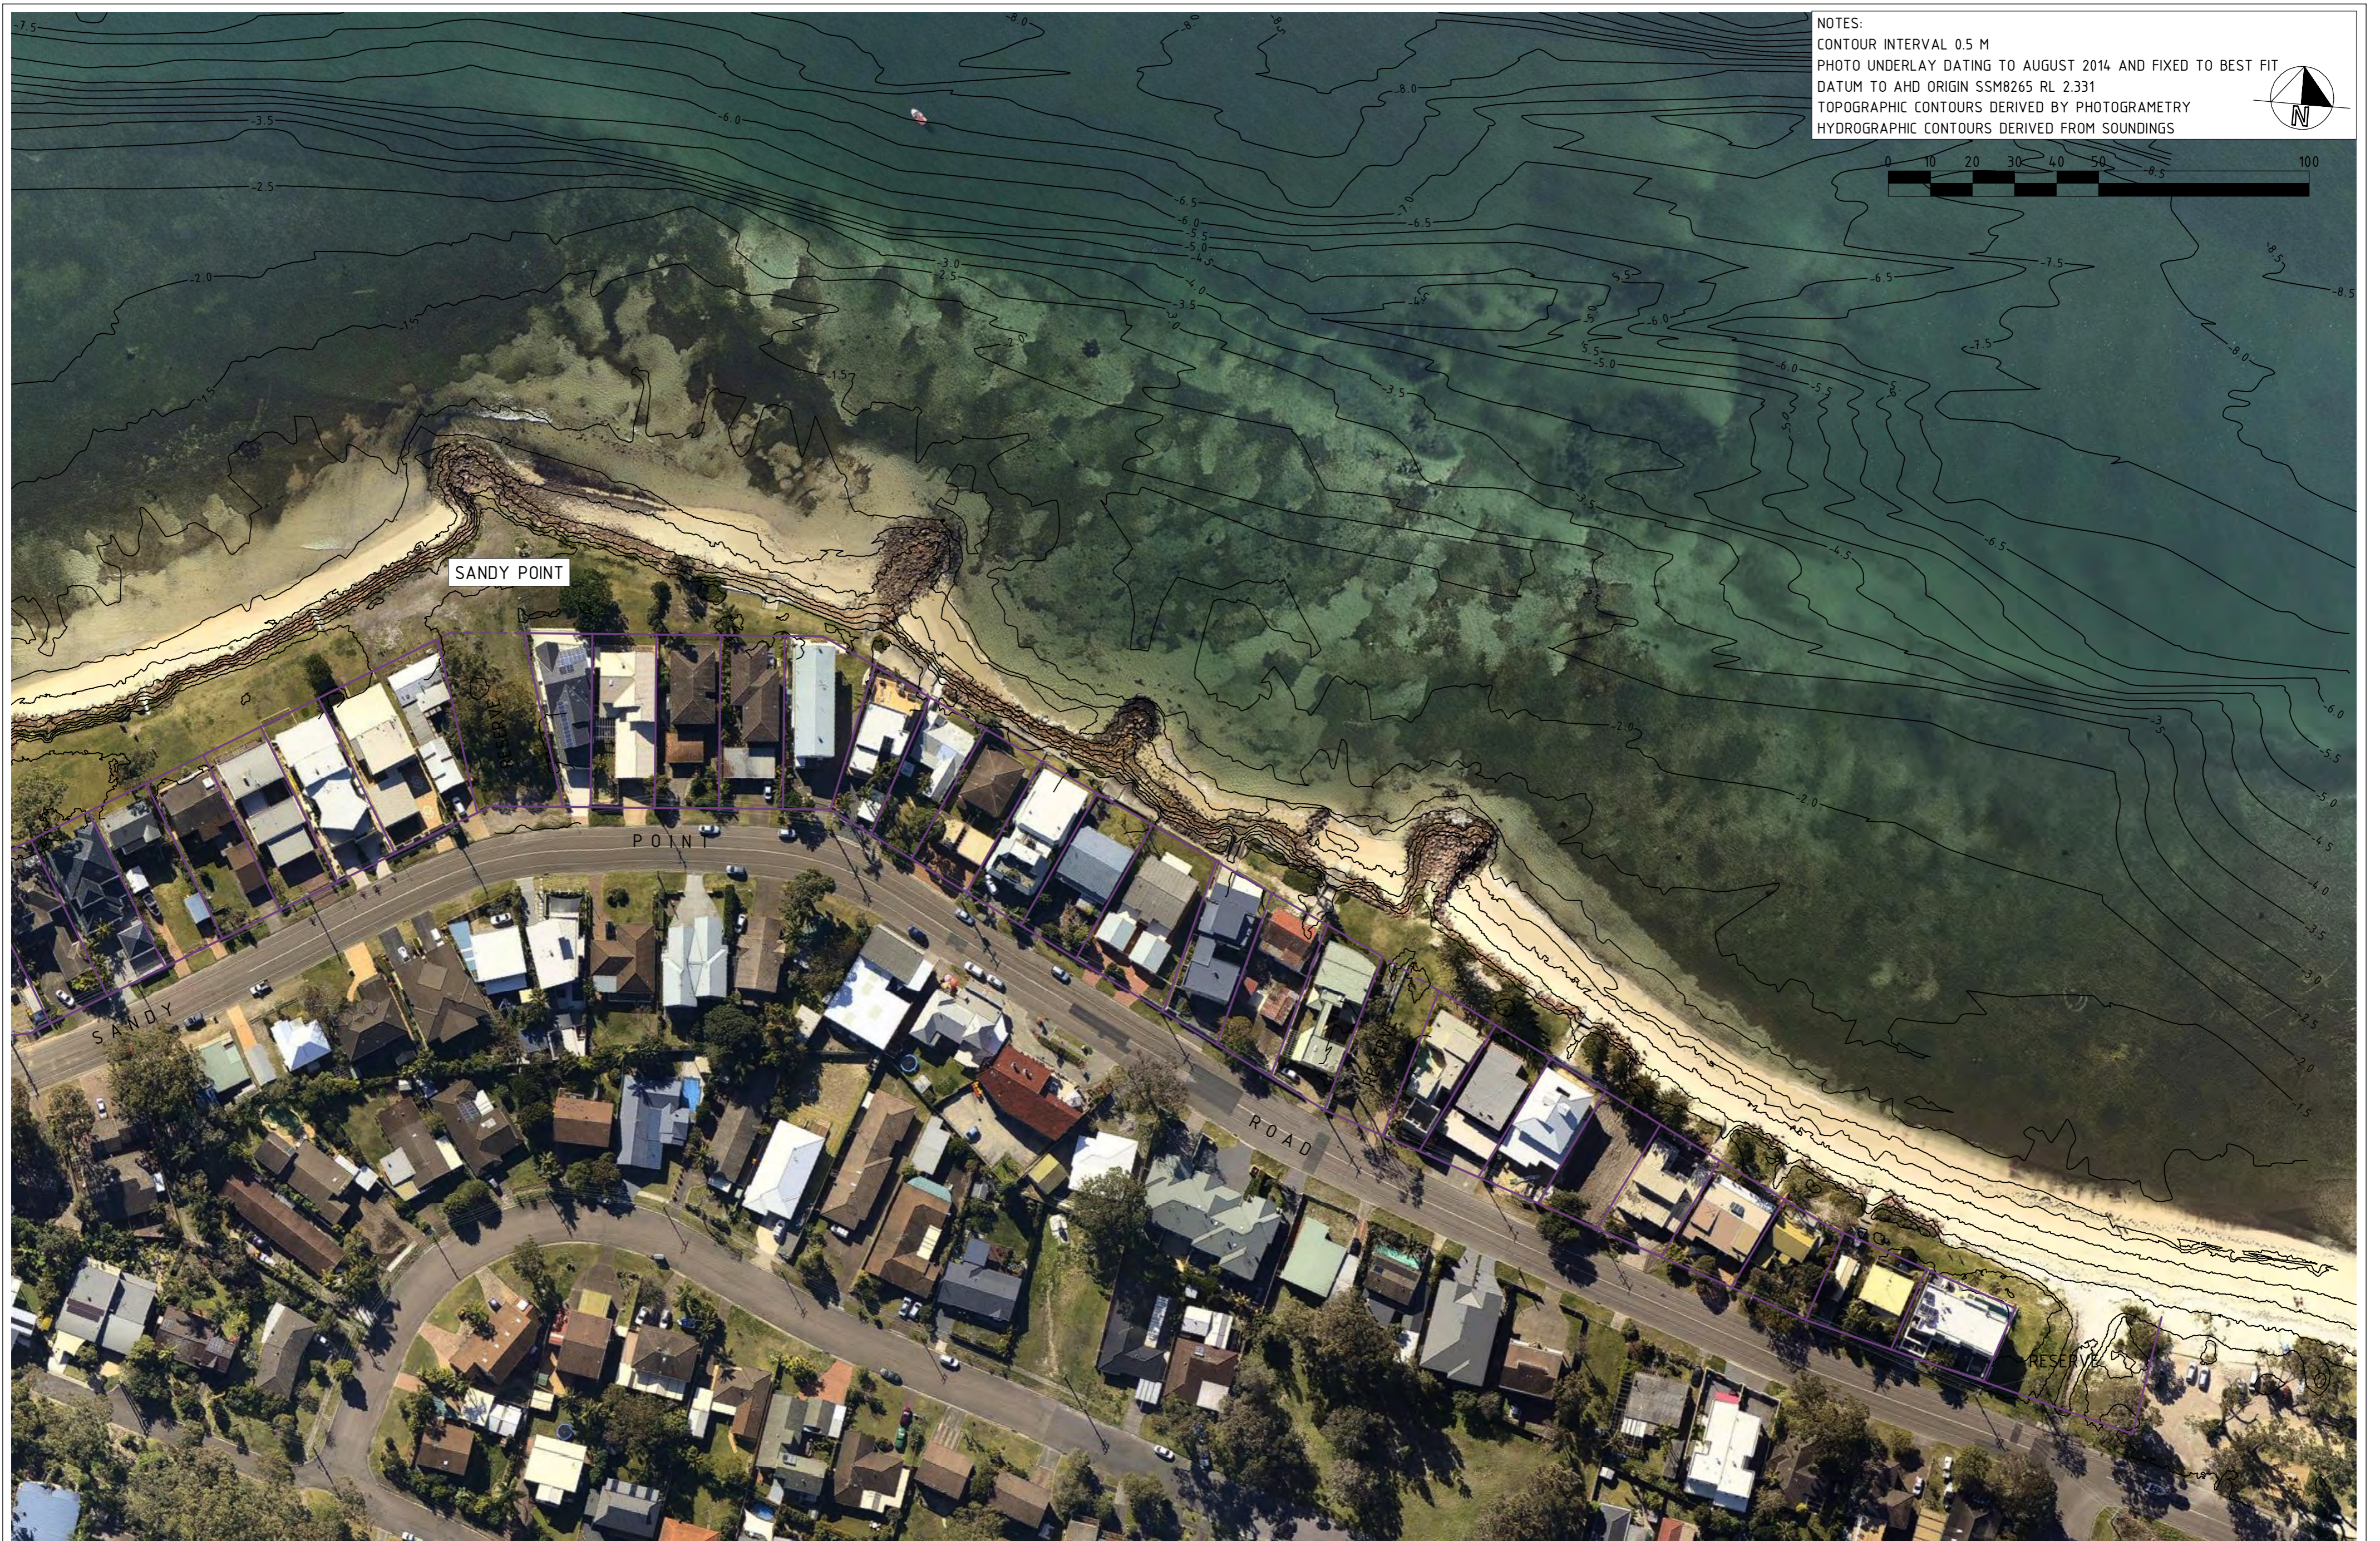
NOTES:
 CONTOUR INTERVAL 0.5 M
 PHOTO UNDERLAY DATING TO AUGUST 2014 AND FIXED TO BEST FIT
 DATUM TO AHD ORIGIN SSM8265 RL 2.331
 TOPOGRAPHIC CONTOURS DERIVED BY PHOTOGRAMETRY
 HYDROGRAPHIC CONTOURS DERIVED FROM SOUNDINGS

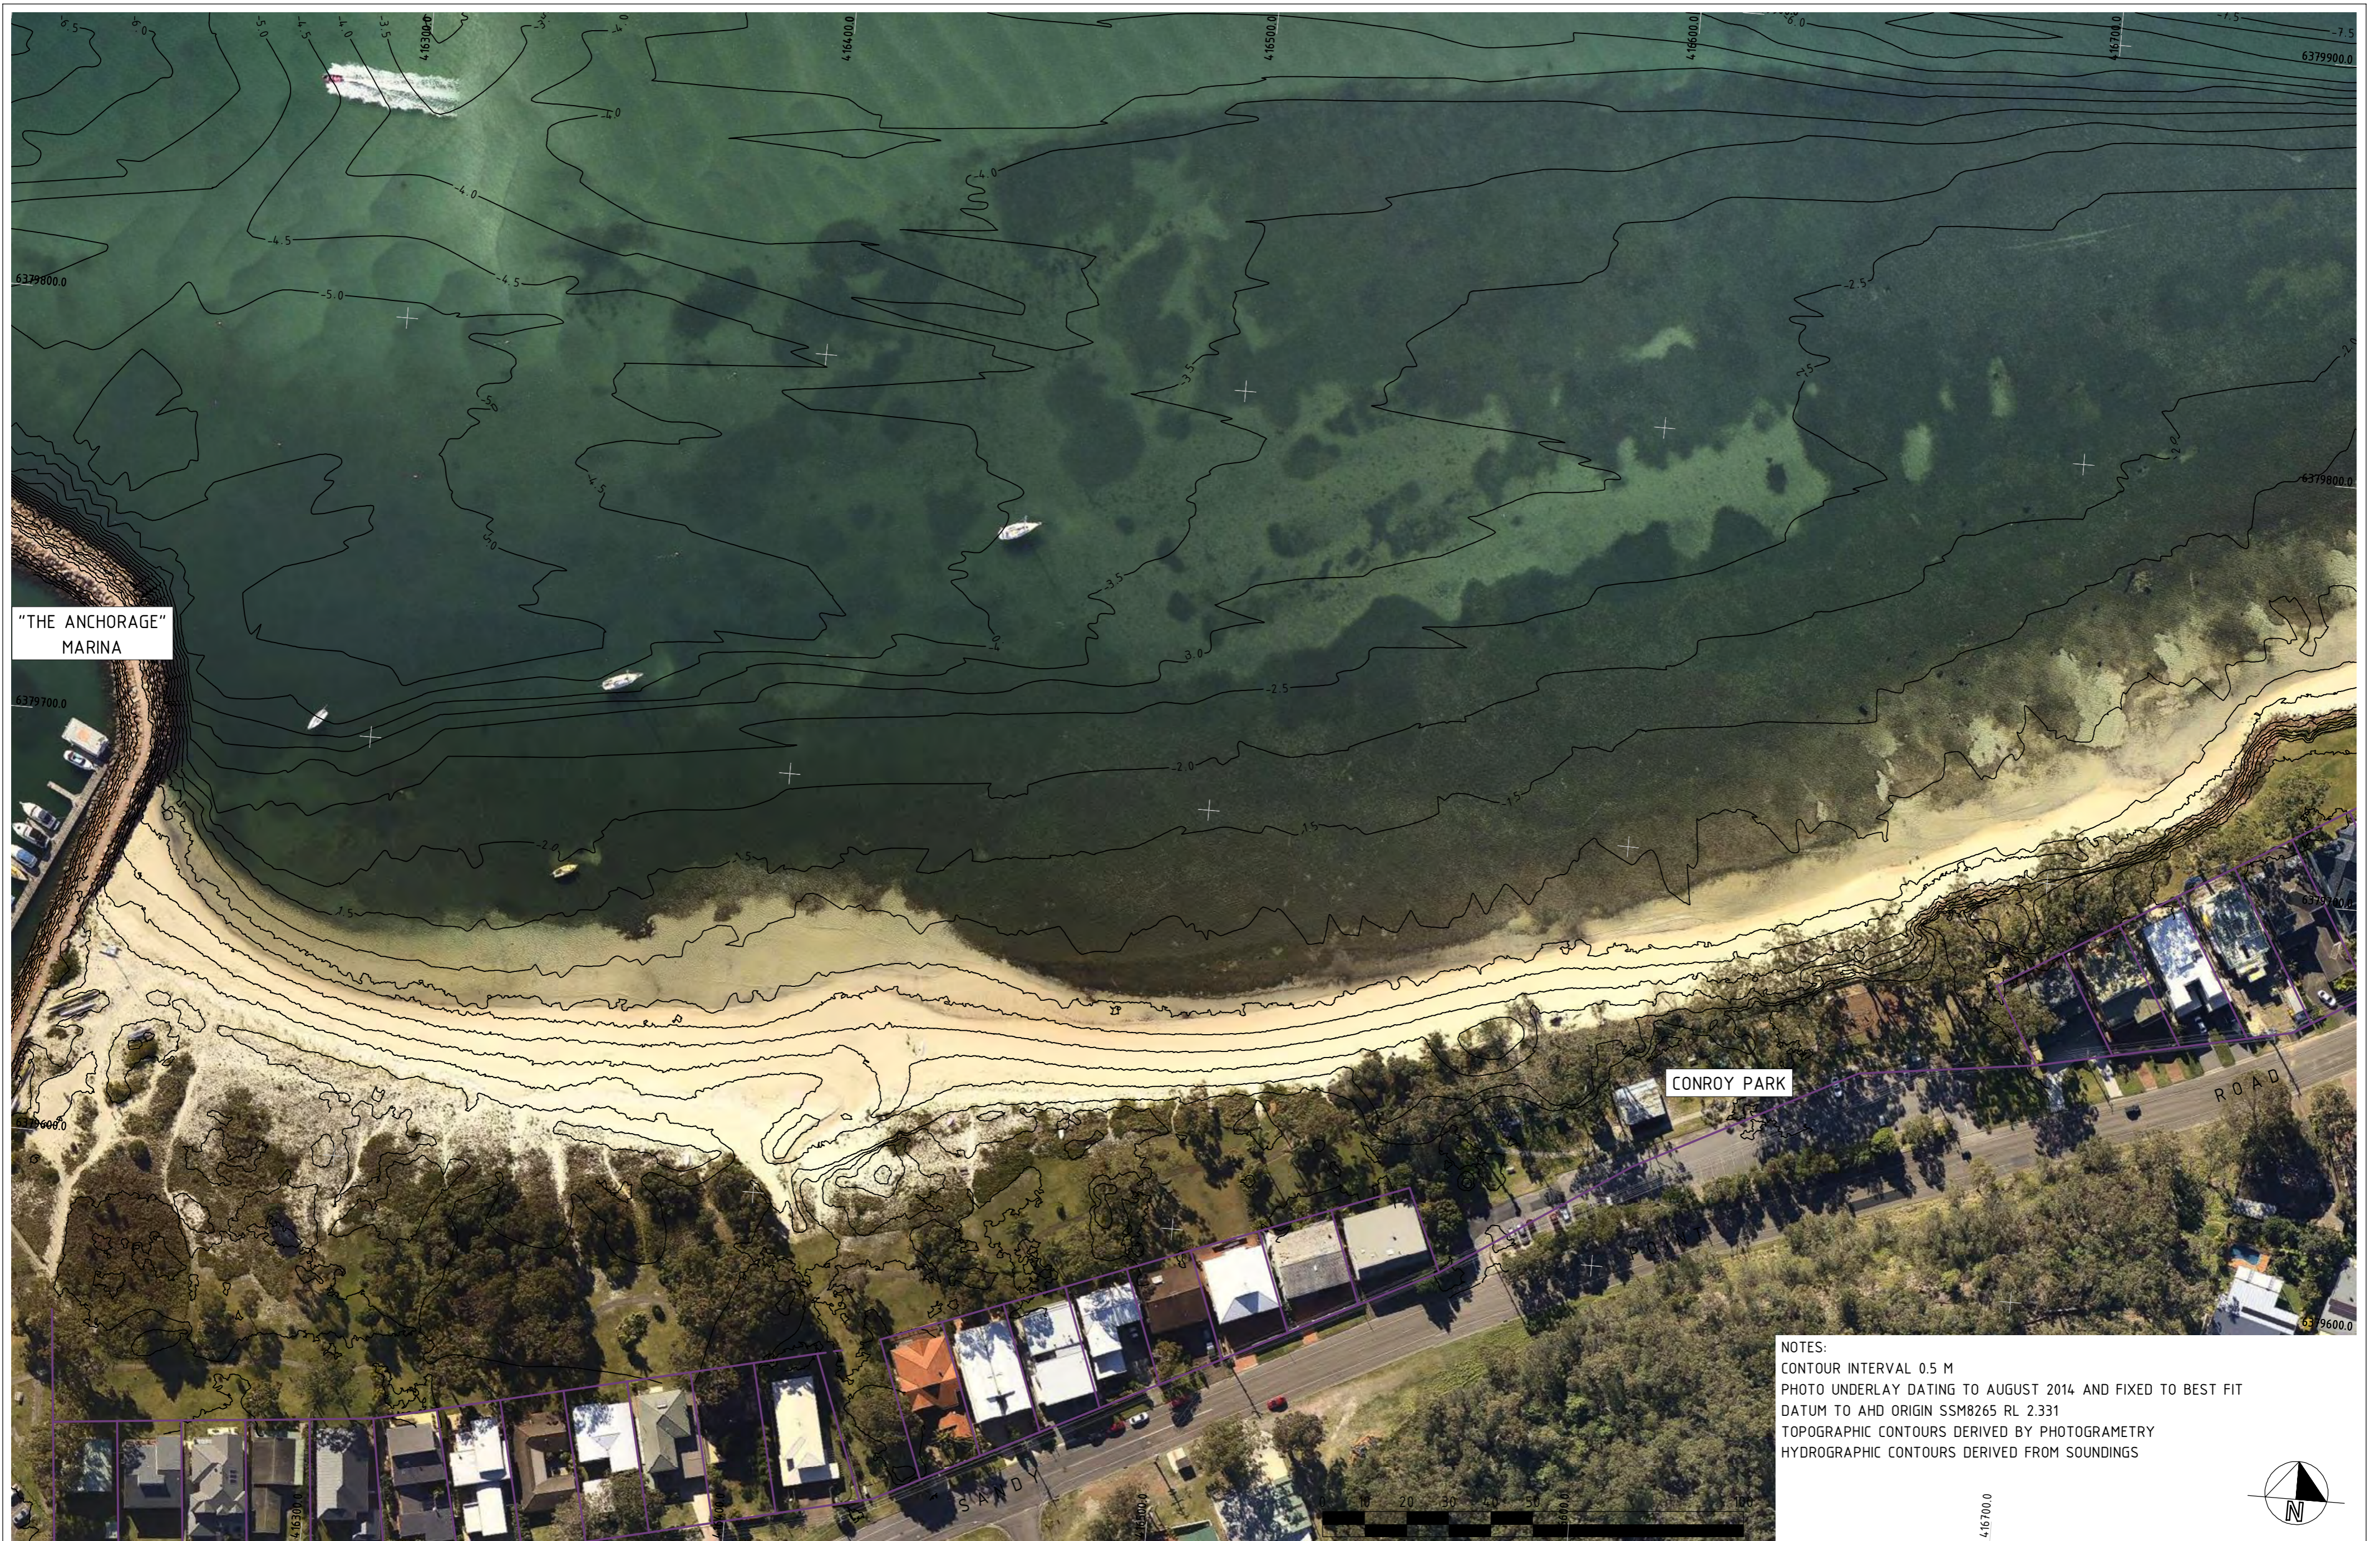
NOTES:
 CONTOUR INTERVAL 0.5 M
 PHOTO UNDERLAY DATING TO AUGUST 2014 AND FIXED TO BEST FIT
 DATUM TO AHD ORIGIN SSM8265 RL 2.331
 TOPOGRAPHIC CONTOURS DERIVED BY PHOTOGRAMMETRY
 HYDROGRAPHIC CONTOURS DERIVED FROM SOUNDINGS
